# Preliminary Information

## PIP5498J SES Lamp P050D P0300 Setting On A Cold Start And/Or a Run Rough Warm with No codes

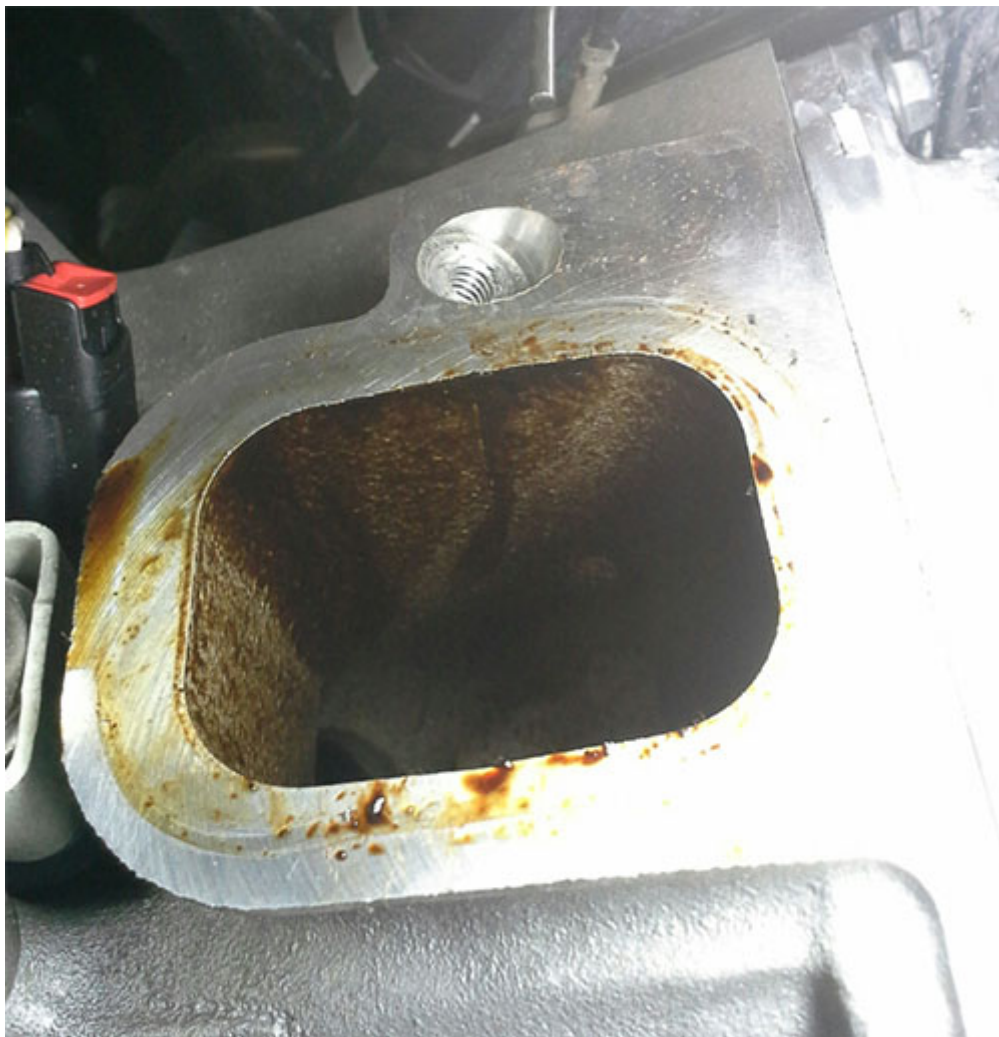
If the head casting line is the concern the intake port will be wet with a coolant oil mix.

This could be the cause of a running rough warm concern with or without codes.

The location of where the coolant is running down in the port will also look washed down.

If this is found the cylinder head will need to be replaced.

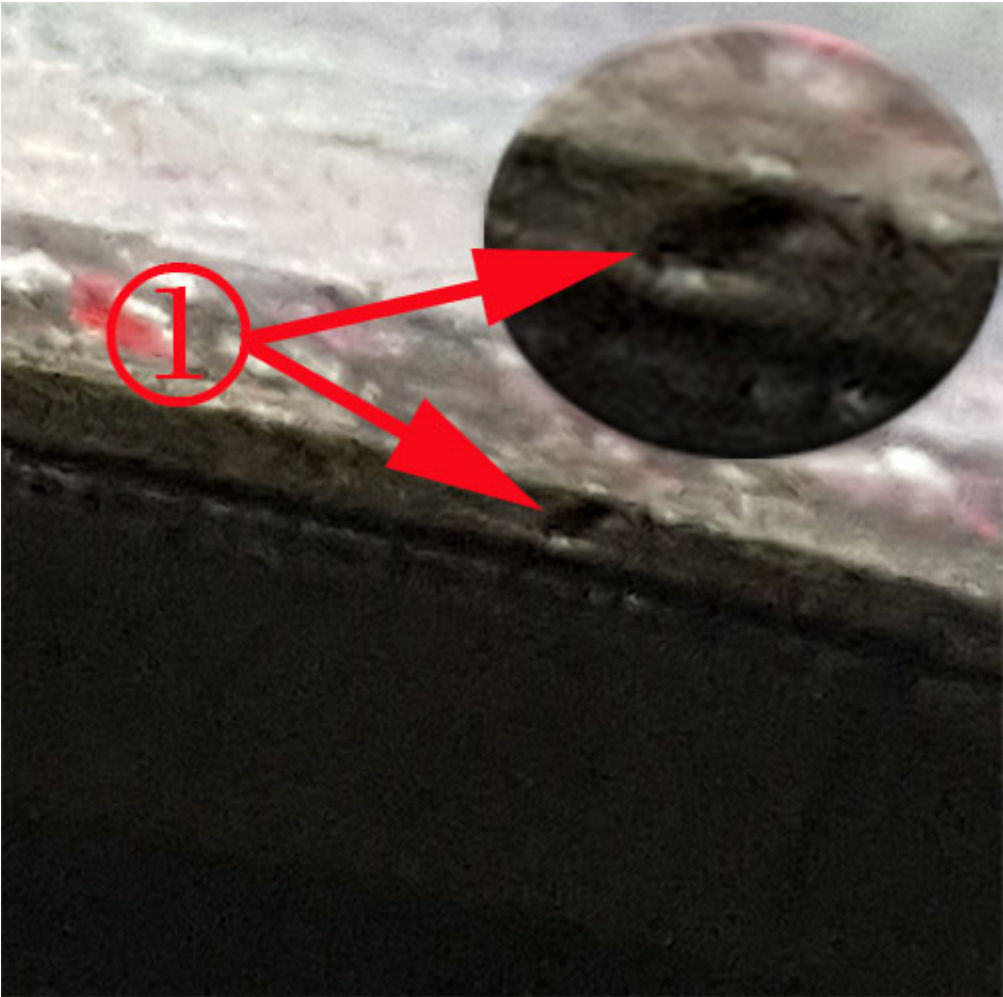
For coolant entry at the liner to deck face casting of the cylinder bore.

It is hard to see the actual source (pin hole) but it usually streams down the liner so that you can see it with a borescope.(Sometimes) The top of the piston will be steam cleaned.

Do not confuse residual fuel on the piston crown / surface as coolant. Some fuel residue may be present and can be mistaken as coolant (reason for the cooling system Dye to be added). Use black light to confirm the liquid is coolant. If this concern is present, do not replace the cylinder head because that will not repair this concern. Call PQC per the latest version of [16-NA-338](#), if required, reference this PI and replace the engine.
