Preliminary Information

PIP5335B SES Lamp With Camshaft Position Codes P0340 and/or P0341

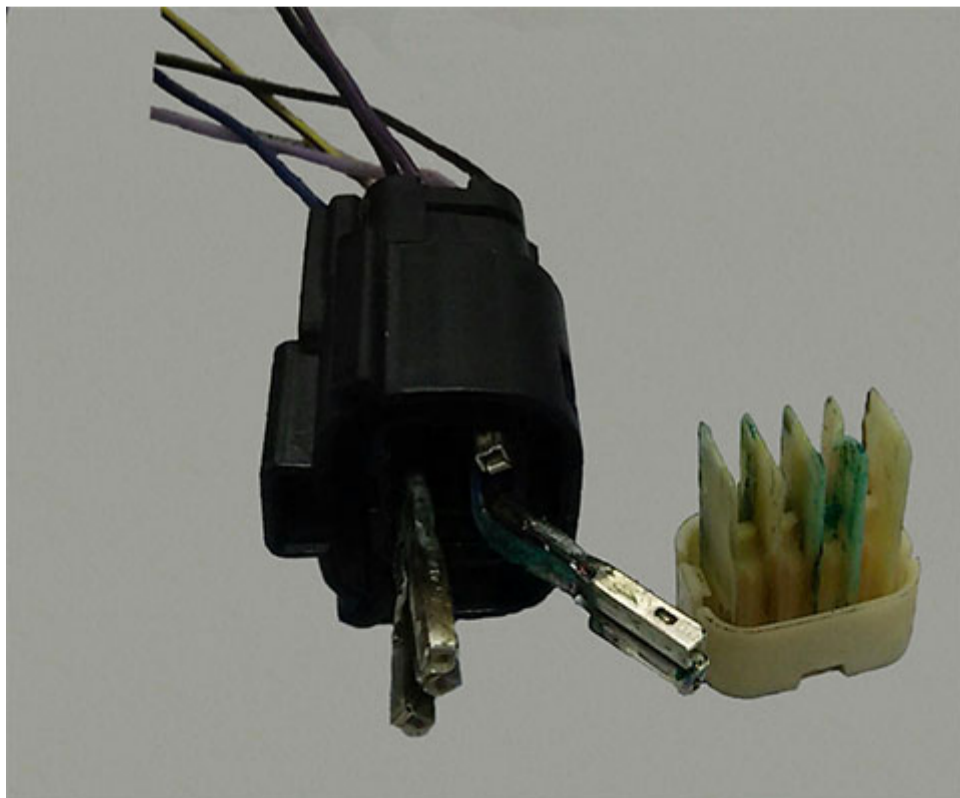
If normal SI Diagnostics does not isolate the concern, inspect for corrosion in connector X154 or X159 (2015 only) located on the front cover next to the vacuum pump.

See the illustration below

If this condition is encountered repair as needed.
