PIC6336 Folding Top Service Tips to Prevent A Broken Rear Glass Assembly

Brand:	Model:	Model Years:	VIN:		Engine:	Transmissions:
			from	to		
Chevrolet	Camaro	2016 - 2019	All	All	All	All

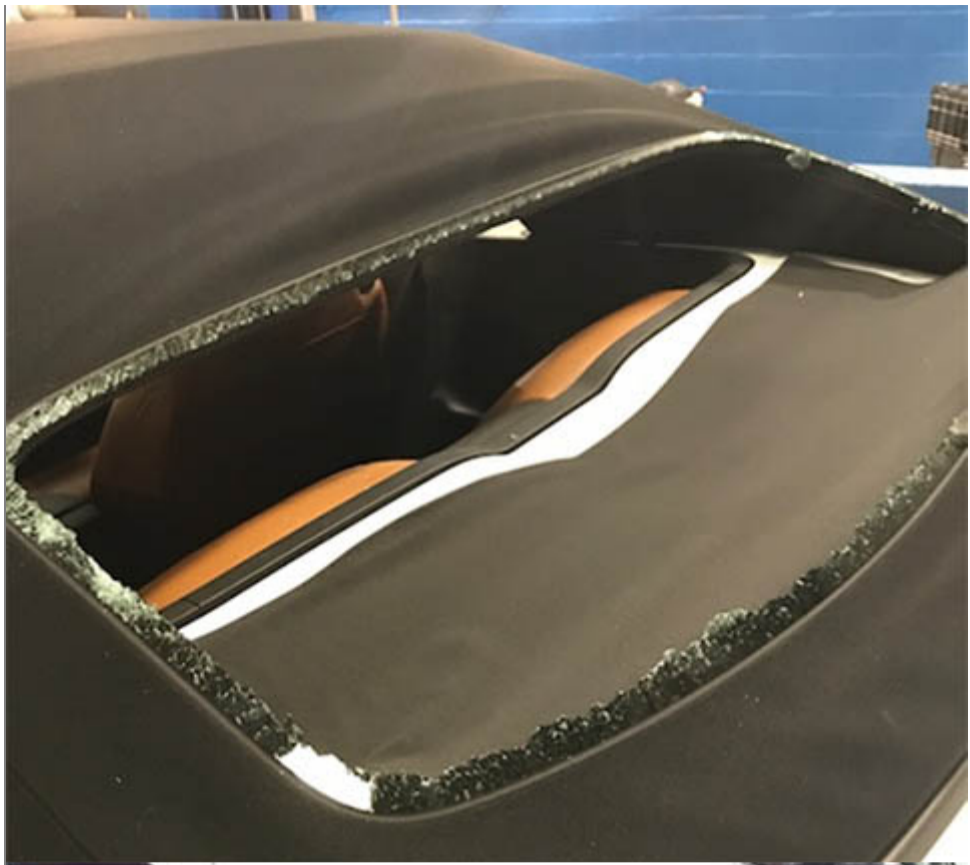
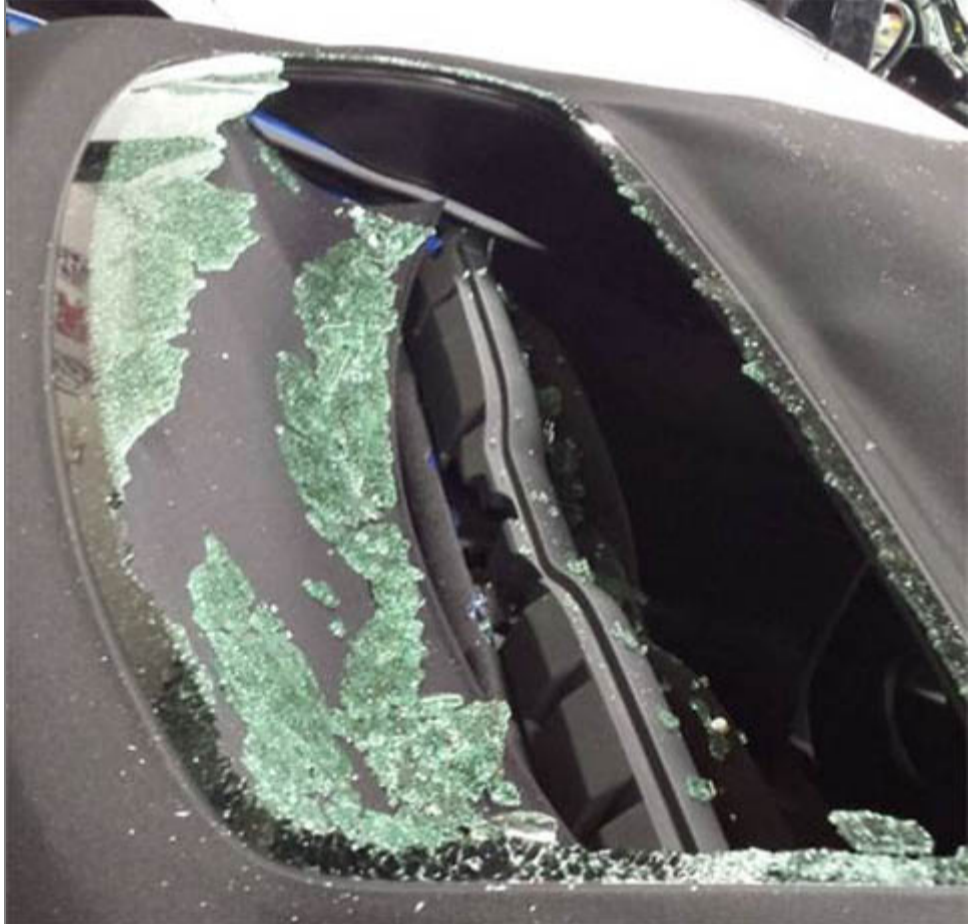
Involved Region or Country	All
Additional Options (RPO)	CM8 - Power Folding Top
Condition	Some technicians may comment that the back glass, which is an integral part of the folding top canvas, had broken after cycling the folding top assembly. This will be noticed very soon after a folding top canvas or a side rail has been replaced for service.

The cause of this concern may be due to improper reassembly of the folding top linkage where it connects to the back glass.

If this concern is encountered, dealership technicians are to first inspect the linkage that connects the folding top frame to the back glass that is attached to the folding top canvas.

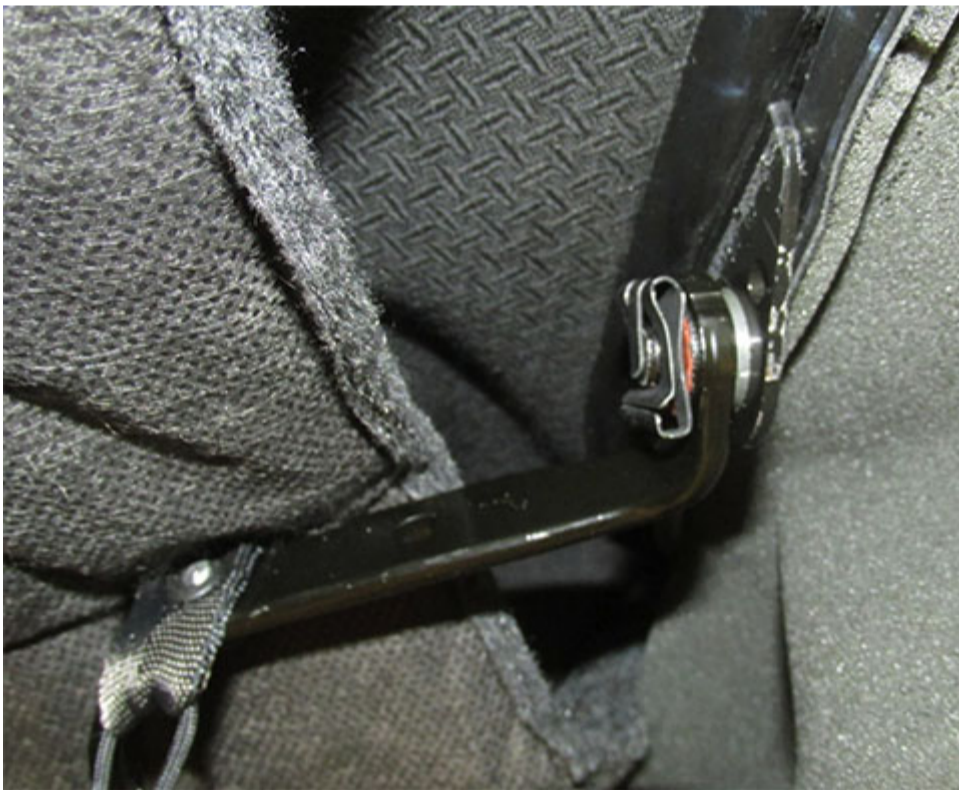
See photo below of a correctly assembled folding top linkage at the rear glass attachment point.

The folding top linkage that attaches to the rear glass **MUST** be located on the outboard side of the back glass bracket.

The pin that holds it together is inserted from the inboard side of the linkage.

It first goes through the back glass bracket, after that it goes through the top frame linkage.

Finally, the spring clip is installed on the outboard side of the top frame linkage.
