Preliminary Information

PIT5387F Radio HVAC IPC Blank out When Operating a Snow Plow

With Snow Plow Prep Package (RPO VYU)

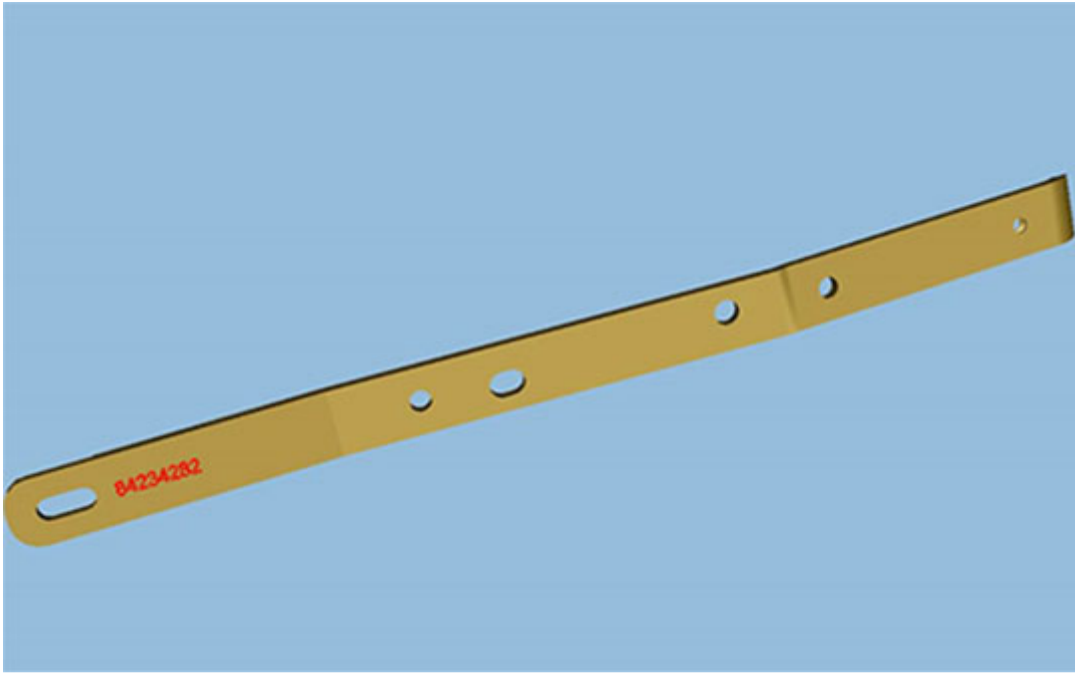
Note: Relay bracket P/N 84234282 (shown below), which is being shipped in the loose parts bag, has prompted questions regarding what it is used for and where to install it. This bracket is intended to replace the left front diagonal brace between the fender and radiator tie bar to provide a mounting spot for the generator snow plow jumper harness relay. Follow the latest version of GM Upfitter Bulletin 124 for mounting the relay.

GM Engineering has released a generator snow plow jumper harness, part number 84043394, to correct this concern. Please reference the latest version of GM Upfitter Integration Bulletin 124 for additional information and installation instructions. To view this bulletin, access <http://www.gmupfitter.com/>, select the "TECHNICAL BULLETINS" tab followed by "Show all bulletins".
