TECHNICAL SERVICE BULLETIN

Long Wheelbase - 60/40 Second Row Seat(s) Stuck Or Difficult To Fold/Unfold - Built On 9-Jan-2013 And Through 5-Jan-2018

18-2179
03 July 2018

Ford 2013-2018 Transit Connect
--

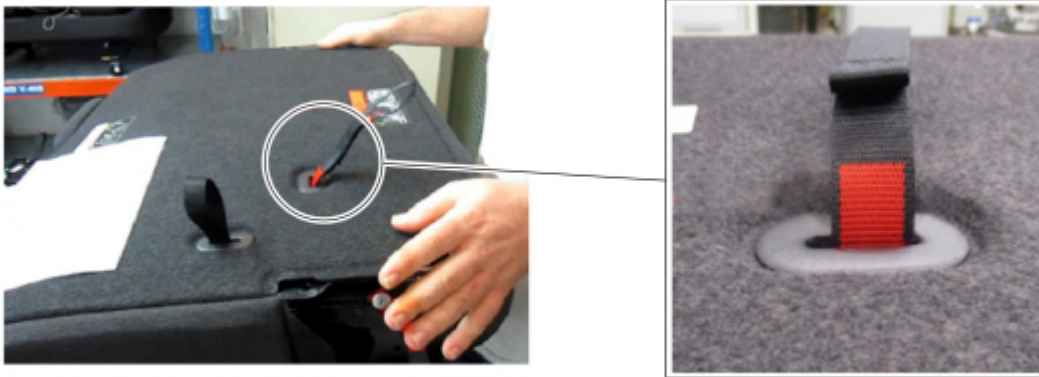
Figure 1

- Check the vehicle build date. Was the vehicle built on 1–Jan–2013 and through 5–Jan–2018?
 - Yes – proceed to Step 2.
 - No – this article does not apply. Refer to Workshop Manual (WSM), Section 501-10B for normal diagnostics.
- Is either section of the second row seat bottom stuck in the folded position and/or is the strap stuck and displaying the red indicator on the strap on the seat back? (Figure 1)
 - Yes - proceed to Step 3.
 - No – this article does not apply. Refer to WSM, Section 501-10B for normal diagnostics.
