Preliminary Information

PIP5487C 6.6L L5P Duramax Coolant Leaks

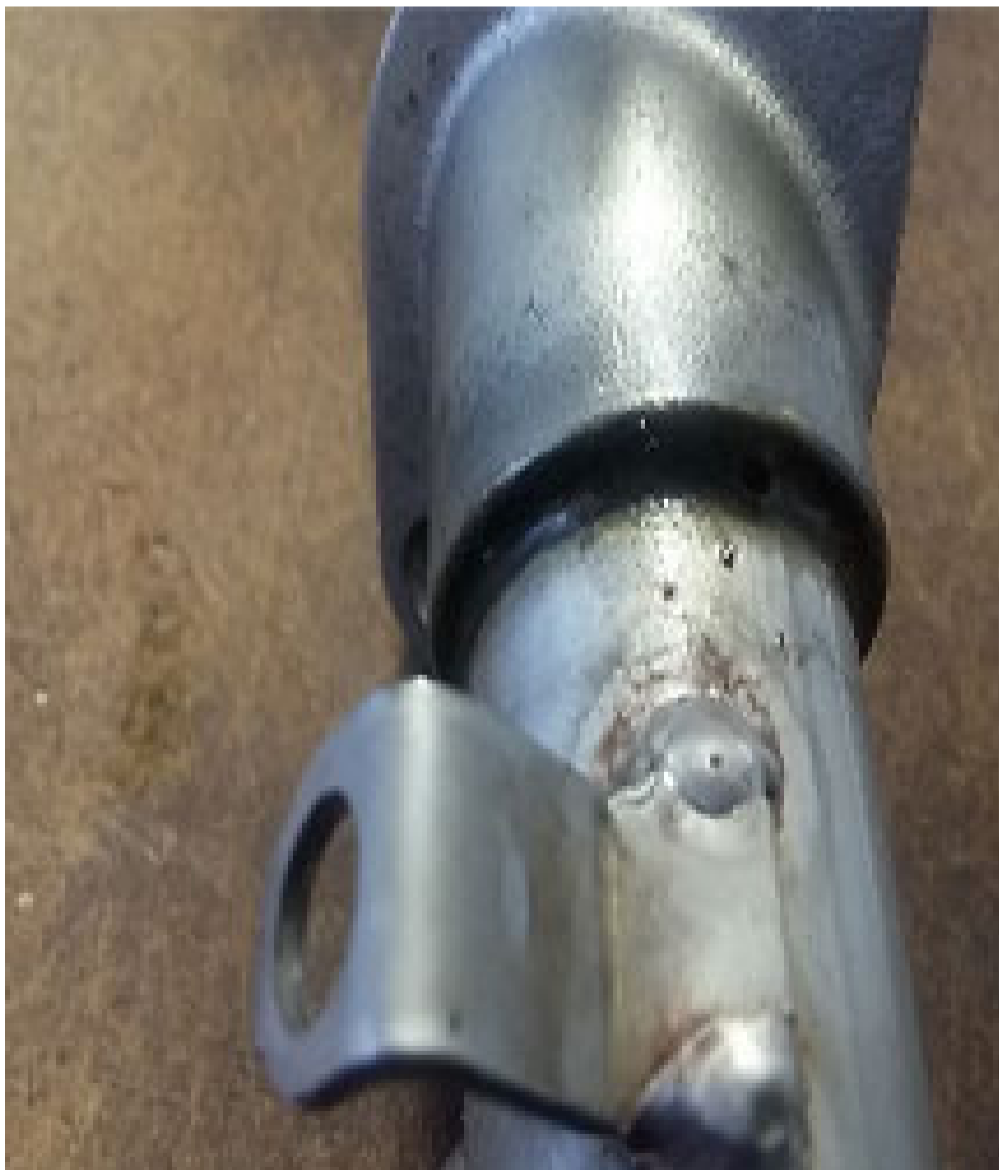
Welded flange leaking on the Exhaust Gas Recirculation (EGR) coolant return pipe. Refer to call out #1 in the above picture.

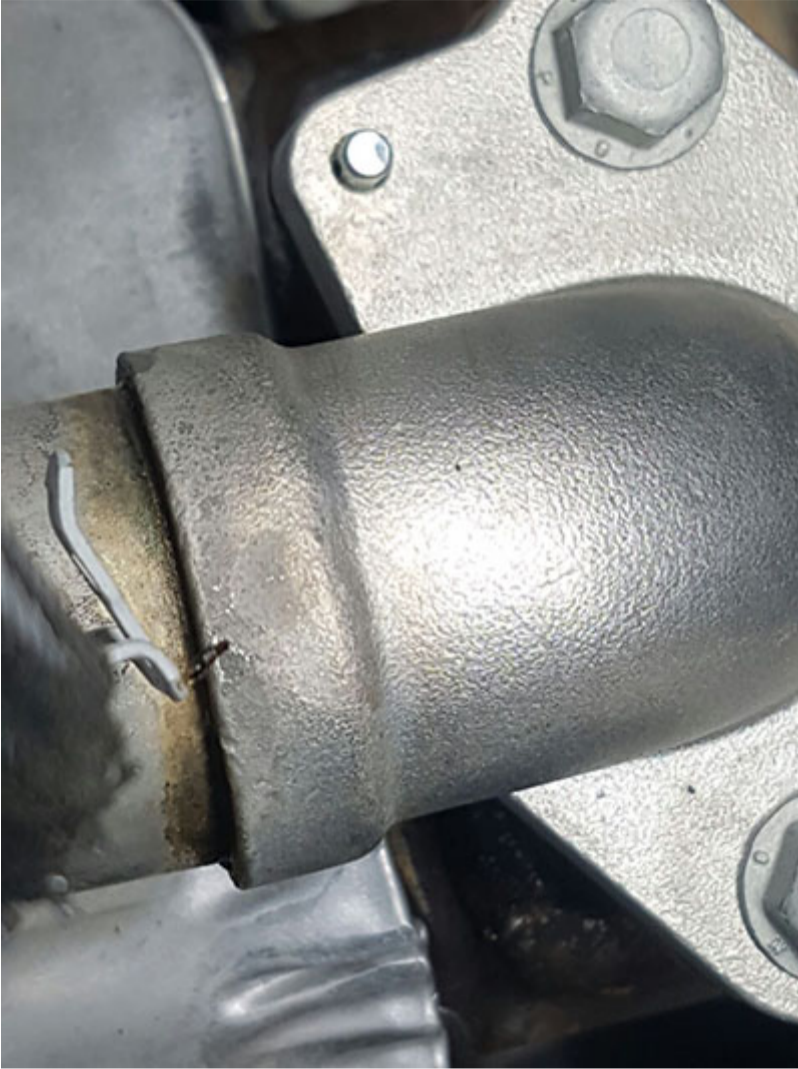
Welded flange leaking on the Exhaust Gas Recirculation (EGR) coolant feed pipe. Refer to call out #2 in the above picture.

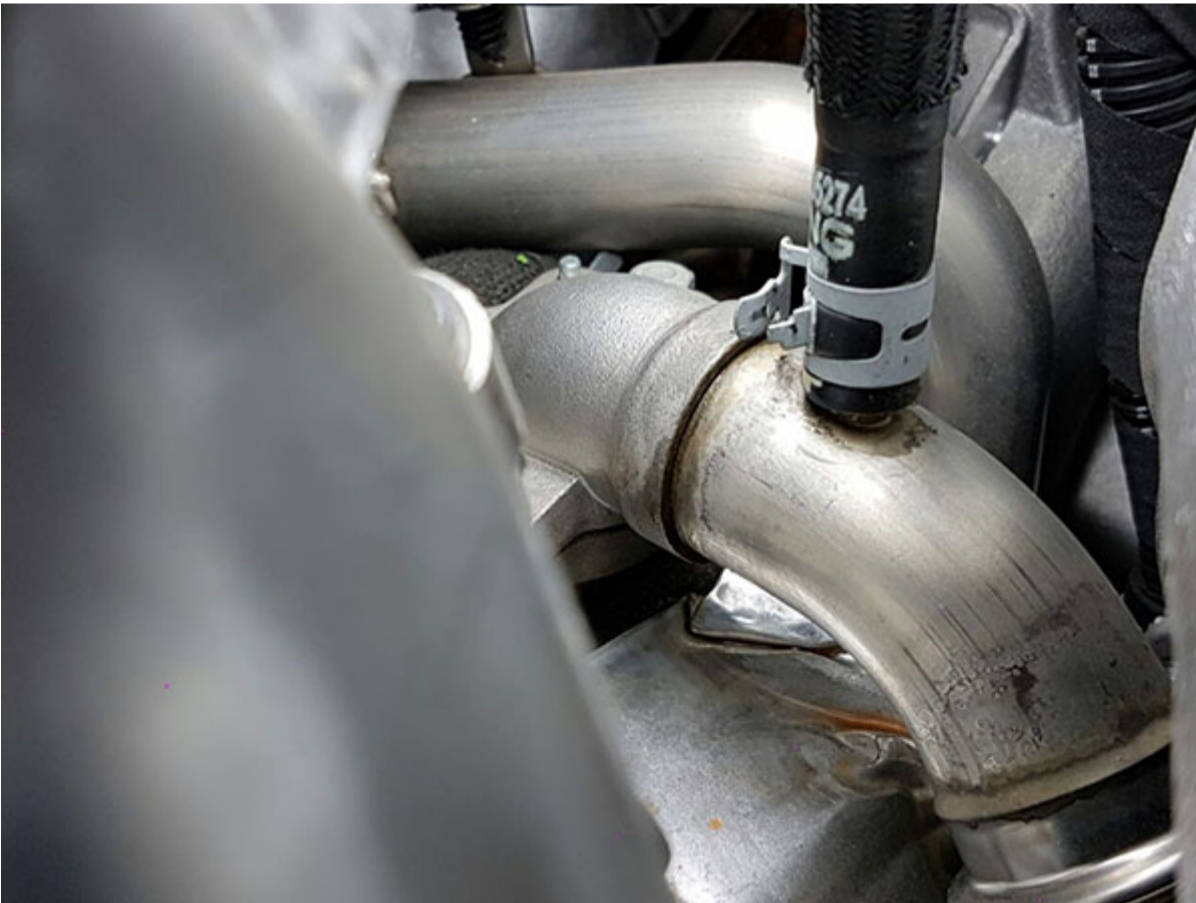
Another view of the leaking welded flange on the Exhaust Gas Recirculation (EGR) coolant feed pipe. Refer to call out #2 in the above picture.

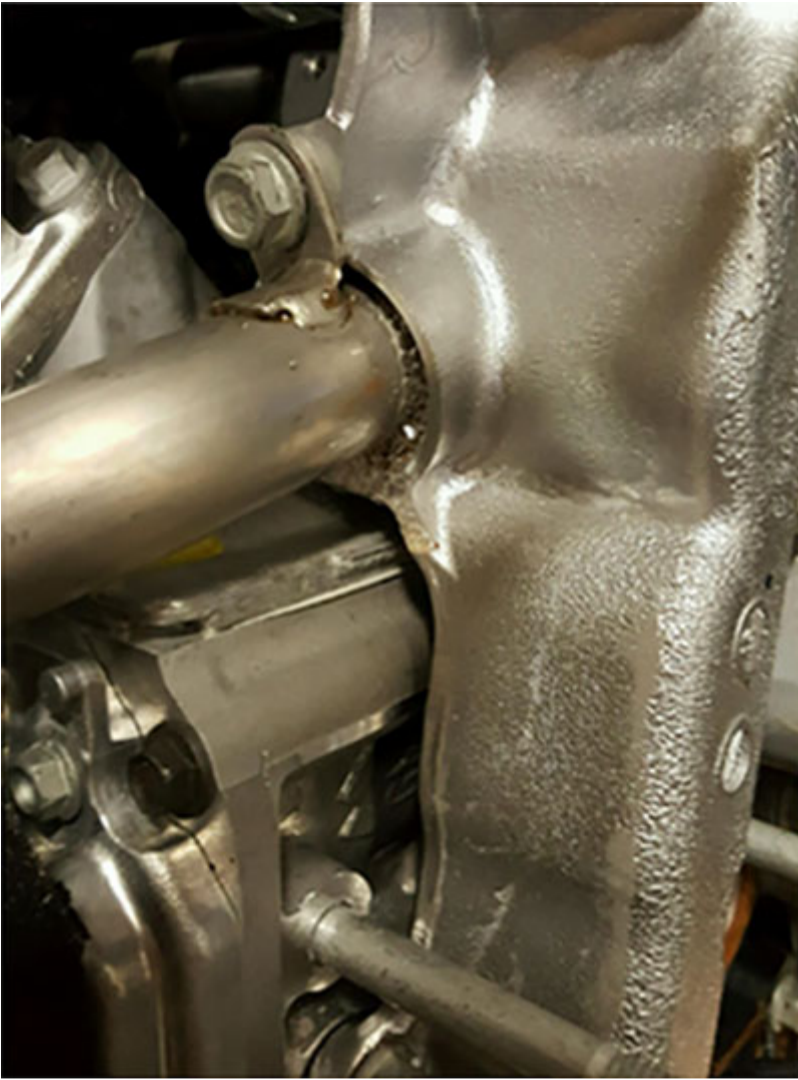
Coolant leak at the O-ring seal of the Exhaust Gas Recirculation (EGR) coolant feed pipe. Refer to call out #2 in the above picture.

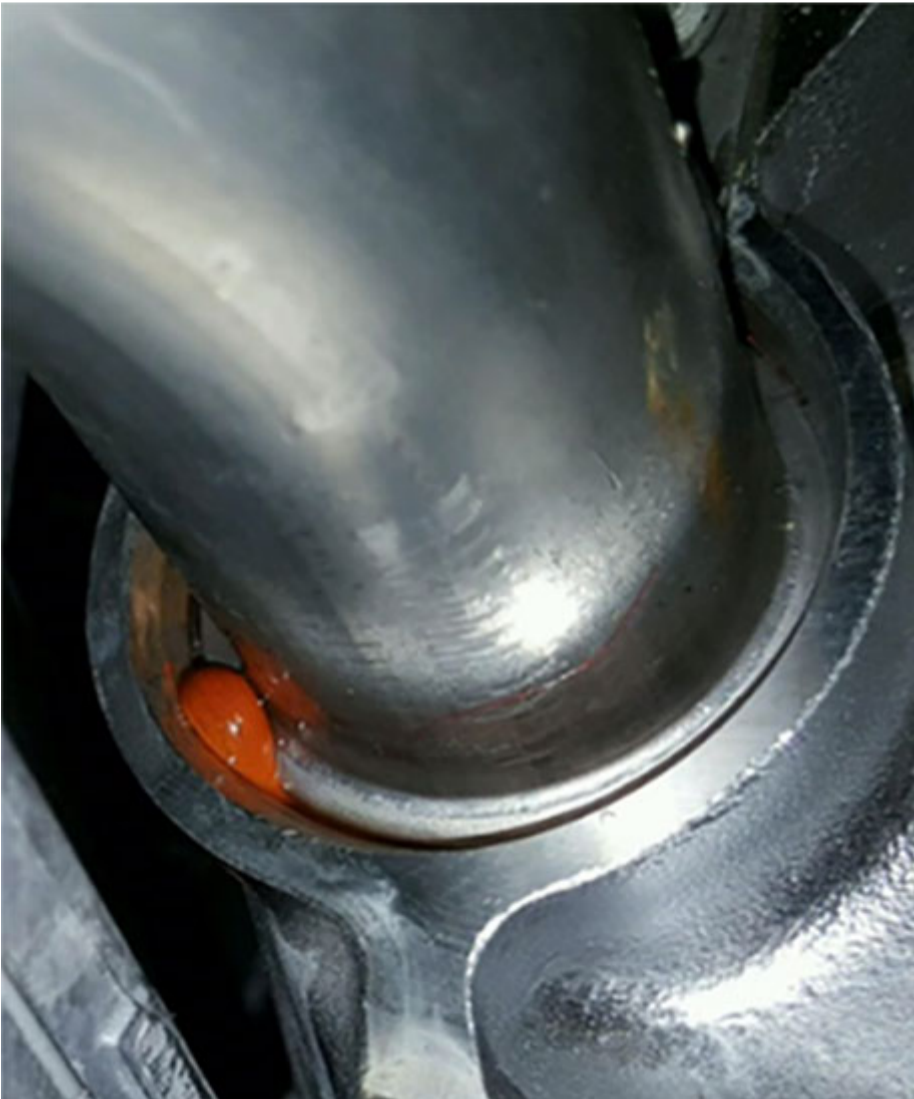
View of a rolled or pinched O-ring at Exhaust Gas Recirculation (EGR) coolant feed pipe. Refer to call out #2 in the above picture.

NOTE : The leak shown above could only be confirmed after removing the front accessory drive bracket and alternator.

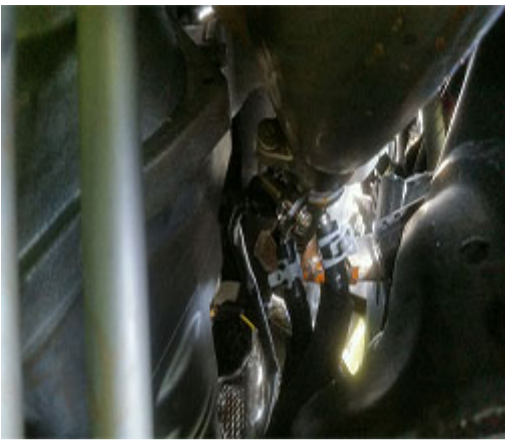
Coolant leaking from coolant hoses at the Emission Reduction Fluid Injector (DEF Injector).
