August 25, 2018

Version 2

A/C Does Not Blow Cold Air and Condenser Leaks at Receiver Dryer Cap

Supersedes 18-080, dated August 22, 2018, to revise the information highlighted in yellow

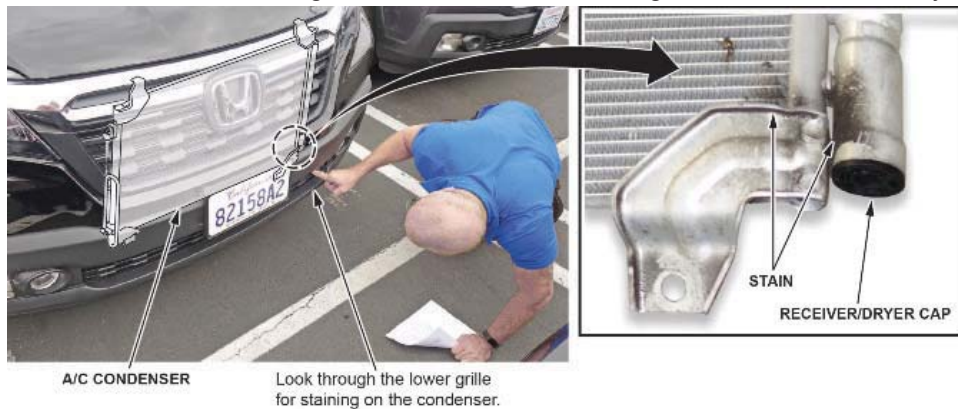
The A/C does not blow cold air, and the lower corner of the condenser around the receiver/dryer cap is stained.

There is poor O-ring compression against the receiver/dryer barrel wall.

Check if the A/C is blowing cold air and there is staining around the receiver dryer cap on the condenser.

- If the A/C is not blowing cold air and there is staining around the receiver dryer cap on the condenser, go to REPAIR PROCEDURE.
- If the A/C is not blowing cold air and there is no staining around the receiver dryer cap, continue with normal system troubleshooting.
