NUMBER: 23-011-15

Tailgate Retaining Strap Over Extends And Breaks

2012 - 2014 (JK)

Wrangler

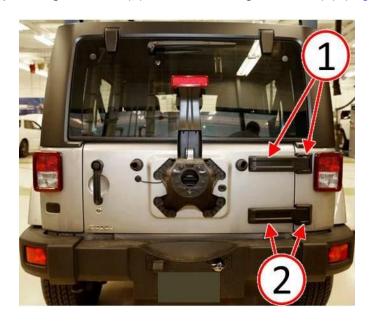
Fig. 1 Tailgate Hinge Covers

^{1 -} Upper Hinge Covers

^{2 -} Lower Hinge Covers

- 1. Paint the new replacement tailgate hinges per the approved warranty refinish paint manufacturers (Akzo Nobel, Axalta, BASF, PPG, and Sherwin-Williams) recommendations.
- 2. Remove the spare tire from the tailgate if applicable.
- 3. Remove the upper hinge covers (1) and lower hinge covers (2) (Fig. 1).

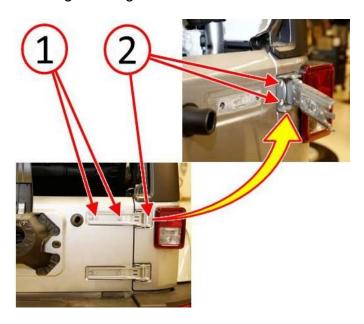
Fig. 2 Tailgate Hinges

- 1 Tailgate Side Hinge Bolts
- 2 Body Side Hinge Bolts

4. Replace both tailgate hinges one at a time. First remove the tailgate side hinge bolts (1) then the body side hinge bolts (2), reverse order for installation (Fig. 2). Apply body sealant per manufacturer's directions to the back surface of the hinge where it makes contact with the vehicle to prevent corrosion (Fig. 3). Refer to the detailed repair procedures available in: DealerConnect> TechCONNECT under: Service Info> 23 - Body> Decklid/Hatch/Liftgate/Tailgate> HINGE> Removal / Installation.

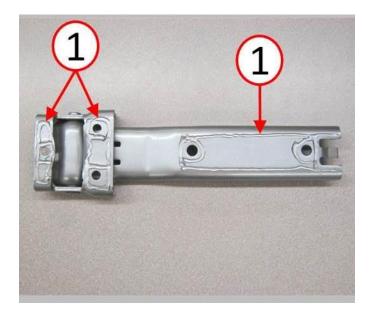
Fig. 3 Tailgate Hinge Body Sealer Application

1 - Body Sealant Application

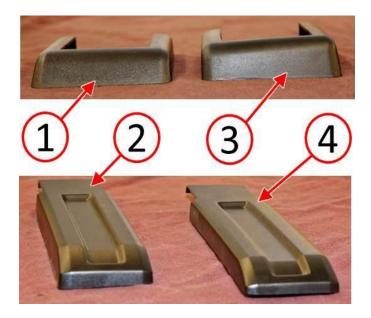
Fig. 4 Tailgate Hinge Cover Identification

- 1 Lower Body Side Hinge Cover
- 2 Upper Tailgate Side Hinge Cover
- 3 Upper Body Side Hinge Cover
- 4 Lower Tailgate Side Hinge Cover
- 6. Install the spare tire to the tailgate if previously removed.
- 7. Remove the right rear quarter trim panel (3). One fastener is located behind the trim bezel (1) and two fasteners are under the cargo floor covering at location (2) (Fig. 5). Refer to the detailed repair procedures available in: DealerConnect> TechCONNECT under: Service Info> 08 Electrical> 8A Audio/Video/Entertainment/Connectivity> SPEAKER> Removal> SUBWOOFER. Quarter trim panel without subwoofer requires a similar removal process but without speaker electrical connector.

5. Install the tailgate hinge covers. If the hinge cover(s) were damaged due to tailgate hinge over extension, replace the damaged hinge cover(s) as necessary. Each hinge cover is a unique shape and **CANNOT** be interchanged. Refer to (Fig. 4) for identification of correct hinge cover placement.

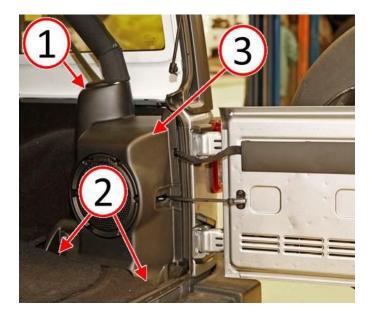
Fig. 5 Right Rear Quarter Trim Panel

- 1 Quarter Trim Bezel
- 2 Fasteners
- 3 Quarter Trim Panel

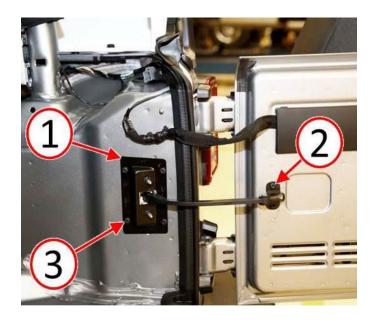
Fig. 6 Tailgate Retaining Strap

- 1 Retaining Strap
- 2 Body Side Fasteners
- 3 Tailgate Side Fasteners
- 9. Install the new tailgate retaining strap (Fig. 6).
- 10. Install the right rear quarter trim panel (Fig. 5). Refer to the detailed repair procedures available in: DealerConnect> TechCONNECT under: Service Info> 08 Electrical> 8A Audio/Video/Entertainment/Connectivity> SPEAKER> Installation> SUBWOOFER. Quarter trim panel without subwoofer requires a similar installation process but without speaker electrical connector.
- 11. If the right side tail lamp was damaged due to tailgate hinge over extension, replace the tail lamp. Refer to the detailed repair procedures available in: DealerConnect> TechCONNECT under: Service Info> 08 Electrical> 8L Lamps and Lighting> Lamps> Lighting Exterior> LAMP, Tail Stop Turn> Removal / Installation.

8. Remove the two retaining strap to tailgate fasteners (2) and four retaining strap to body fasteners (3) then remove the tailgate retaining strap (1) from the vehicle (Fig. 6).
