## SERVICE BULLETIN

**APPLICABILITY:** 2013-14MY Legacy and Outback Models with 2.5L FB Engines  
 2011-14MY Forester Models with 2.5L FB Engines  
 2015 MY Forester (Manual Transmissions Only) with 2.5L FB Engines  
 2012-13 MY Impreza and XV Crosstrek Models with 2.0 FB Engines  
 2014-15 MY Impreza and XV Crosstrek Models (Manual Transmissions Only) with 2.0 FB Engines

**NUMBER:** 02-157-14R

**SUBJECT:** Engine Oil Consumption

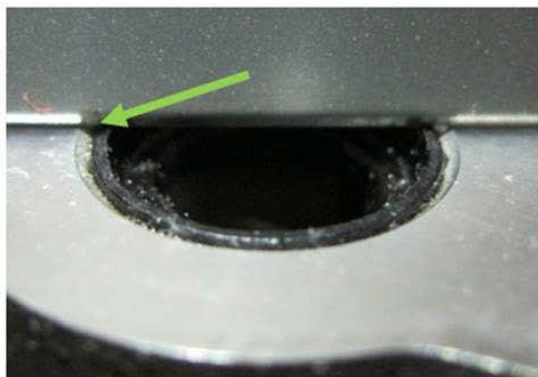
**OK-** Filter Screen flush with machined surface of camshaft carrier.

- **IMPORTANT:** The **one-time use** AVCS filter screens in the cam carriers are available separately (p.n. 14451AA050). **NOTE:** Although the filter screens are not directional, they **must be installed flush with the machined surface of the cam carrier as shown in the OK photo below.** The **NG photo shows the screen installed too deep into the camshaft carrier.** Engines with AVCS on both intake and exhaust will have 2 filters in each carrier as opposed to just one (intake only AVCS).

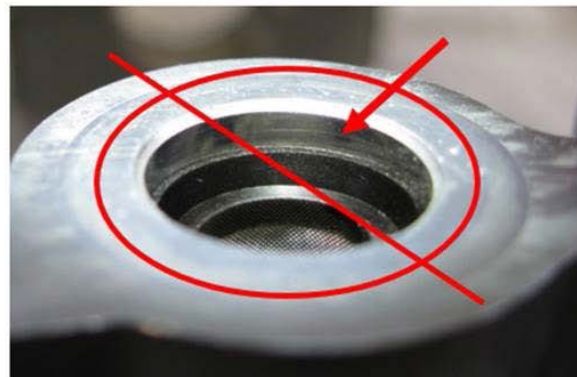
**NG-** Filter Screen installed too deep into the camshaft carrier bore.
