NUMBER: 23-007-15

Rear Liftgate Will Not Open Intermittently

2015	(WK)	Jeep Grand Cherokee
2015	(WD)	Dodge Durango

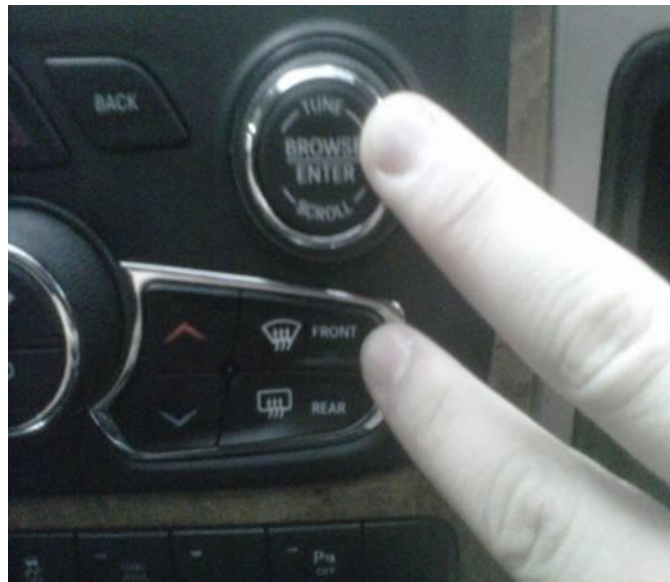
Fig. 1 Taking Vehicle Out Of Ship Mode

1. Is the vehicle in Ship Mode?
 - a. Yes >>> Proceed to [Step #2](#).
 - b. No >>> Proceed to [Step #3](#).
2. Press and hold the 'Enter/Browse' button and the 'Front Defrost' (about 5 seconds) until "Ship Mode" is no longer displayed on the instrument cluster. See ([Fig. 1](#)).
