SERVICE BULLETIN

APPLICABILITY: 2017-2019MY Impreza
 2018-19MY Crosstrek
 2018-19MY Legacy and Outback
 2019MY WRX and WRX STI
 2019MY Ascent
 2018-19MY BRZ

NUMBER: 15-226-18R
DATE: 08/21/18
REVISED: 09/05/18

SUBJECT: Harman Audio / Infotainment: Troubleshooting
 USB Functionality Concerns

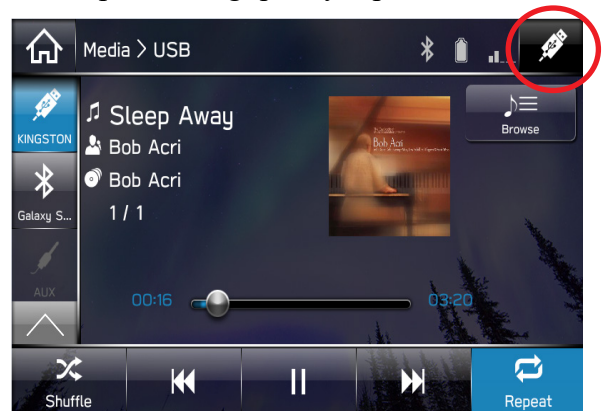
- 1) Always confirm the condition as reported by the customer.
- 2) This section addresses USB detection symptoms.
 - a. Confirm the USB is recognized (USB icon appears) on the Media screen as shown in the figure below.

- b. If the USB is not recognized, follow Service Diagnostic Mode from the Service Manual:
 - i. Turn the ignition switch to ACC.
 - ii. Press the “TUNE/SCROLL” button six times while pressing the “HOME” button.

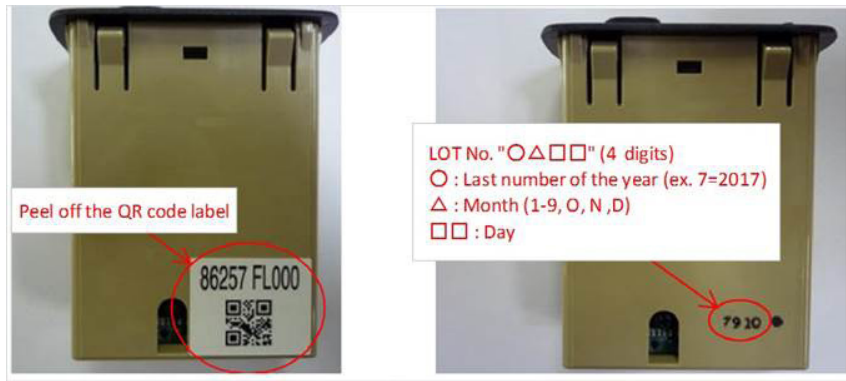
New firmware was released during late 2017 to enhance connectivity for Auxiliary Terminal part numbers: **86257FL00A** and **86257FL101** (MID, HIGH).

- CAREFULLY peel off the QR code / part number label.
- Check the Lot# as shown below. If the number is after “**7411**” it is post-CM.
