### PIP5197H Possible Oil Consumption - Oil Leaks - Blue Smoke From The Exhaust - Whistle Noise - MIL On - DTC P0171

Brand:	Model:	Model Years:	VIN:		Engine:	Transmissions:
			from	to		
Buick	Encore	2013 - 2019	All	All	LUJ and LUV	All
Chevrolet	Cruze	2011 - 2016	All	All	LUJ and LUV	All
Chevrolet	Sonic	2012 - 2019	All	All	LUJ and LUV	All
Chevrolet	Trax	2013 - 2019	All	All	LUJ and LUV	All

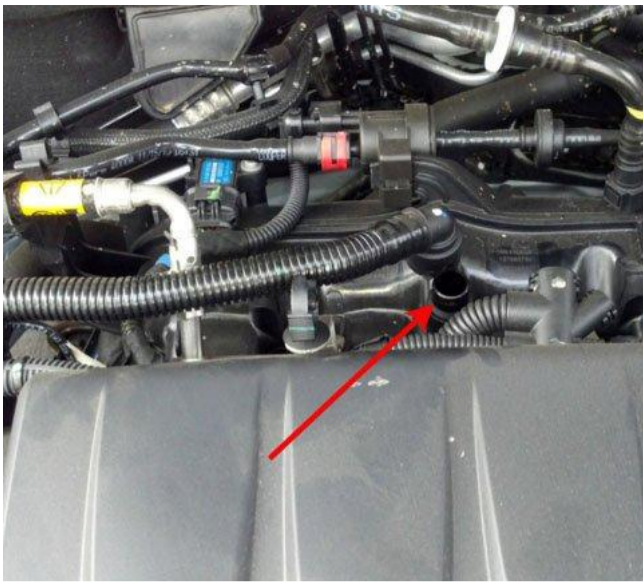
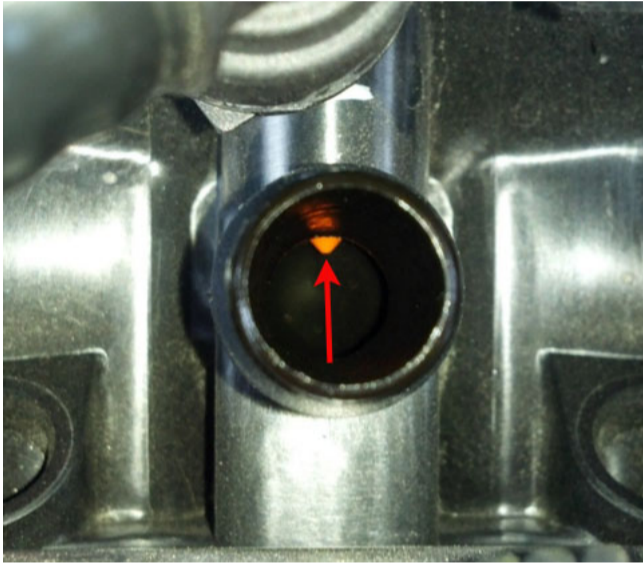
**Check for a missing intake manifold Non Return Valve that may have damaged the PCV orifice diaphragm. (See pictures below for inspection procedure).**

**If the non return valve is not visible as shown in picture, then use a long cotton swab to wipe any excess oil from the valve to validate.**

**If the non return valve is still not visible, then intake manifold removal for inspection is required to validate.**

**If the valve is present reinstall the intake manifold. Do not replace.**

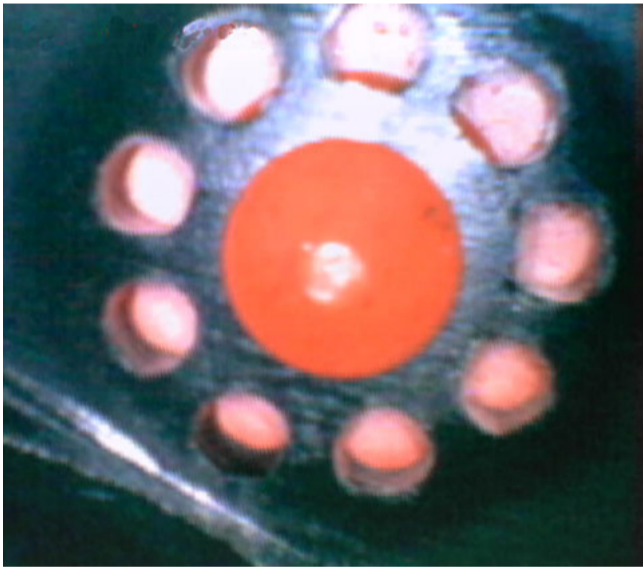
**Properly seated Non Return Valve as viewed with the intake manifold removed.**

**If the intake manifold Non Return Valve is missing, then replace the intake manifold assembly,**

**Clean oil from all induction system components and retest for oil consumption, leaks or DTCs resetting.**

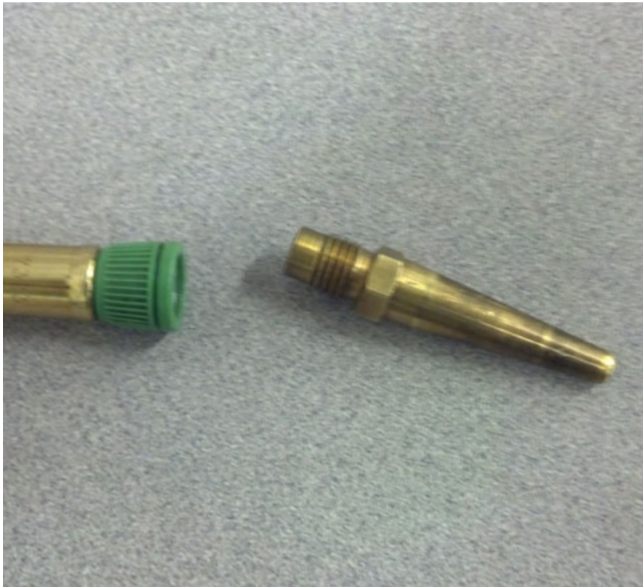
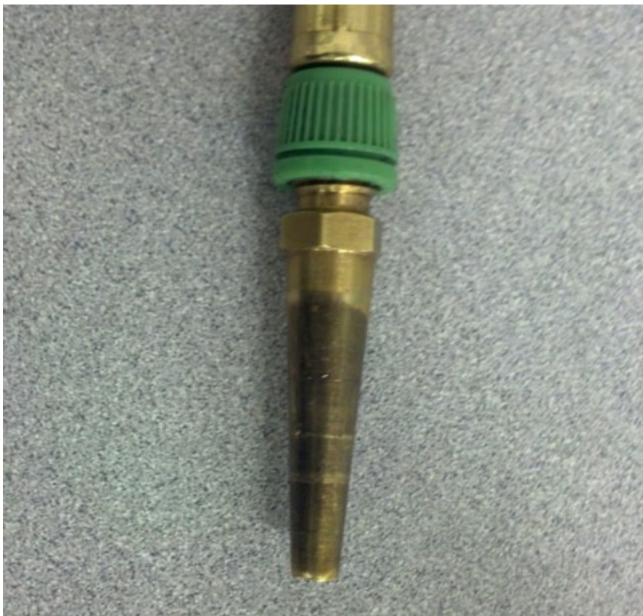
**Record the crankcase pressure. (Normal crankcase pressure readings are between -11 & -18 inches of water in park at hot idle) / (ESST gage works best, see pictures below for connection of ESST at the engine oil dipstick hole in the camshaft cover.**

**Record the crankcase pressure at hot idle in park as well as under snap throttle.**

**Note: The connection must be made with the engine off. The engine is then started and the pressure readings are recorded.**

If the crankcase pressure is between -10 and 0 inches of water then a cylinder leakage / crankcase pressure concern exists.

This is likely caused by a weak or broken piston ring land.

Replace all four piston assemblies and retest for proper crankcase pressures.

Clean oil from all induction system components and retest for oil consumption, leaks or DTCs resetting.
