## Preliminary Information

### PIP5579A Front and Rear Axle Restriction for Vehicles with RPO SU5 SU8

#### Models

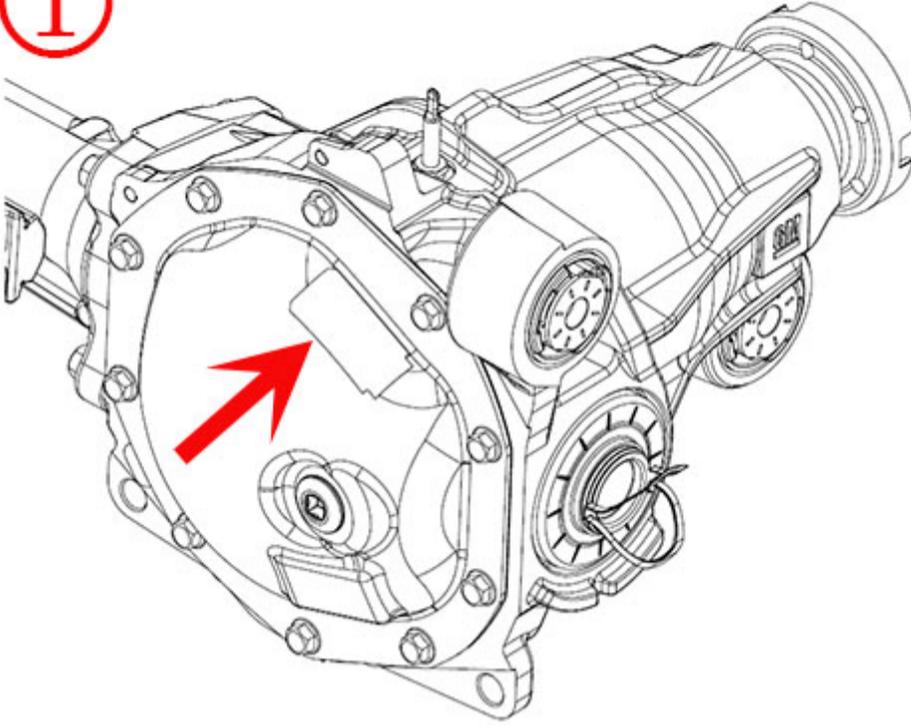
①

**Pictures labeled 1 and 2 below show the tag location on the front differential. Item 2 is near the actuator.**
