Preliminary Information

PIT5438E Click / Rattle / Tick / Pop / Creak / or Squeak Noise from Dash Area

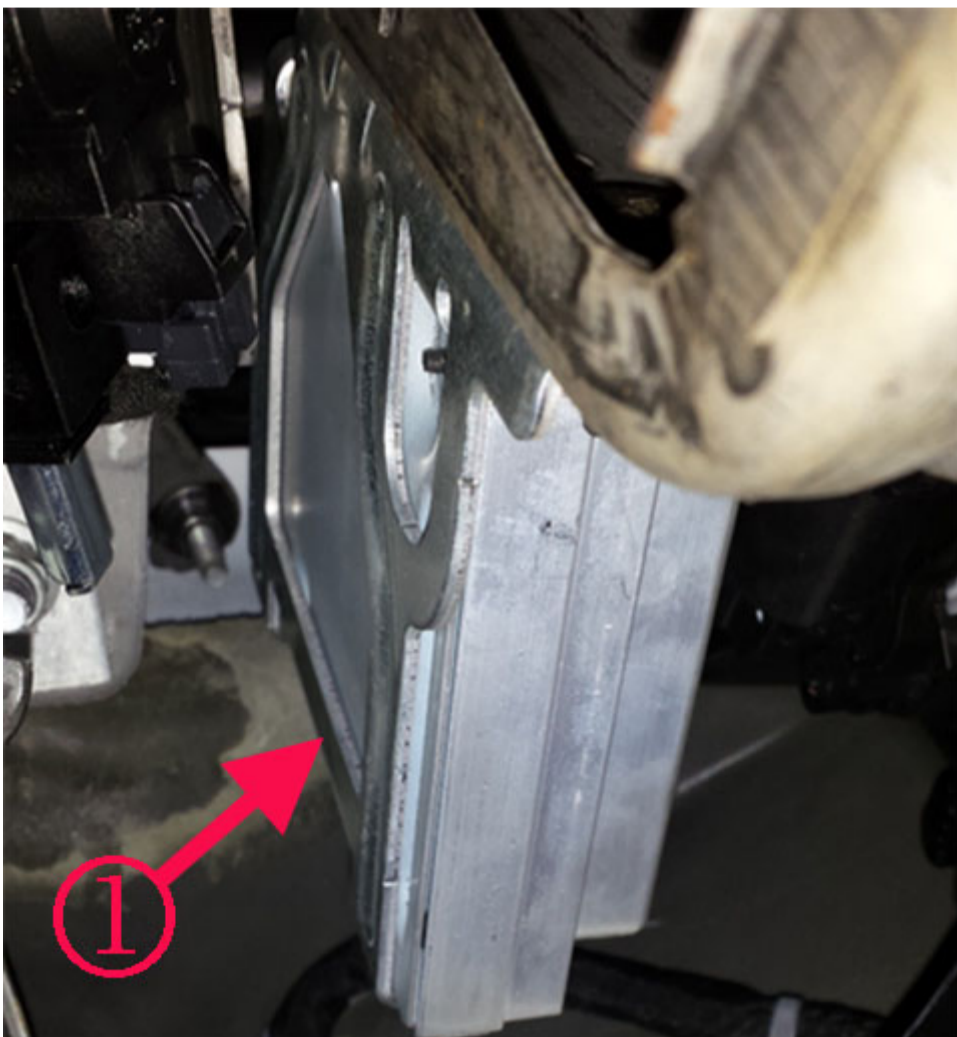
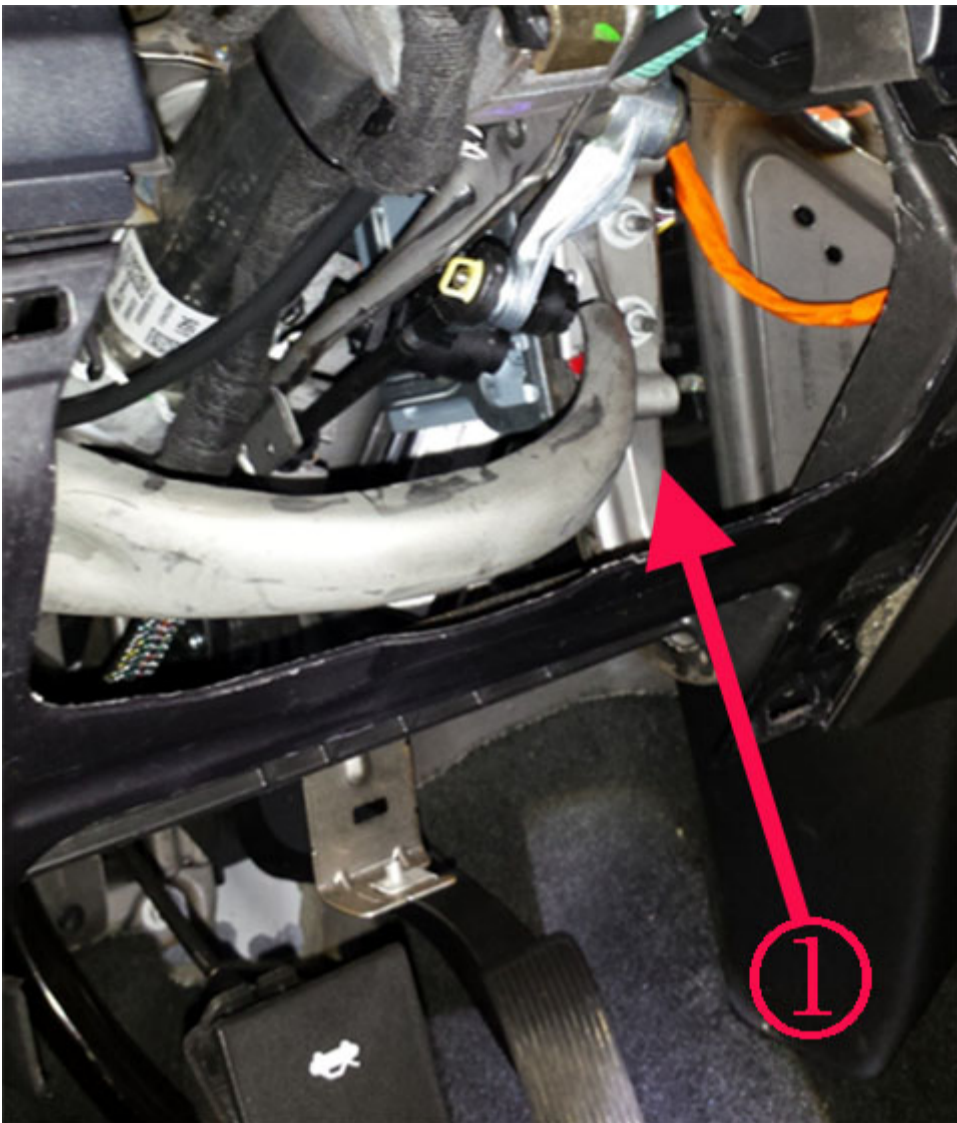
See #1 in photos below:

Condition 1: Tinny or metallic rattle type noise from the IP area to the left of the steering column.

The noise may be caused by the 110 Volt Power Inverter Module not being seated properly in the mounting bracket (if equipped with RPO K14).

Inspect the power inverter module for possibly moving slightly against mounting bracket and creating the noise.

Follow SI to locate the Accessory AC and DC Power Control Module located to the right of the steering column.

Remove the K14 power inverter module and apply two sided tape to the module bracket to insulate it from the mount.

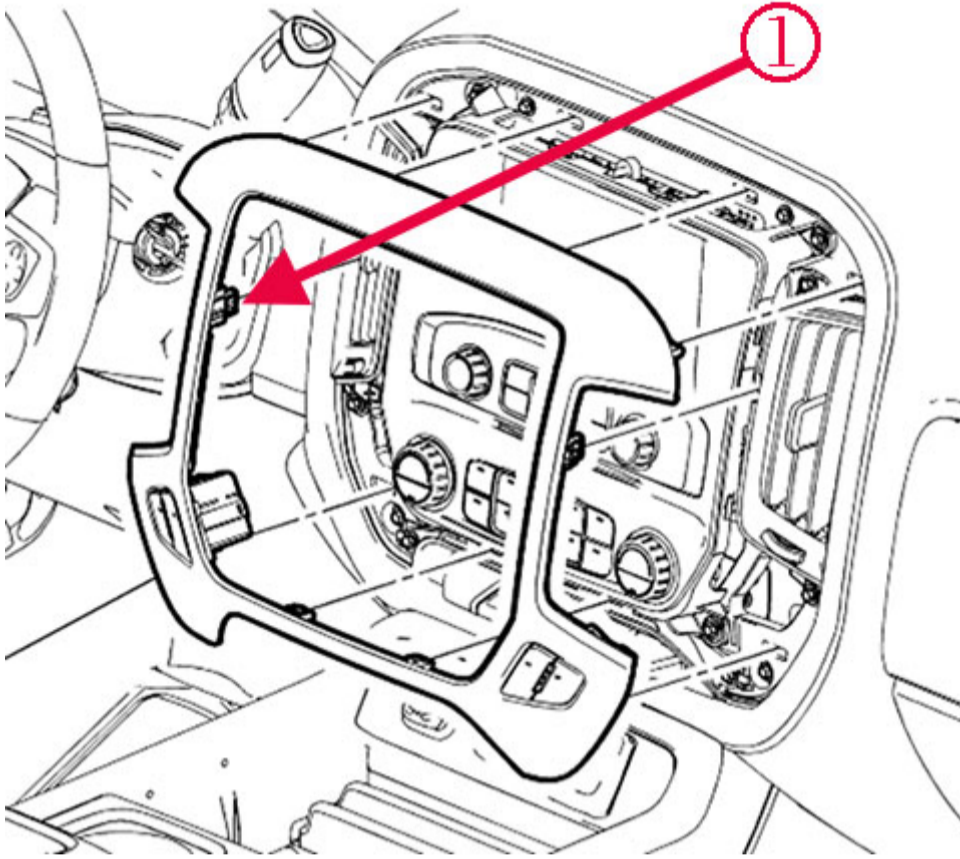
Condition 2: Rattle, squeak or itch type noise from the center of the dash in the radio area.

The instrument panel accessory bezel may be rattling due to insufficient tension of retainers. Press on the bezel while duplicating noise to see if it is eliminated.

Wrap Kent automotive BRS flocking tape part number KT13487 over retainers (#1 in illustration) and reinstall bezel.

This will require an application of BRS flocking tape on ten retainers (one strip @ 1" x 10").
Two sheets should repair 16 vehicles.

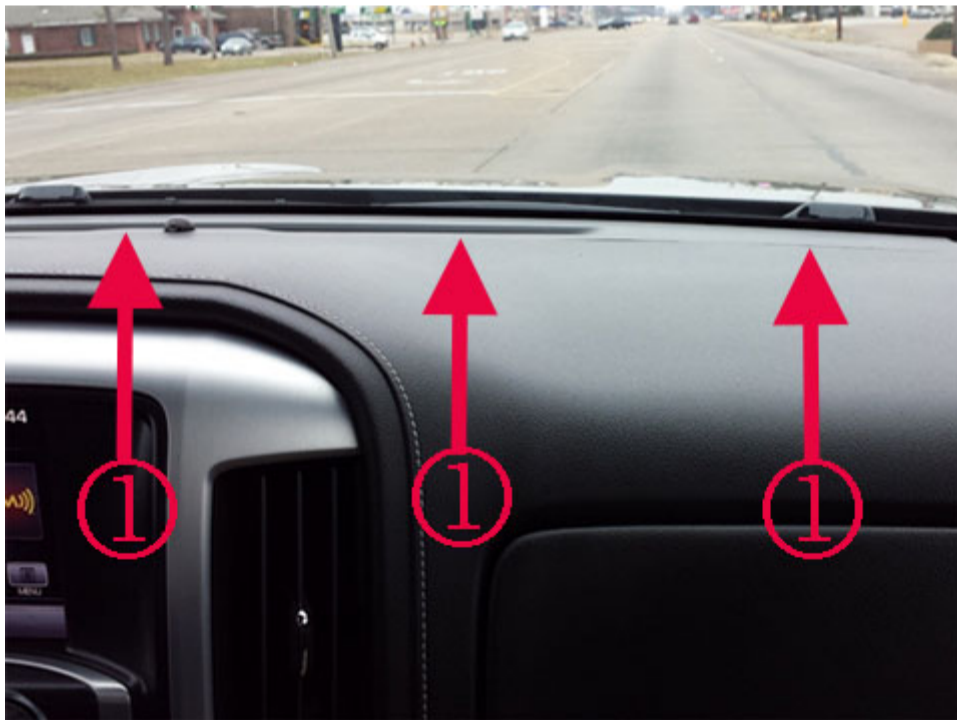
Condition 3: Rattle or itch type noise from the dash area near the windshield

Defroster grill may be rattling due to insufficient retention of retainers. Press on defroster grill (# 1 in illustration) while duplicating concern to see if it is eliminated.

Remove defroster grill.

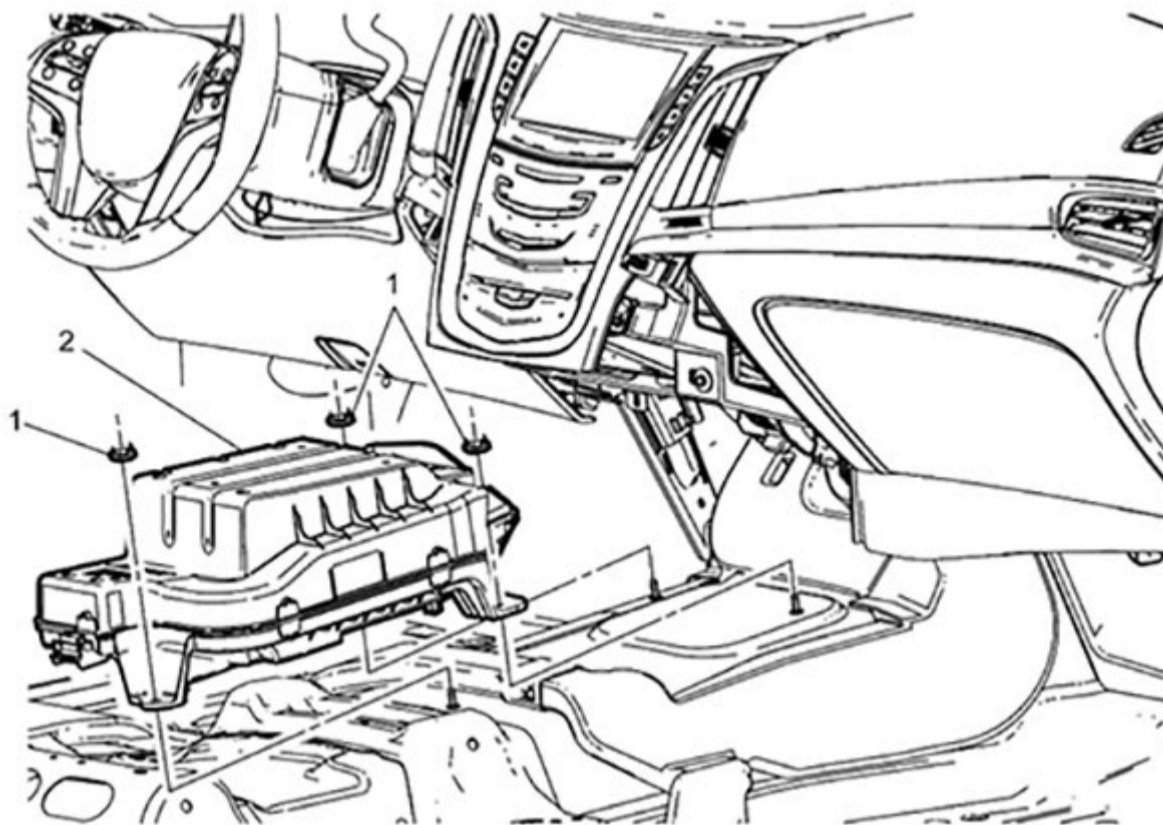
Condition 4: Rattle, tick, knock type noise from the front center floor or center of dash area (Applies to trucks equipped with

This concern could be caused by the radio subwoofer speaker mounting nuts either being loose or missing.

To correct this issue, inspect the center console subwoofer speaker (2) mounting nuts (1) for being loose or missing. Subwoofer speaker mounting is shown below. Install and tighten the subwoofer speaker mounting nut(s) to 6 Nm (53 lb in).

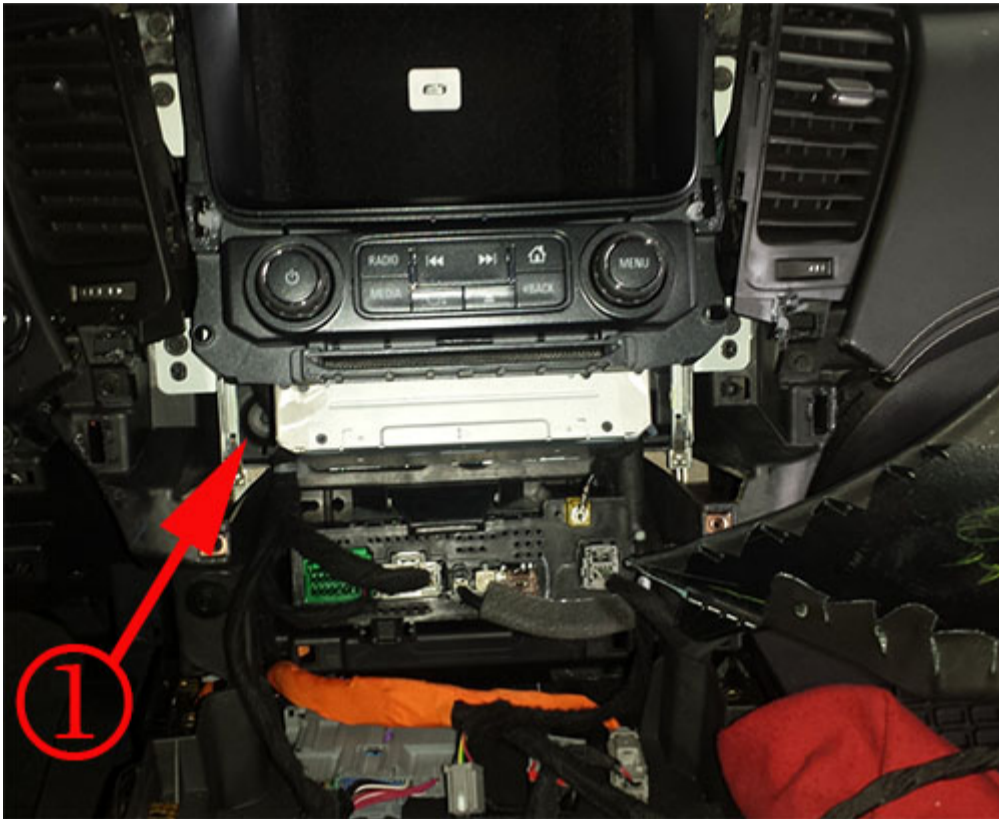
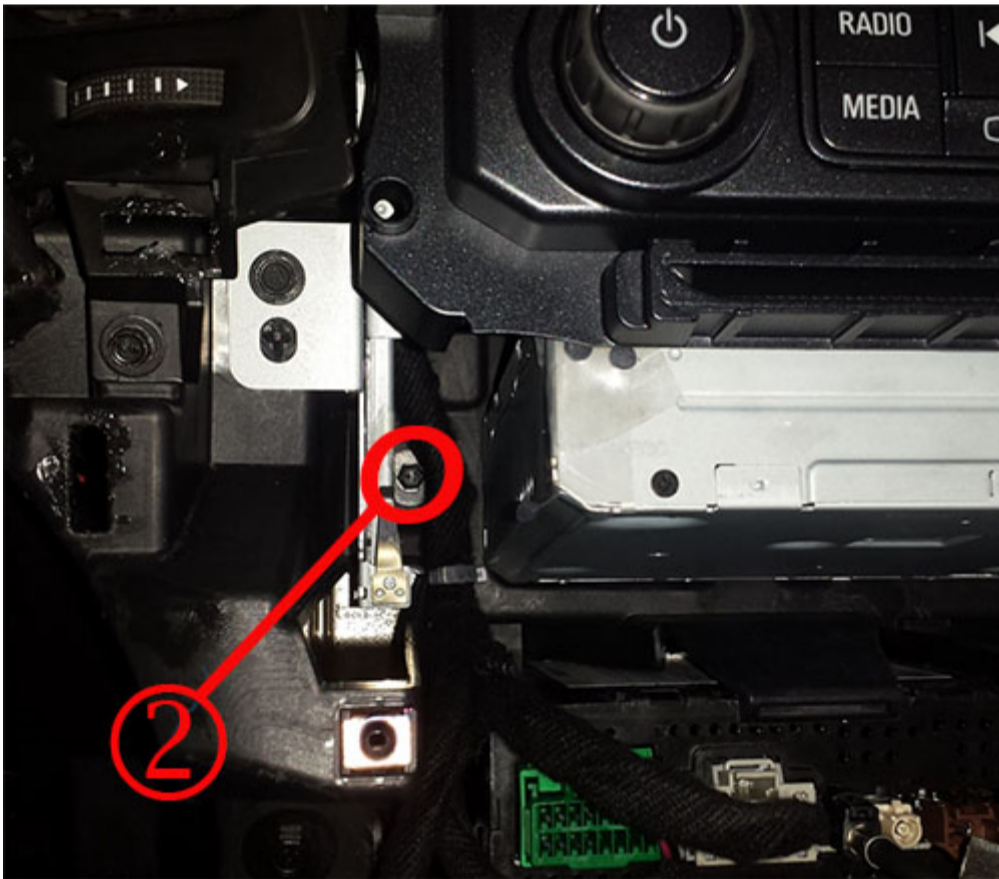
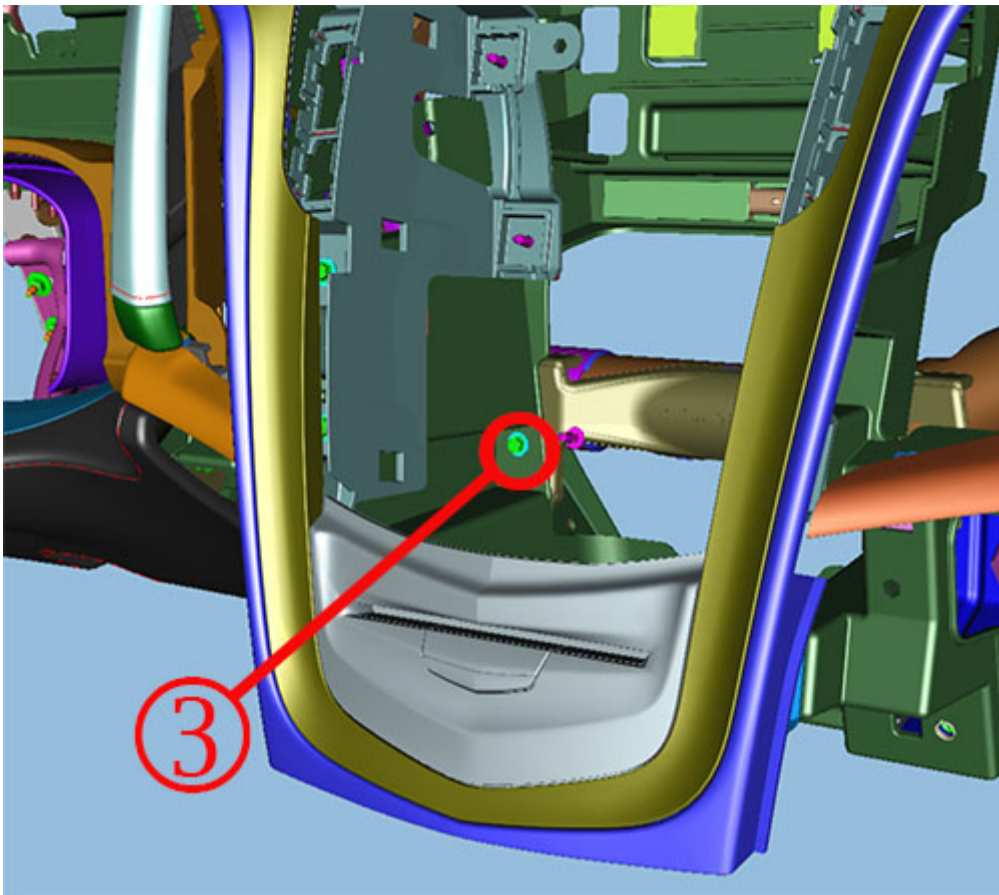
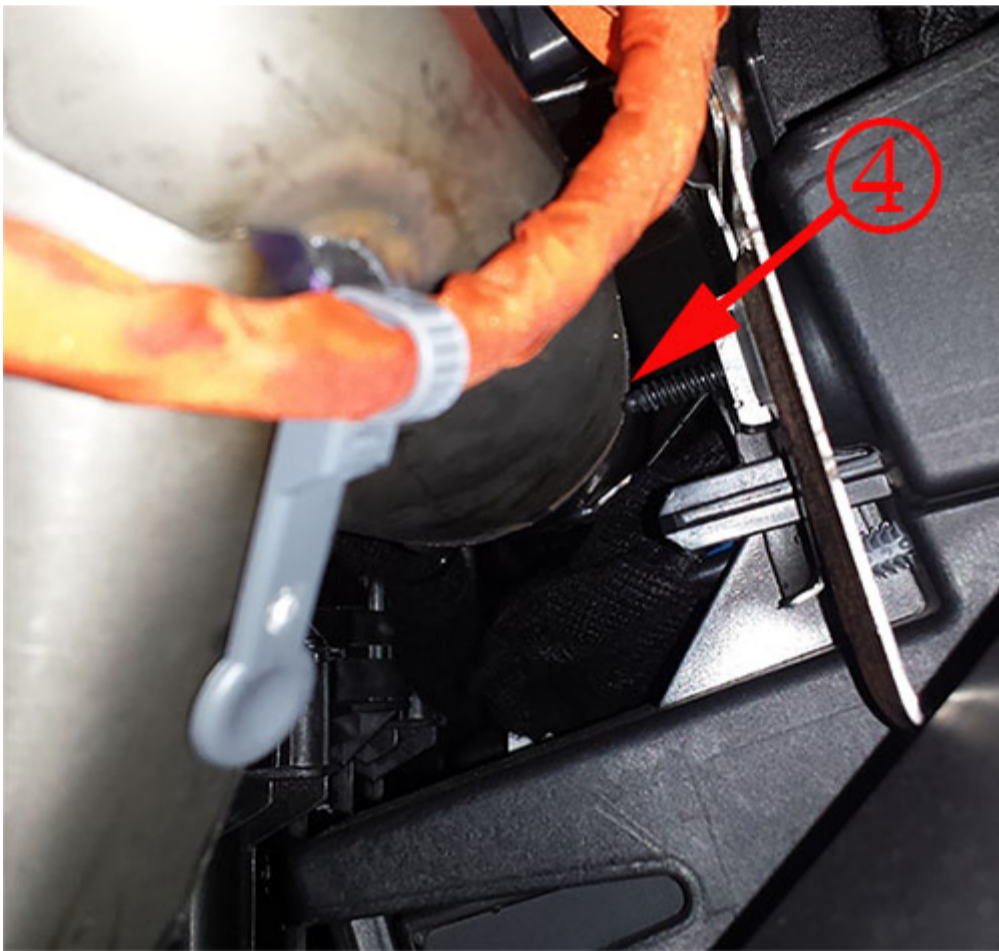
Condition 5: Creak, ticking or popping type noise heard from the left center stack area. (This issue only applies to Full Size Utilities built before November 18, 2016)

This concern could be caused by the use of an incorrect screw that secures the instrument panel carrier in place. The screw that may have been used is too long, and it may contact the instrument panel tie bar. In some cases, this noise may only occur after the vehicle has been driven for a period of time.

The screw shown in the photos below may be too long and the screw tip actually contacts the instrument panel tie bar. This contact is shown as item #4 below. This screw secures the instrument panel carrier to the instrument panel tie bar.

Chevrolet/GMC models are shown as item# 1 and a close-up of this fastener can be seen as item #2. Replace this screw with a shorter fastener, GM part number 11547755, which is approximately 24 mm in length.

Cadillac models can be seen in item #3 below. Replace this screw with a shorter fastener, GM part number 11547755, which is approximately 24 mm in length as well.

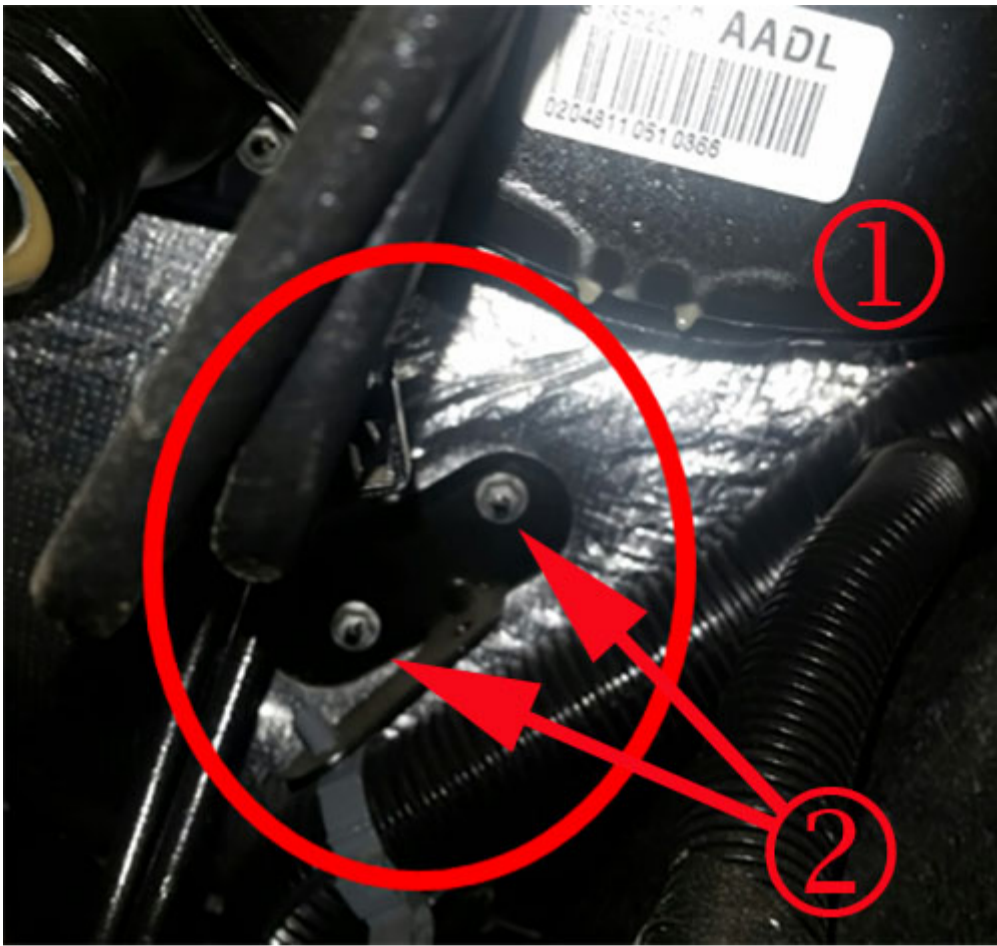
Condition 6: Chirp or squeak noise coming from the lower left side of the center stack area.

This concern could be caused by loose retaining nuts on the chassis harness retention bracket that is located below the brake booster.

The following picture shows the chassis harness retaining bracket and nuts (2) below the brake booster (1). Verify the retaining nuts are tight.
