Service Bulletin

Bulletin No.: PI0962D

Subject: Radio Resets, Navigation Inoperative, Map Not Displayed, DVD Will Not Play or Resume, Bluetooth® Inoperable, Radio Lockup, Voice Recognition Cuts Off, USB Source not Returning to Last Song, OnStar® Default Volume Low

Models: 2013-2014 Buick Enclave
2013-2014 Chevrolet Traverse
2014 Chevrolet Captiva
2013-2014 GMC Acadia
Equipped with Radio RPO UHU, UG4, UGU, UGY, UGX, UHW or UHV

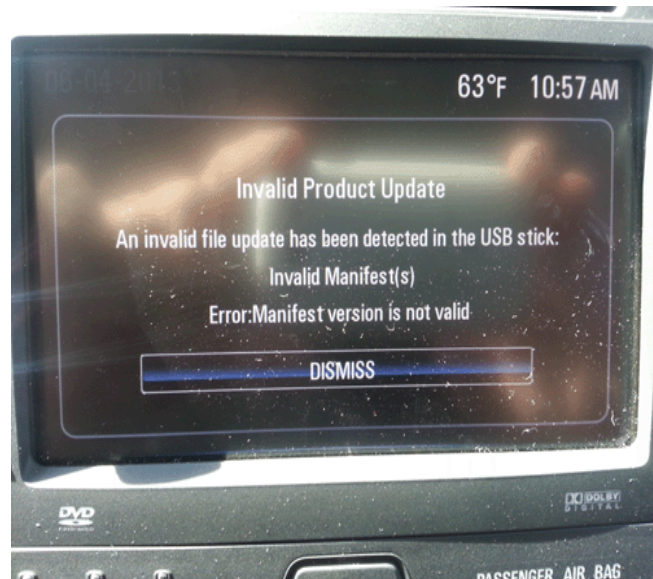
3462549

Note: If the following screen above is shown on the screen, the radio already has the latest calibration installed and no further action is required.
