SERVICE INFORMATION BULLETIN

APPLICABILITY: 2018-19MY Impreza

NUMBER: 05-66-18

SUBJECT: Front Suspension Crossmember Bolt Change

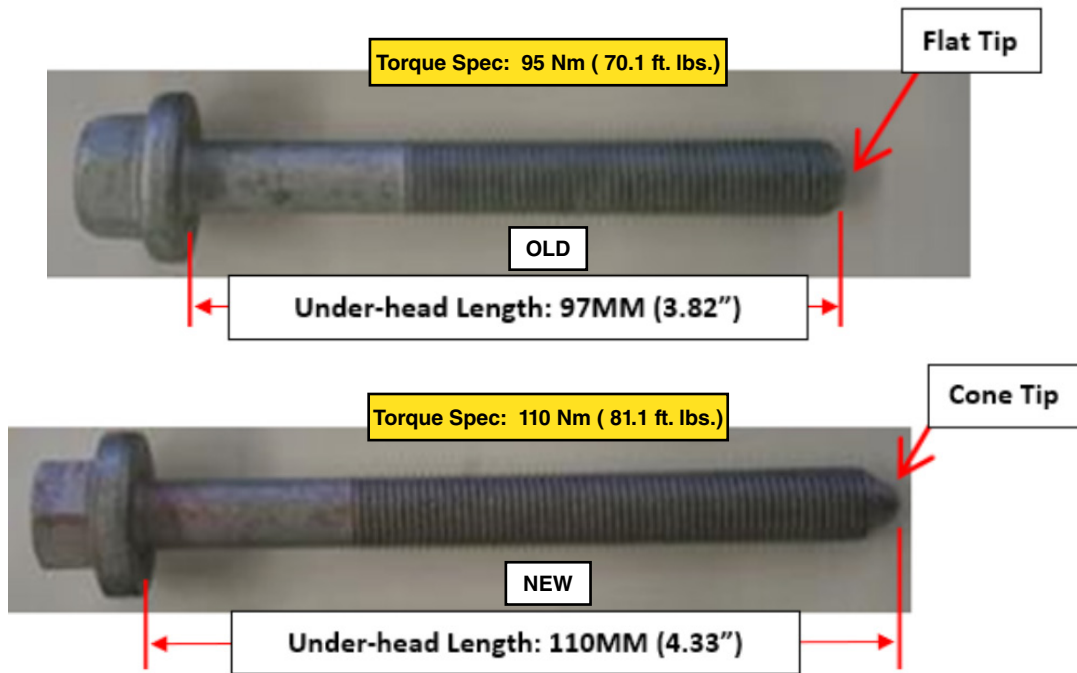
COMPARISON PHOTOS:

This Service Information bulletin announces a running change to the four (4) front suspension crossmember retaining bolts to improve production efficiency. The new bolts have an increased length and are easily identifiable with their “cone” shape on the threaded end.

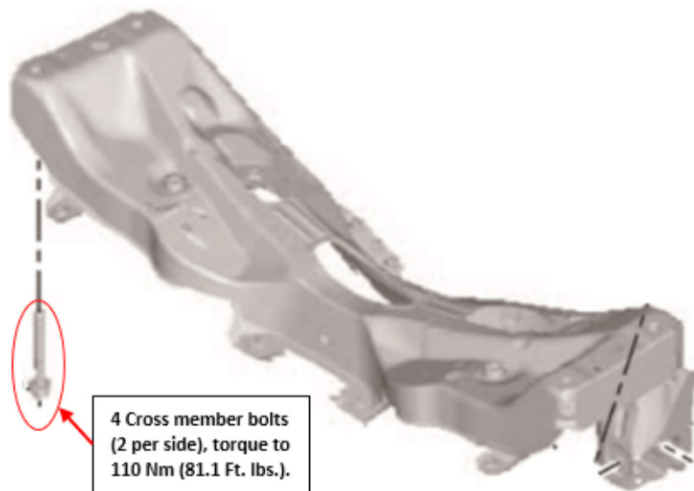
IMPORTANT: While the old design and new design bolts may be used in combination, due to the differences in torque requirements, when replacement is necessary, it is recommended to ensure all 4 bolts being used are the same type in order to eliminate having a mix of both with their different torque requirements during the installation process.

REMINDER: Customer satisfaction and retention starts with performing quality repairs. These new crossmember bolts have a **revised (HIGHER) torque specification of 110 Nm (81.1 ft. lbs.)**. Otherwise, the Service Procedure for their replacement remains unchanged. Always refer to the applicable Service Manual and review the full requirements of the repair being performed. The Service Manual procedures contain information critical to performing an effective repair the first time and every time. This includes but is not limited to: important SAFETY precautions, proper inspection criteria, necessary special tools, required processes and related one-time-use parts needed for a complete and lasting repair.
