## SERVICE INFORMATION BULLETIN

**APPLICABILITY:** 2013-2014MY Legacy and Outback with EyeSight    **NUMBER:** 06-67-18  
 2015-2016MY Impreza with EyeSight    **DATE:** 10/19/18  
 2015-2017MY Crosstrek with EyeSight

**SUBJECT:** DTC C0075- Additional Diagnostic Procedures

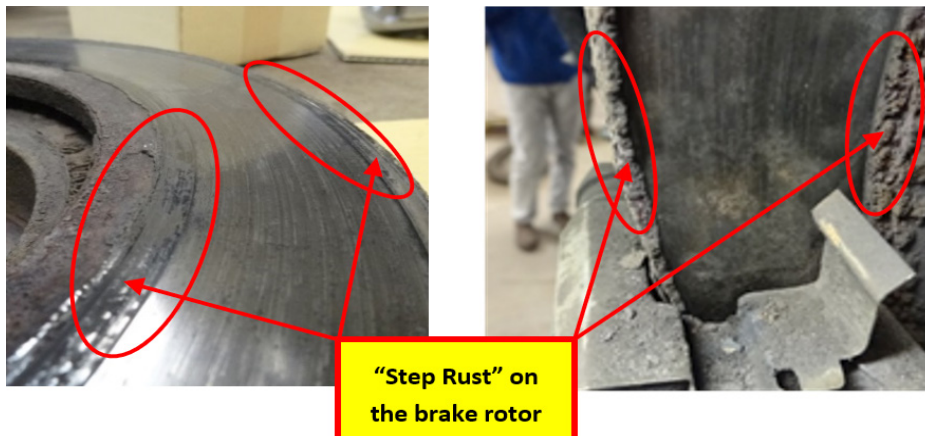
- When the rotor is rusted as shown in the photos below, replace it with a new rotor and brake pad set even if the rotor thickness has not reached minimum thickness.

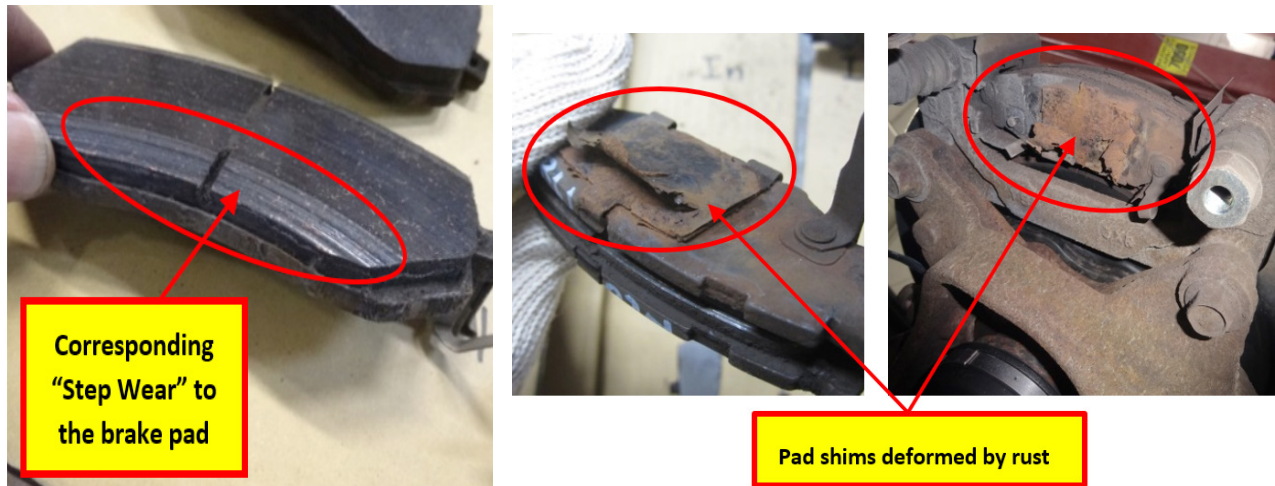
- When the pad shims are rusted or deformed as shown below, replace with new shims.
