SERVICE BULLETIN

APPLICABILITY: 2012-2017MY Impreza
 2013-2017MY Crosstrek
 2014-2017MY Forester
 2015-2017MY WRX and WRX STI
 2013-2017MY BRZ

NUMBER: 12-251-18

SUBJECT: Gap Between Top of Glove Box and Instrument Panel

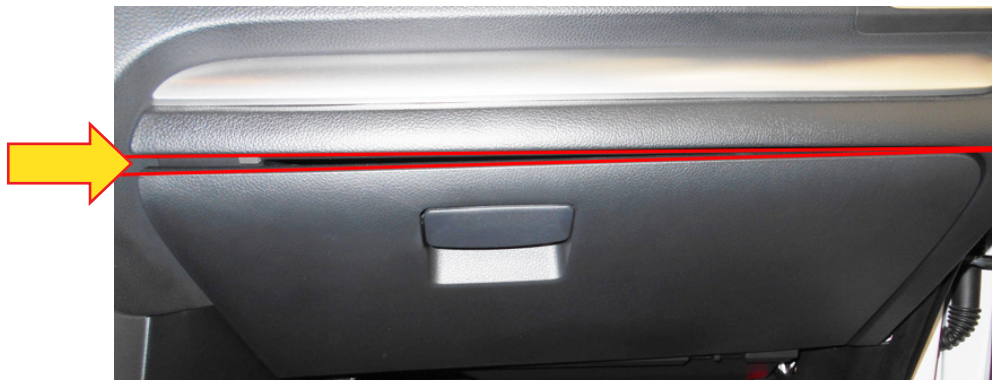
This bulletin provides a service procedure to address a gap between the top edge of the door and the instrument panel on the models listed as shown in the photo below. The gap may also make the glove box door difficult to close fully.

There is a latch to keep the glove box closed on both sides of the glove box door. If the door is closed without using enough force to engage both latches or by pushing it shut on just one side instead of in the middle, one may close and not the other. Over time, if the door is not fully closed with both latches, high cabin temperatures along with weight of the items inside the glove box may cause the assembly to deform slightly and a gap to develop.
