TECHNICAL SERVICE BULLETIN

Lack Of Air Conditioning (A/C) - High-Voltage Battery Cooling Unit (Chiller) Leak

18-2352
28 November
2018

Ford 2012-2018 Focus BEV

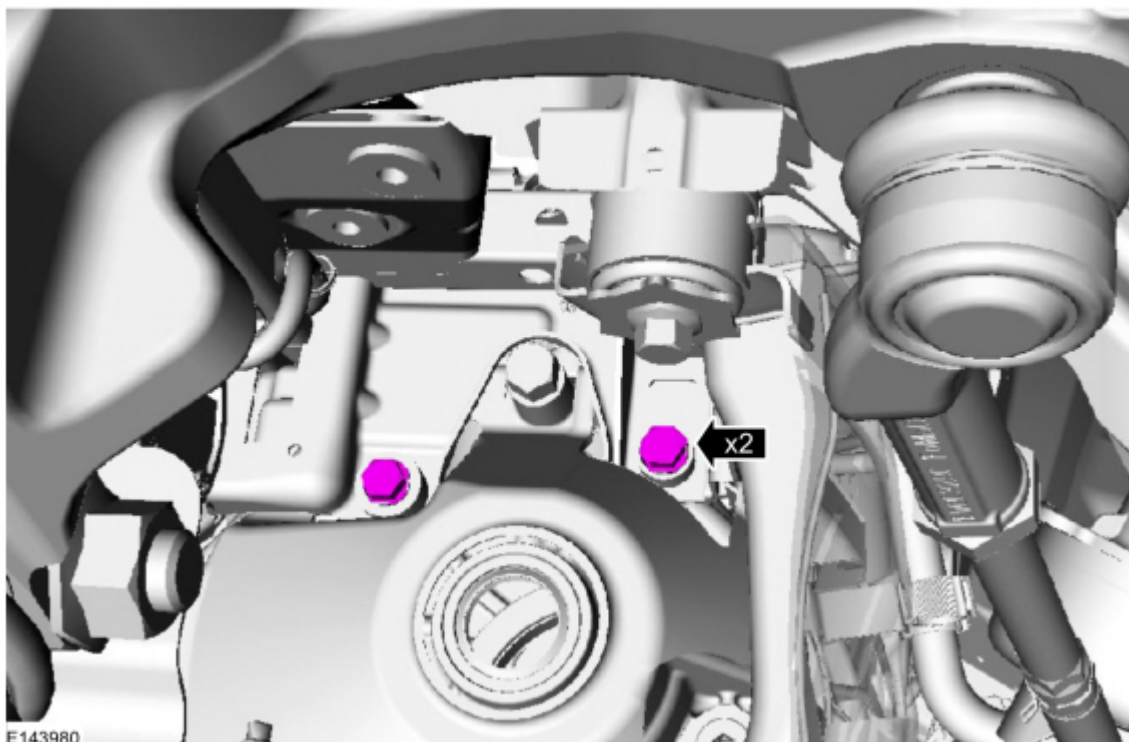
Figure 1

- Perform a visual inspection of the high-voltage battery coolant cooler. Are there any signs of damage or is the high-voltage battery coolant cooler oil stained indicating a freon leak?
 - Yes - proceed to Step 2.
 - No - this article does not apply. Refer to Workshop Manual (WSM), Section 412-00 for normal diagnostics.
- Inspect for loose, missing, or damaged rear transmission to mount bolts. Are any rear transmission to mount bolts loose, missing, or damaged? (Figure 1)
 - Yes - replace the affected bolts. Tighten to 107 lb-ft (145 Nm). Refer to WSM, Section 303-01.
 - Position a transmission jack under the electric motor. Remove the coolant filter and coolant filter bracket bolts and position aside to gain access to the mount bolts.
 - Tighten the bracket bolt to 89 lb.in (10 Nm).
 - Tighten the coolant filter bolt to 18 lb.in (2 Nm).
 - No - proceed to Step 3.

- Replace the high-voltage battery coolant cooler. Refer to WSM, Section 412-00.
