## SERVICE BULLETIN

**APPLICABILITY:** 2015-2018MY Legacy and Outback  
 2012-2018MY Impreza  
 2013-2018MY Crosstrek  
 2014-**2018MY** Forester  
 2015-**2018MY** WRX

**NUMBER:** 16-112-18R

**SUBJECT:** Ignition Key Sticking / Design Change to CVT Shifter / Selector Lever Components

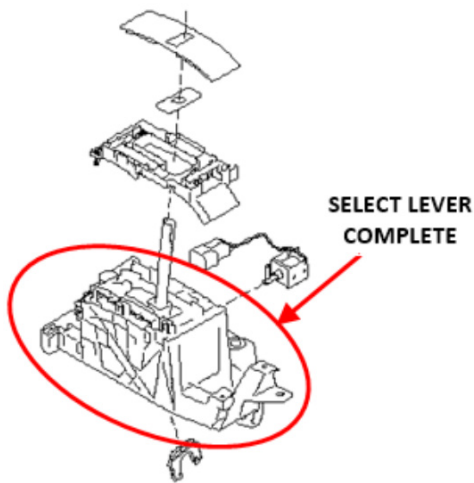
**For Legacy and Outback:**

- The term PLATE-GUIDE B refers to the Park-Range switch which is a serviceable part of the select lever assembly on all models listed above **EXCEPT** Legacy and Outback. See the illustrations provided below for more details.
- For **Legacy and Outback**, the shifter assembly (SELECT LEVER COMPLETE) must be replaced if the Park-Range switch is found to be faulty.

- Replace the SELECT LEVER COMPLETE assembly (on Legacy and Outback models) or,
- Replace the Park-Range switch (PLATE-GUIDE B) following the Select Lever disassembly / assembly procedure in the applicable Service Manual.
