SERVICE INFORMATION BULLETIN

APPLICABILITY: 2012-2017MY Legacy and Outback
 2012-2016MY Impreza
 2013-2017 Crosstrek
 2011-2017MY Forester NA and DIT
 2015-2017MY WRX
 2013-2017MY BRZ
 2012-2014MY Tribeca

NUMBER: 07-133-18R

SUBJECT: Knock Sensor Design Change, DTCs P0327, P0328, P0332 and P0333

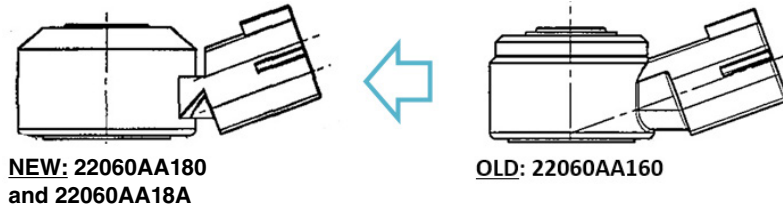
- The part number for the new knock sensor to be used on Japan-built vehicles is: **22060AA180**.
- The part number for the new knock sensor to be used on SIA / US-built vehicles is: **22060AA18A**.

The reference illustrations below show the difference between the new and the old part.

Follow the procedure in the applicable Service Manual when replacing the knock sensor. The torque specification for the retaining bolt (24 Nm / 17.7 ft. lbs.) is unchanged.

REMINDER: Do NOT use anti-seize compound on the sensor retaining bolt threads.
