SERVICE BULLETIN

APPLICABILITY: 2014-16MY Crosstrek Hybrid (HEV) **NUMBER:** 07-144-18
SUBJECT: Tail Lamp (Rear Combination Lamp) Assembly Procedure Change **DATE:** 12/20/18

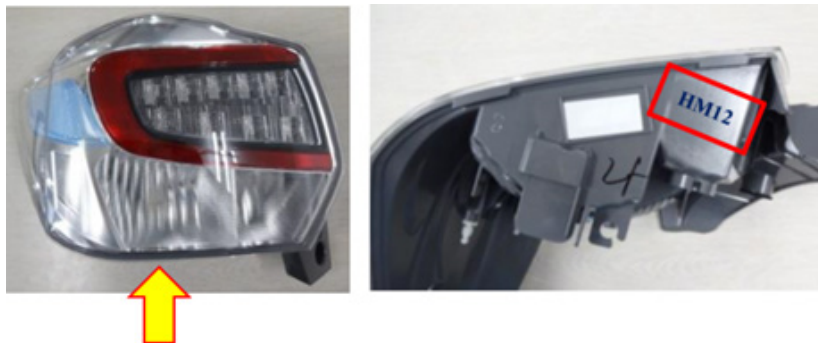
The new lamps are identified by a Lot Number printed on the underside of the housing as shown in the photos below. In the photo below, **HM12** is the Lot Number which translates to October 12, 2018.

- **H** = Model Year (Alpha 1)
- **M** = Production Month (Alpha 2)
- **12** = Day of Production Month

IMPORTANT: The starting Lot Number for new combination lamps is: **HM16** (October 16, 2018 and after).

If moisture is found inside one combination lamp, replace the affected lamp assembly. There is no need to replace both as a set. The service procedure for replacement remains unchanged. Always refer to the applicable Service Manual and review all requirements of the repair being performed. Service Manual procedures contain information critical to performing an effective repair the first time, every time.
