SERVICE INFORMATION BULLETIN

APPLICABILITY: 2015-2017MY Legacy and Outback
2015-2016 Impreza
2015-2017 Crosstrek
2016-2018MY Forester
2016-2018MY WRX

NUMBER: 15-205-16R

SUBJECT: Reprogramming File Availability to Address
Operational Concerns with “Gen 2.0” and “Gen 2.1”
Fujitsu-TEN (F10) Navigation and 7” Display Audio Units

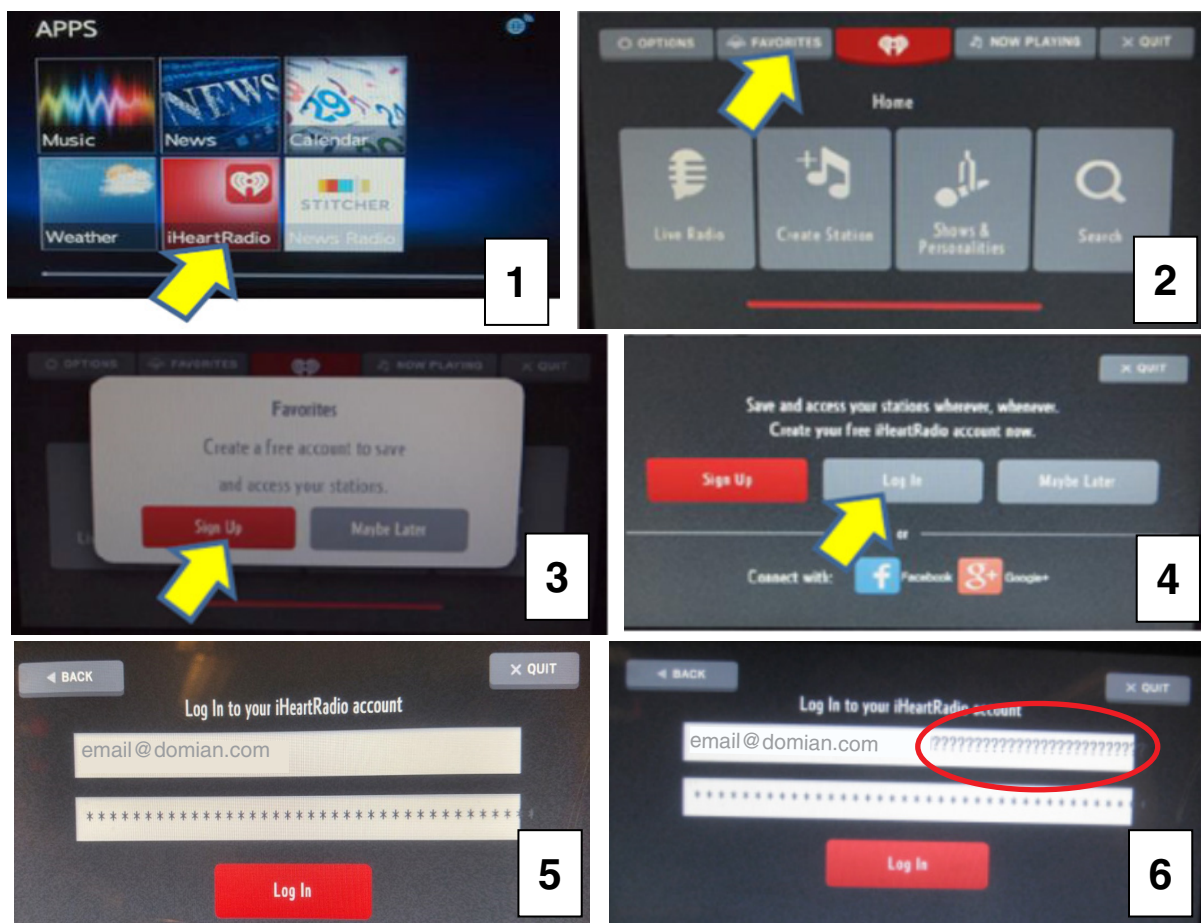
- SXM channels higher than 256 cannot be selected using the voice command feature.
- Additional characters appear (in this example, question ??? marks) after entering an e-mail address and password using the software keyboard when attempting to log in to an iHeart radio account as shown in the screen shot sequence below.

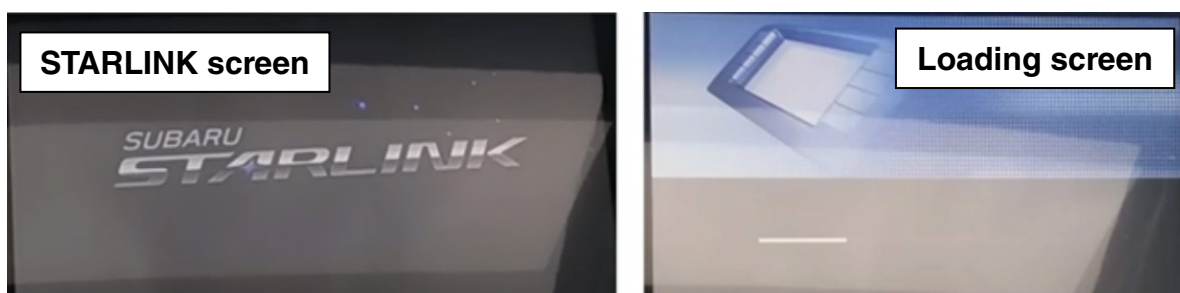
- The Navigation system re-boots from the Loading screen (not the STARLINK screen) when utilizing the remote engine starter (RES) feature (if equipped).

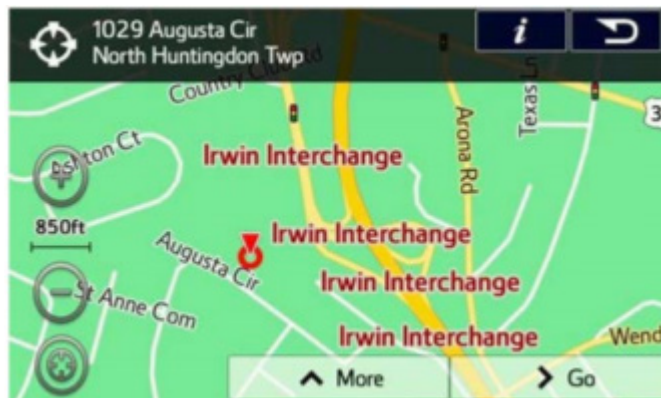
Symptom 6: Roads or interchanges have the same name displayed multiple times.

Change: Logic update to show only one road or interchange name at the same time.

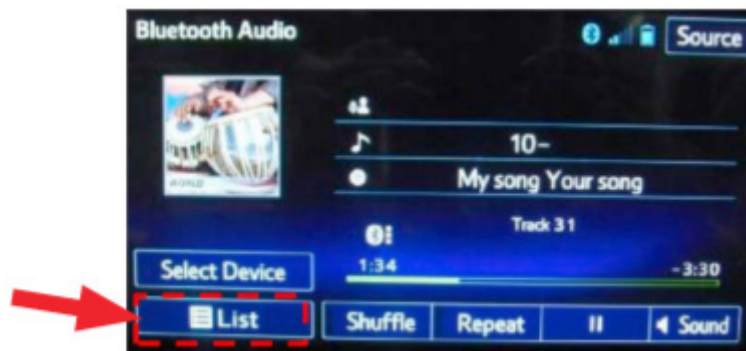
Symptom 15: “LIST” soft touch key is not displayed on Bluetooth Audio screen while using Bluetooth audio feature with an Apple device utilizing iOS8 software version.

Change: Logic change to enhance compatibility with iOS8 software.

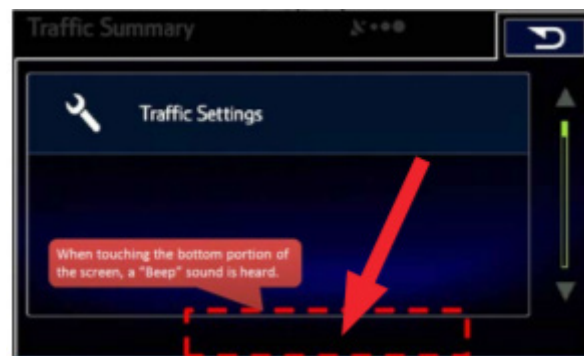
Symptom 16: “Beep” sound heard when touching the bottom of the display screen where no function soft touch keys are displayed.

Change: Logic change to eliminate beeping sound from inactive soft touch key screen areas.

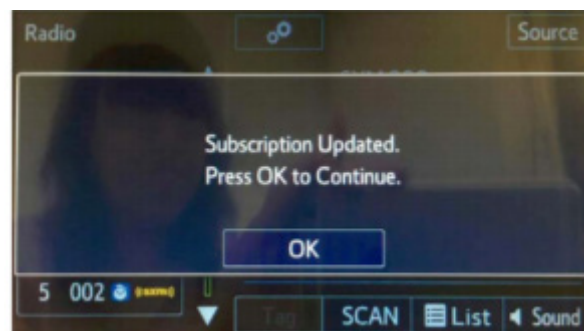
Symptom 17: SXM caution message screen is displayed in English even when French language operation settings are selected.

Change: Logic change to make all messages display in the selected operating language.

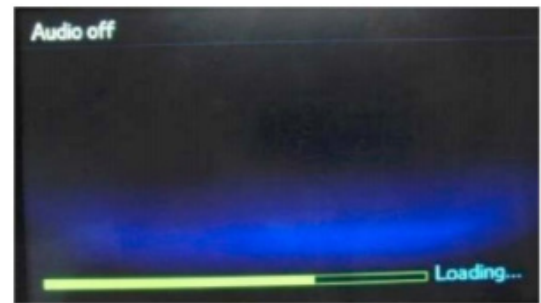
Loading Screen

Symptoms 18-23: The following symptoms are all related to the inability of the software to properly load. One or all of these 5 conditions may occur at the same time.

Change: Logic updates included where applicable to address each of the following conditions:
