TECHNICAL SERVICE BULLETIN

Console Media Bin Door Will Not Open Or Is Binding

18-2364
08 January 2019

Ford 2015-2019 F-150

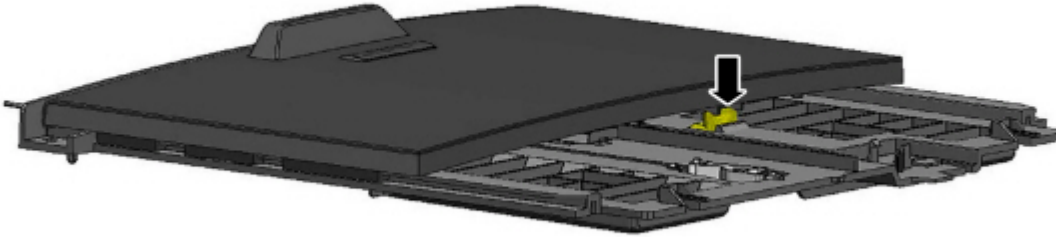
Figure 1

- Is the console media bin door stuck in the closed position with no visible damage?
 - Yes - proceed to Step 2.
 - No - this article does not apply. Refer to the Workshop Manual (WSM), Section 501-12 for normal diagnostics.
- Remove the console upper finish panel. Refer to the WSM, Section 501-12.
- Remove the 2 cup holder screws and remove the cup holder.
- Remove the 2 media bin retaining screws and remove the media bin.
- Inspect the inertia switch. Is the inertia switch in the active position? (Figures 1 - 2)
