TECHNICAL SERVICE BULLETIN

18-2362

Inoperative Park Aid Camera, Luggage Compartment Lamp, Luggage Compartment Lid Release And/Or Poor Satellite Radio Reception

Ford 2015-2017 Mustang

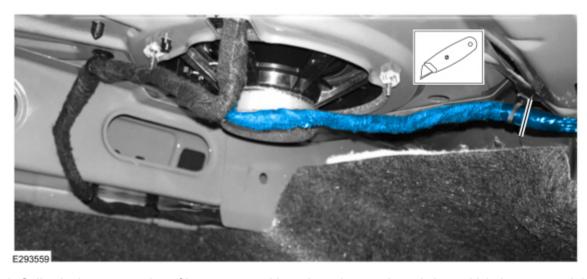
1. Cut out the damaged section of the harness. Make the cut at the location of the harness noted. (Figure 1) Figure 1

2. Splice in the new section of harness, matching wire colors on the existing vehicle harness and the replacement section of harness as necessary. Follow the recommended wiring splice procedures in Section 5 of the Wiring Diagram. Stagger the location of each of the wire splices along the harness to minimize the overall size of the repair.

- 3. Wrap the spliced area in Coroplast Electrical Wire Harness Tape or equivalent.
- **4.** Secure the replacement section of harness into the same body holes as the original section of harness was using the clips attached to the replacement section of harness.
- **5.** If DTCs were previously present, connect the appropriate Ford scan tool or equivalent to the DLC and clear all DTCs.

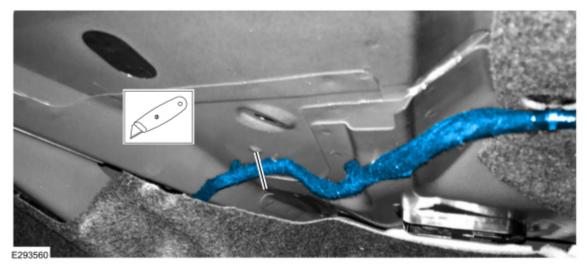
1. Cut out the damaged section of the harness. Make the cut at the location of the harness noted. (Figure 2) Figure 2

- 2. Splice in the new section of harness, matching wire colors on the existing vehicle harness and the replacement section of harness as necessary. Follow the recommended wiring splice procedures in Section 5 of the Wiring Diagram. Stagger the location of each of the wire splices along the harness to minimize the overall size of the repair.

- (1). Note: While it is necessary to cut and remove a section of the old satellite radio antenna cable along with the rest of the harness, it is not necessary to splice the satellite radio antenna cable where the harness is cut. The satellite radio antenna cable provided with the new harness is long enough to overlay the entire length of the old cable.

- **3.** Remove the existing ground on this section of the harness from the body of the vehicle. Reinstall the ground on the new section of harness to the body of the vehicle.

- **4.** Overlay the satellite radio antenna cable included with the new section of harness. Refer to WSM, Section 415-00B, Satellite Radio Antenna, Removal and Installation.

- 5. Wrap the spliced area in Coroplast Electrical Wire Harness Tape or equivalent.
- **6.** Secure the replacement section of harness into the same body holes as the original section of harness using the clips attached to the replacement section of harness.

- 7. If DTCs were previously present, clear all DTCs with the appropriate Ford diagnostic scan tool or equivalent.
