Preliminary Information

PIP5081L (EREV) Whine, Scrape, Whistle Type Noise While Driving, P0A46

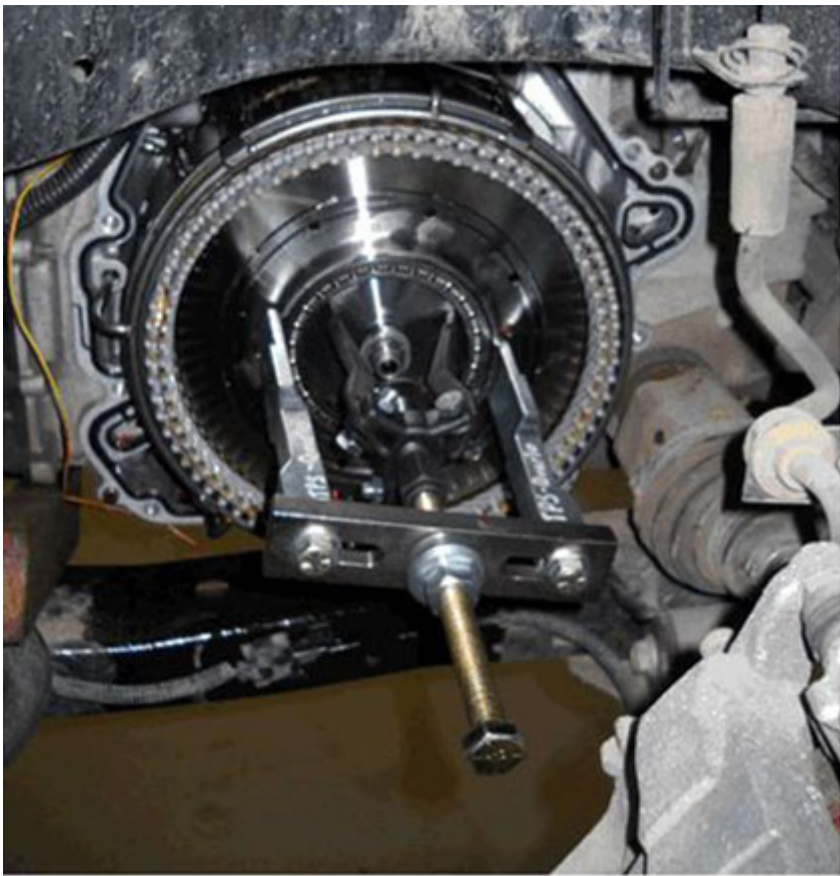
This noise may be caused by a separated electric drive motor B rotor bearing cage. A revised bearing has been released for installation into the drive unit.

Important: Please ensure that the Special Tools DT-47865 - Bearing Remover and J-45124 - Removal Bridge are used to remove bearing. If proper tools are not used the rotor may be damaged leading to a repeat repair. DO NOT TRY TO PRY OUT.
