SERVICE BULLETIN

APPLICABILITY: 2019MY Ascent “Touring” Models
SUBJECT: Rear Door Handle Frame- Design Change

NUMBER: 12-255-18R
DATE: 12/13/18
REVISED: 01/10/19

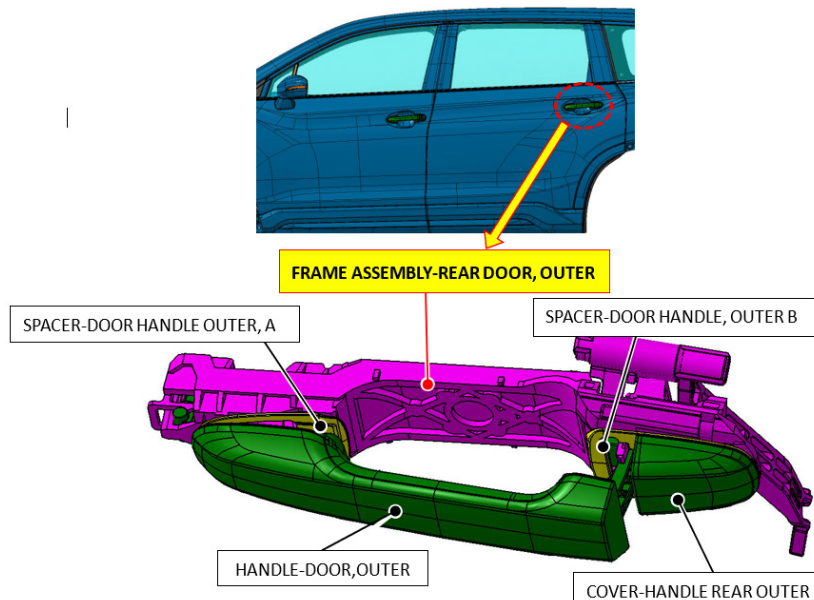
This bulletin outlines a design change made to the inner frame assembly used with the silver (“chrome”) type outer door handle to improve its reliability.

NOTE: The changes were made to the Frame Assembly, not the outer door handle. See illustration below.

- If the customer reports there are times when the rear door(s) is unlocked but cannot be opened from outside the vehicle, replace the corresponding Frame Assembly following the procedure in the applicable Service Manual. If the door will not open when presented, let it cool to room temperature or colder and try again to open it before attempting any internal dismantling.
