SERVICE BULLETIN

APPLICABILITY: 2017-18MY BRZ NUMBER: 12-257-19

SUBJECT: Instrument Panel Cover Peeling DATE: 01/31/19

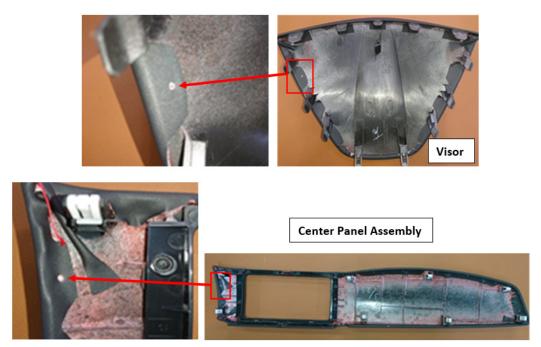
The new parts are identified by the small hole located in a flap of the cover material on the back side of the parts as shown below:

The production process was enhanced by increasing both the application area sizes and amount of adhesive used. Parts produced with the new process were incorporated into production starting with VIN J9601567.
