# Service Bulletin

Bulletin No.: 17-NA-221

**Subject:** Poor Engine Performance in Extremely Cold Weather Conditions for LE2 Engines, Charge Air Cooler Icing - Malfunction Indicator Lamp (MIL) Illuminated, DTC P0299, P0236, P2227, P00C7 Set

Brand:	Model:	Model Year:		VIN:		Engine:	Transmission:
		from	to	from	to		
Buick	Encore	2016	2019	SOP	September 18, 2017	Equipped with 1.4L (RPO LE2)

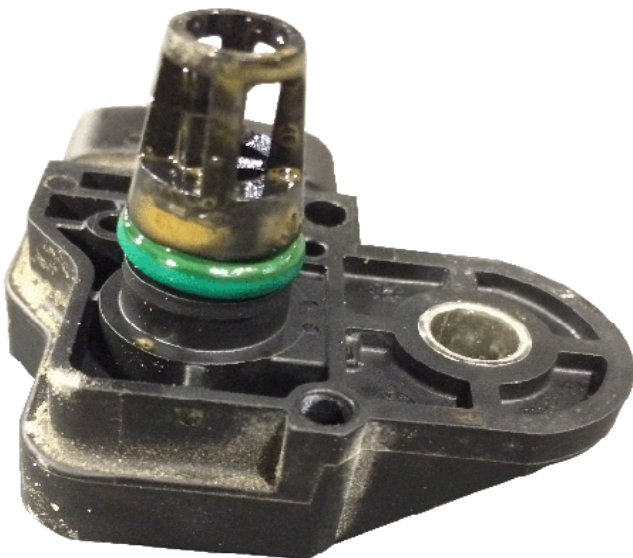
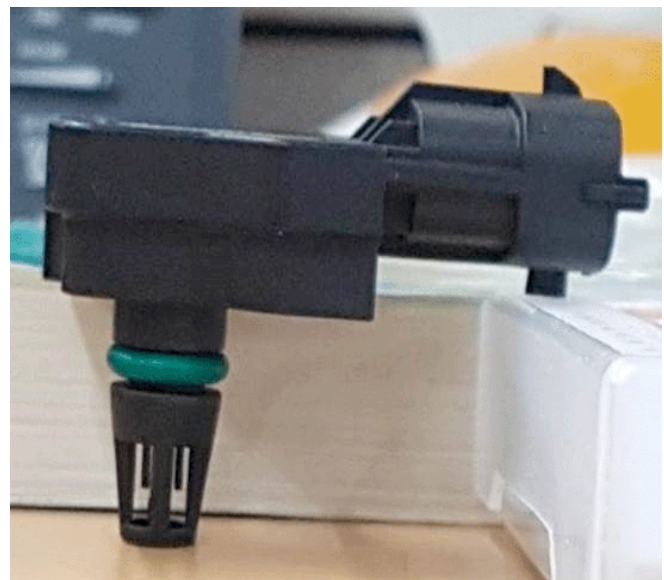
2. Inspect the sensor for any contaminants.

3. Allow time for any ice build-up to melt by placing the sensor port down.
4. Clean the sensor with a clean towel.
5. Install the sensor.
