Service Bulletin

Bulletin No.: 18-NA-020

Subject: Malfunction Indicator Lamp Illuminated with DTC P0300 and/or P0299/P2227 Set

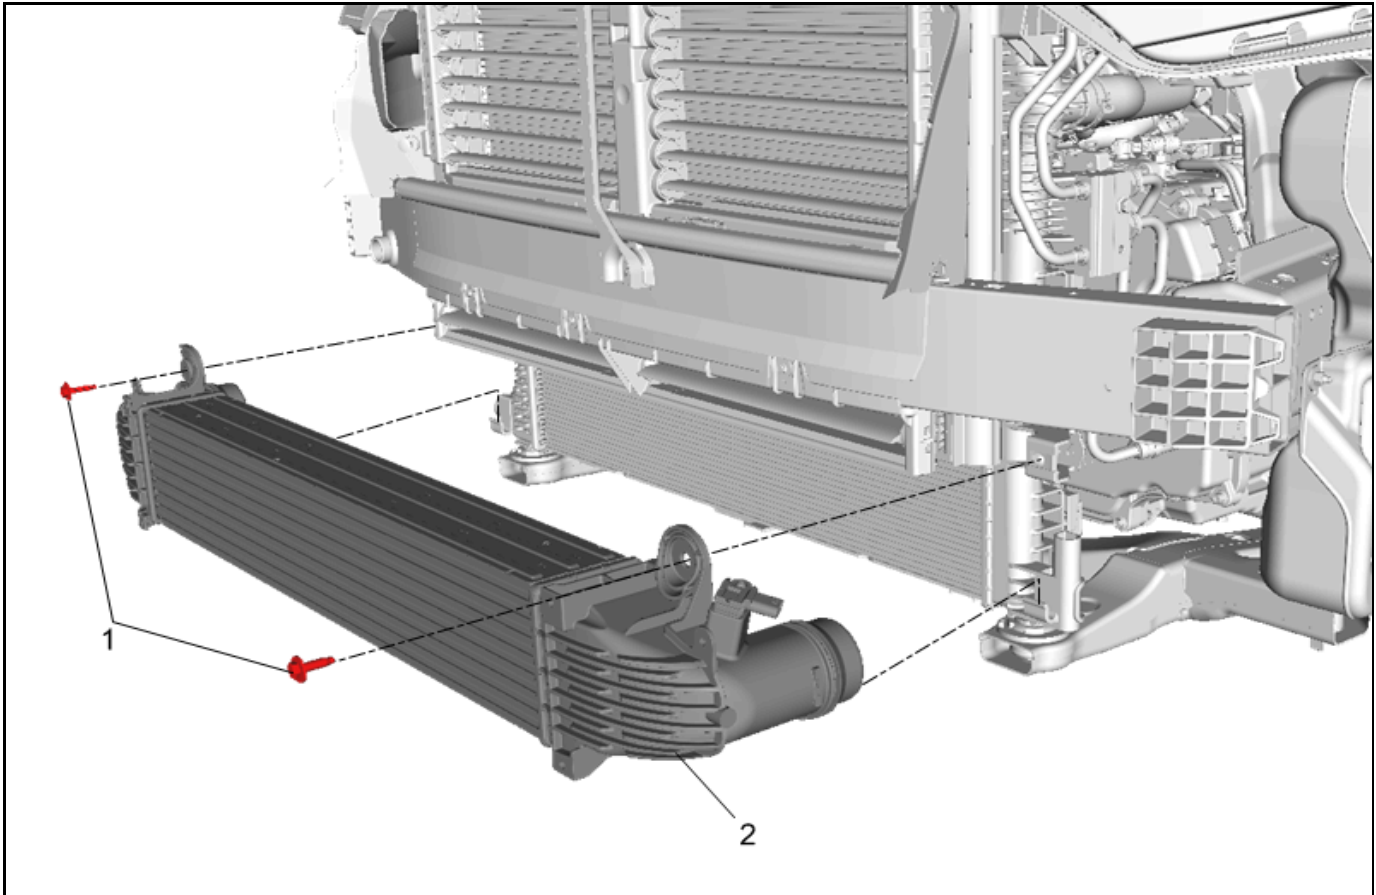
4597334

1. Perform a smoke leak test of the charge air cooler.

- If a leak is determined, replace the charge air cooler with the newly designed part. Refer to *Charge Air Cooler Replacement* in SI.
- If there is NO leak, but a P0300, P0299 and/or P2227 are present, **AND the vehicle was built ON or BEFORE March 1, 2018**, then replace the charge air cooler with the newly designed part. Refer to *Charge Air Cooler Replacement* in SI.
- If there is NO leak, but a P0300, P0299 and/or P2227 are present, **AND the vehicle was built AFTER March 1, 2018**, refer to SI for further diagnosis.

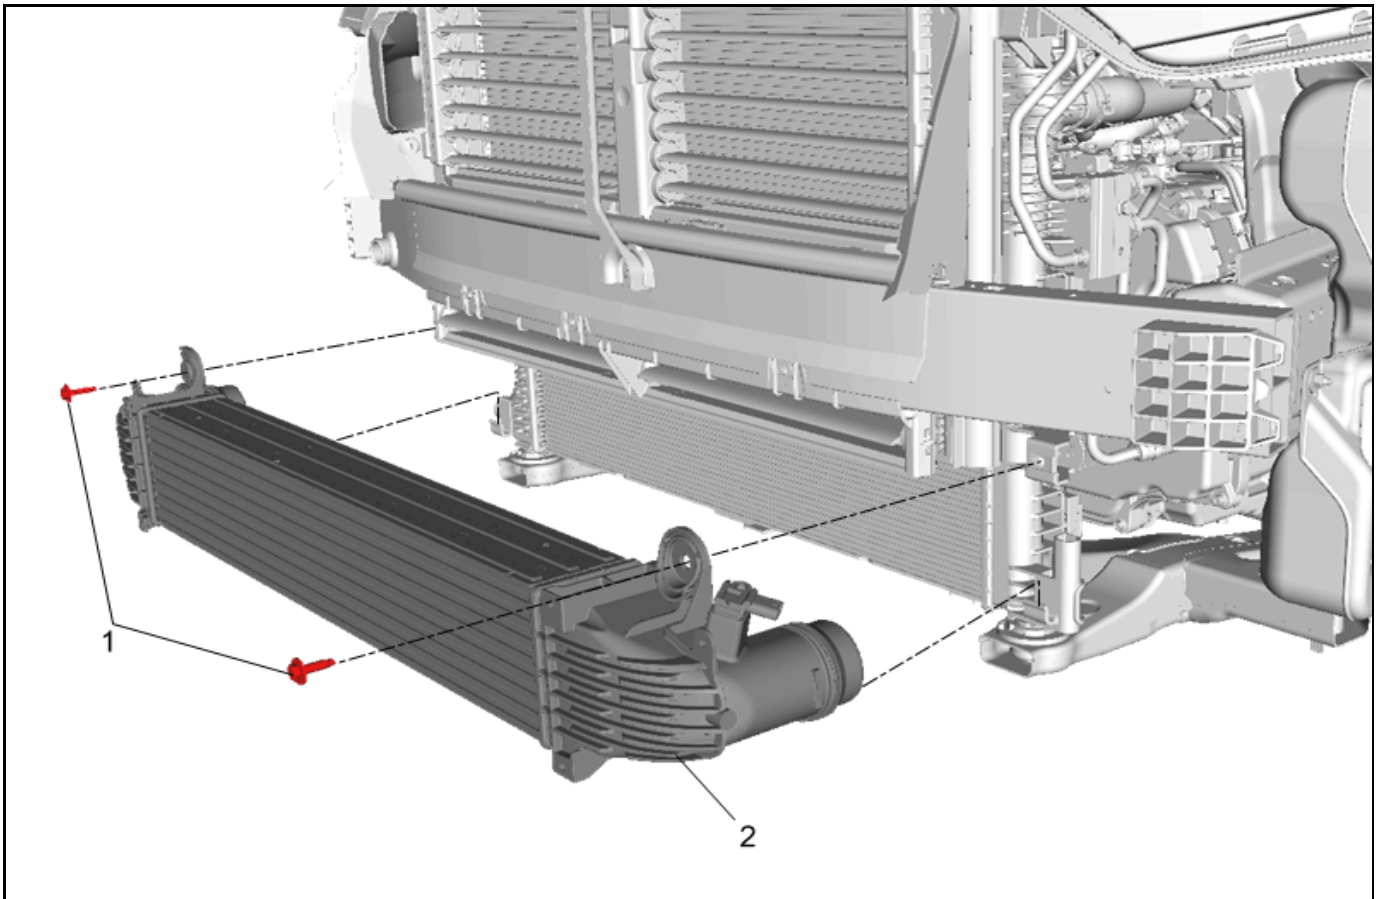
4597334

1. Perform a smoke leak test of the charge air cooler.

- If a leak is determined, replace the charge air cooler with the newly designed part. Refer to *Charge Air Cooler Replacement* in SI.
- If there is NO leak, but a P0300, P0299 and/or P2227 are present, **AND the vehicle was built ON or BEFORE January 5, 2019**, then replace the charge air cooler with the newly designed part. Refer to *Charge Air Cooler Replacement* in SI.
- If there is NO leak, but a P0300, P0299 and/or P2227 are present, **AND the vehicle was built AFTER January 5, 2019**, refer to SI for further diagnosis.
