Service Bulletin

Bulletin No.: 12-08-51-002I

Subject: Spray-in Bed Liner General Information and Repair Procedures

Models: 2013-2014 Chevrolet Silverado HD 2500/3500 Series

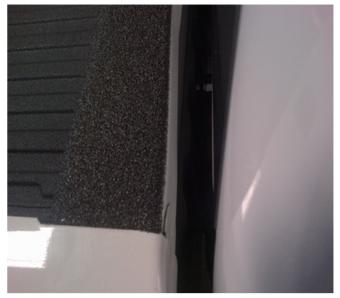
2968678

Because the bed liner material is sprayed on evenly, any variation in the bed such as seam sealer or spot welds in the sheet metal will show underneath the spray on coating. This is an expected condition. The coating does not completely fill in these variations.

Spot weld under bed liner example
