# Service Bulletin

Bulletin No.: PI1354I

**Subject:** Information on Vibration Analysis and Diagnostic

**Models:** 2014 Chevrolet Silverado 1500  
2015-2018 Chevrolet Silverado 1500  
2019 Chevrolet Silverado LD \*  
2014 GMC Sierra 1500  
2015-2018 GMC Sierra 1500  
2019 GMC Sierra Limited \*  
EXCLUDES HD Trucks

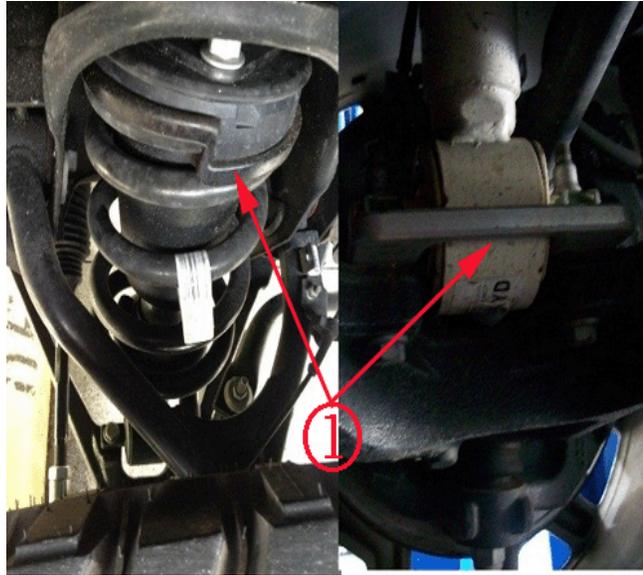
4002193

1. Inspect the truck for any aftermarket equipment installations. For example: non factory tires, wheels and/or lift kits or leveling kits – shims (1) installed as shown above. Aftermarket equipment does include running boards, bug deflectors, and window shades, etc. Remove any aftermarket that might cause vibration transmission paths.
2. Mark each tire valve stems location on the tire. This will be utilized to check for tire slippage on the rim.

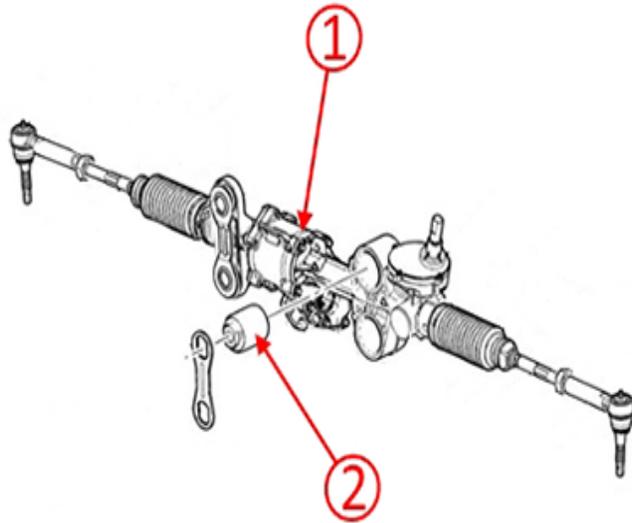
4743660

*A revised steering bushing (2) has been released to address customer vibration concerns. After various testing and measurement of the T1 vibration, a vibration path from the tie rods =>steering rack=>steering bushings=>frame=>Body Mount=>Cabin Floor=>Seat has been identified. To help isolate the steering rack (1), a revised hydraulic bushing has been released and tuned to the T1 frequency. The new steering bushing dampens minor T1 vibrations. This is the reason that the causal part (normally the Tire/Wheel Assembly) must be corrected first. If the T1 vibration is over 20-25m/g's, the bushings will have little to no effect.*

*For vehicles with T1 vibrations under 20-25m/g's, replace steering bushing per parts catalogue. Utilize SI procedure "Steering Gear Mount Bushing Replacement" for replacement of the steering bushings.*

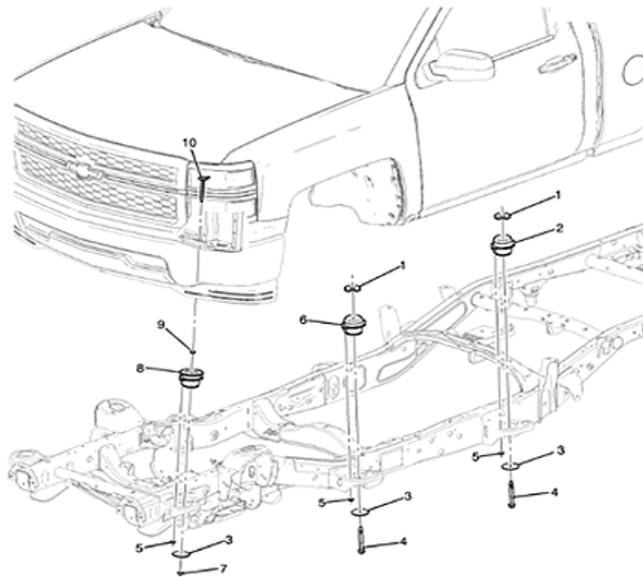
4816998

A revised Rear Cab Mount has been released to address customer vibration concerns. After various testing and measurement of the T1 vibration, a vibration path from the tie rods =>steering rack=>steering bushings=>frame=>Body Mount=>Cabin Floor=>Seat has been identified. To help isolate the cab, a revised Cab Mount has been released and tuned to the T1 frequency. The new cab mount dampens minor T1 vibrations. This is the reason that the causal part (normally the Tire/Wheel Assembly) must be corrected first. If the T1 vibration is over 20-25m/g's, the cab mount will have little to no effect.

Correction: Replace Rear Cab Mount with Revised part number.

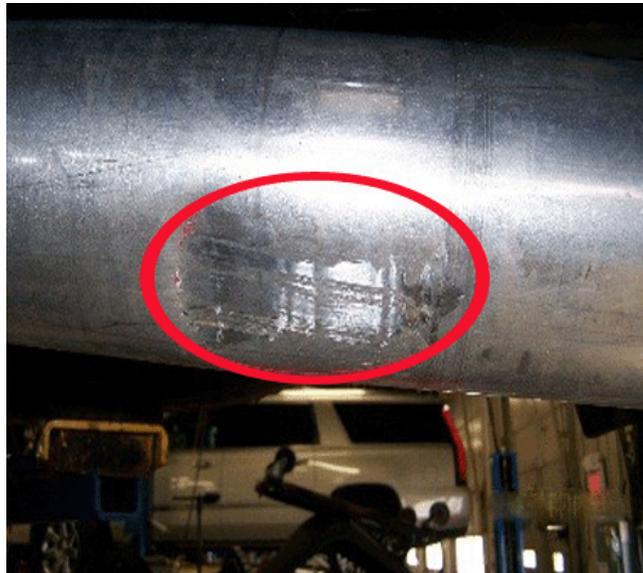
4002784

- Inspect the propeller shaft for dents or damage. There have been many cases of dented propeller shafts.
- For 4WD Trucks, remove the rear propeller shaft, seal output shaft and drive the vehicle in 4WD. If the vibration is gone, the rear prop shaft could be the problem.
- For vehicles with a 3:08 with a one-piece steel shaft, this can be replaced with a one-piece aluminum one that is utilized on all 3:42 and 3:73 ratios (K15543 and K15753 Models only).
- PIP5140: Low Speed Vibration 30-35 mph (48-56 km/h).
- Inspect the transmission output shaft bushing for irregular wear.

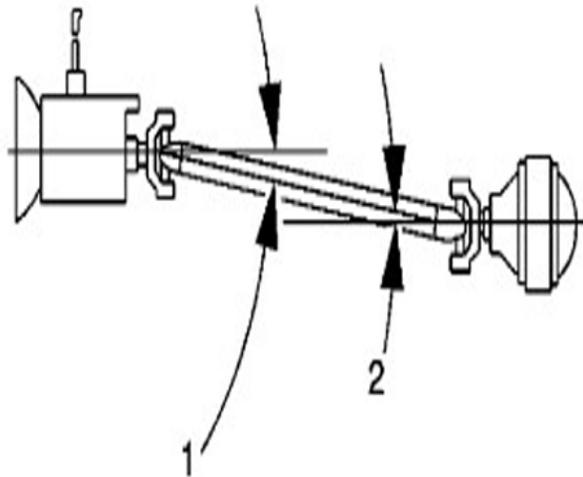
4002865

Propeller systems containing only 1 U-joint: The U-joint working angle should be between 1/2 and 3/4 degrees. Allowable range of difference between cancelling U-joint working angles: 0.25 to 1.0 degrees.
