TECHNICAL SERVICE BULLETIN

Technical Service Bulletin: 225-0970

Forest River is alerting you to an issue involving certain 2018 through 2019 – Crossfit – CFB22CF, CFB22CFEB, CFB22CFEBCA, CFB22DF, CFB22DFEB Class B motorhome recreational vehicles. Please see the information below which describes the issue and provides you with details on the steps you should take to have your vehicle repaired.

CORRECT INSTALLATION VALIDATION PROCEDURE • 02/19/2019

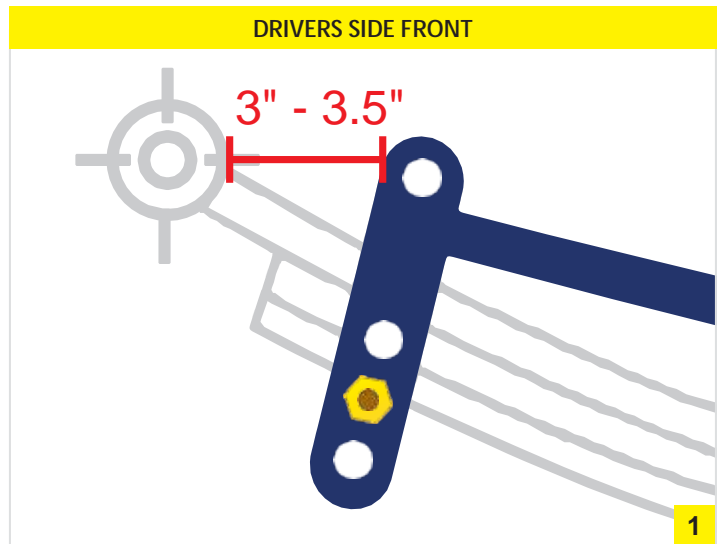
It has been reported that the SuperSprings may interfere with the Ford Transit 350 vehicle chassis rear factory spring hanger when incorrectly installed. This interference can result in a mechanical noise when fully loaded and hitting a severe pothole or speed bump.

To ensure proper positioning, the measurement of space between the front of the SuperSprings and the rear of the vehicle front spring eye is necessary. This dimension should be no less than 3.00" and must not exceed 3.5" (SEE IMAGE 1). If the measurement is within this range, then no further action is required. If this measurement is outside of this range then corrective action is required – refer to:
