SERVICE PROGRAM BULLETIN

APPLICABILITY: 2018MY Impreza

NUMBER: WTX-83

SUBJECT: Rear Subframe- Lateral Link Bracket Weld Inspection

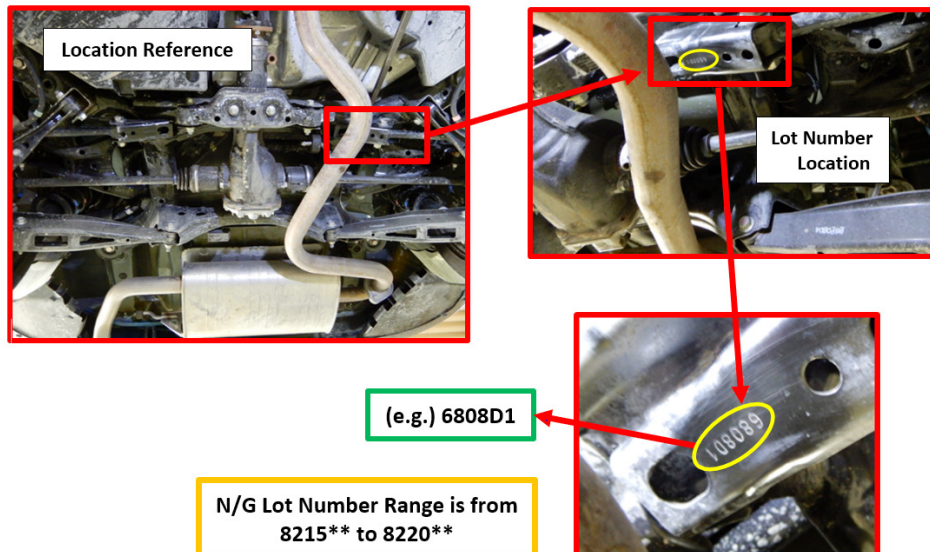
Step 1: Clean the area on the bottom of the lateral link bracket and verify the first 4 numbers of the 6-digit lot number as shown below. If the first 4-digits of the lot number are equal to or between **8215**** and **8220****, proceed to **Step 2** below. If not, record the lot number on the repair order to complete the procedure. **NOTE:** This lot number will be required for claim entry.

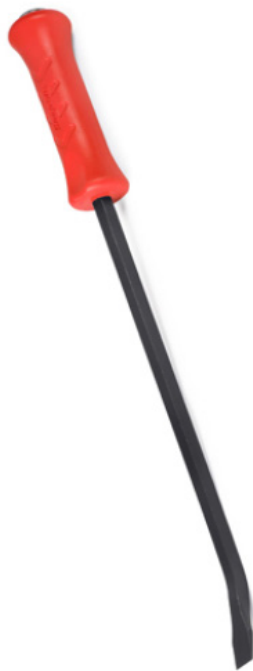
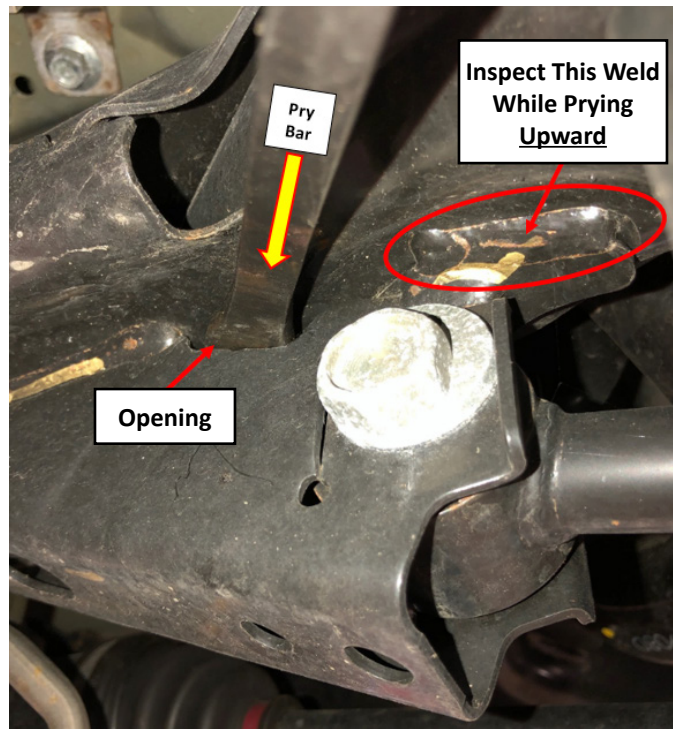
Step 2: Insert the end of a standard 24” pry bar into the opening between the lateral link bracket and subframe to the left of the weld being inspected. While prying, inspect the weld securing the bracket to the subframe closely as shown in the photo below. Use a helper if necessary.

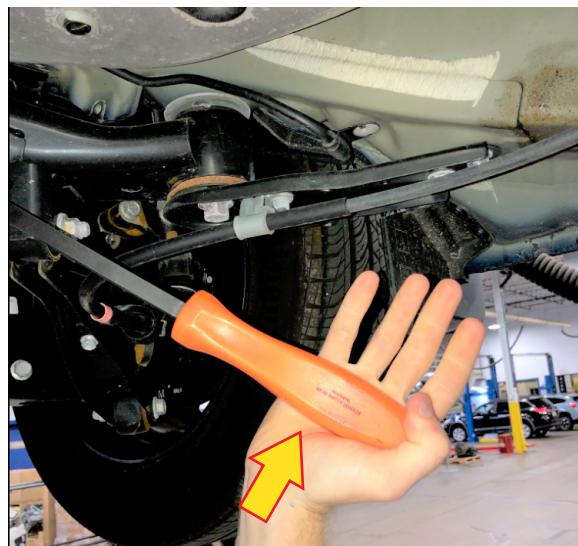
Push **UPWARD** on the pry bar approximately 2" (**3" MAX**) to apply downward force on the bracket and weld as shown below.

If the weld is broken, cracked or at all damaged and the base metal is exposed, replace the rear sub-frame with a new part. If the weld is OK, always make sure to touch-up any paint damage from the pry bar. Wipe the area clean with mild solvent on a fresh shop cloth, allow to dry then apply rust-preventative touch-up** to prevent corrosion.
