SERVICE BULLETIN

APPLICABILITY: 2015-2018MY Legacy and Outback
 2012-2018MY Impreza
 2013-2018MY Crosstrek
 2014-2018MY Forester
 2015-2018MY WRX

NUMBER: 16-112-18R

SUBJECT: Ignition Key Sticking / Design Change to CVT Shifter / Selector Lever Components

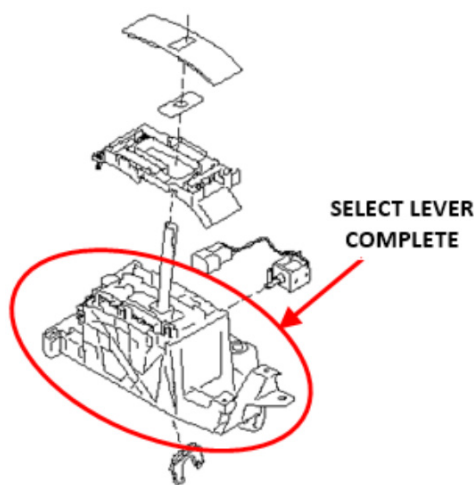
For Legacy and Outback:

- For **Legacy and Outback**, the shifter assembly (SELECT LEVER COMPLETE) must be replaced if the Park-Range switch is found to be faulty.

- Replace the SELECT LEVER COMPLETE assembly (on Legacy and Outback models) or,
- Replace the Park-Range switch (PLATE-GUIDE B) following the Select Lever disassembly / assembly procedure in the applicable Service Manual.

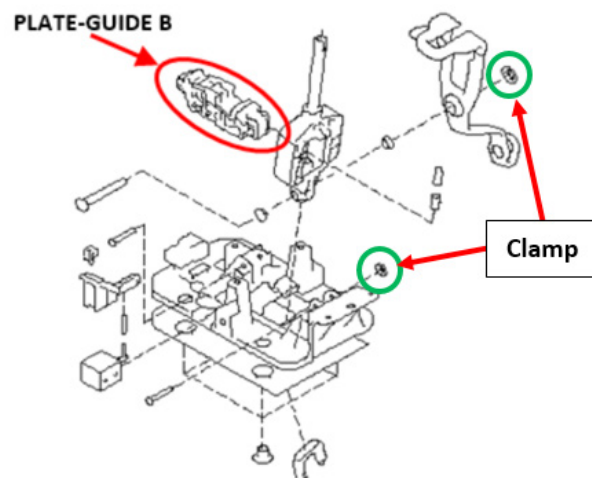
For all other models listed:

- The term PLATE-GUIDE B refers to the Park-Range switch which is a serviceable part of the select lever assembly on all models listed above **EXCEPT** Legacy and Outback. See the illustrations provided below for more details.
