TECHNICAL SERVICE BULLETIN

6.7L - Illuminated MIL With DTCs U029D And/Or P2209

18-2365
18 February
2019

Ford 2017-2019 F-Super Duty

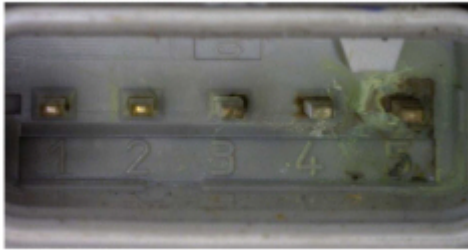
Figure 1

Issue: Some 2017-2019 F-Super Duty vehicles equipped with a 6.7L engine may exhibit an illuminated malfunction indicator lamp (MIL) with diagnostic trouble codes (DTCs) U029D and/or P2209 in the powertrain control module (PCM). This may be due to water intrusion.

1. Disconnect the nitrogen oxides (NOx) sensor module 11 and inspect for moisture or corrosion on the pins of the sensor or the wiring harness. Are there any signs of moisture or corrosion present? (Figures 1-2)

(1). Yes - replace the NOx sensor module 11. Refer to Workshop Manual (WSM), Section 303-14. Proceed to Step 2.
