TECHNICAL SERVICE BULLETIN

Headliner Loose And/Or Sagging At The Rear Near The High Mounted Stoplamp

19-2051
26 February
2019

Ford
2013-2019 Police Interceptor Sedan
2011-2019 Taurus

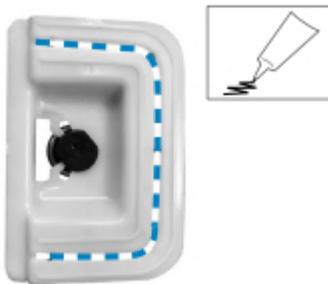
Figure 2

Issue: Some 2011-2019 Taurus and 2013-2019 Police Interceptor Sedan vehicles may exhibit a loose and/or sagging headliner near the high mounted stoplamp. This may be caused by the headliner mounting bracket separating from the headliner. To resolve the condition, reapply adhesive to the headliner mounting bracket.

3. Gently pull down on the rear of the headliner to gain access to the center mounting bracket location.
4. Apply 3M™ Super-Fast Repair Adhesive or equivalent to the back of the headliner mounting bracket. Removal of the original adhesive is not necessary.(Figure 2)
