TECHNICAL SERVICE BULLETIN

Glove Box Misaligned

19-2071
12 March 2019

Ford 2015-2019 F-150

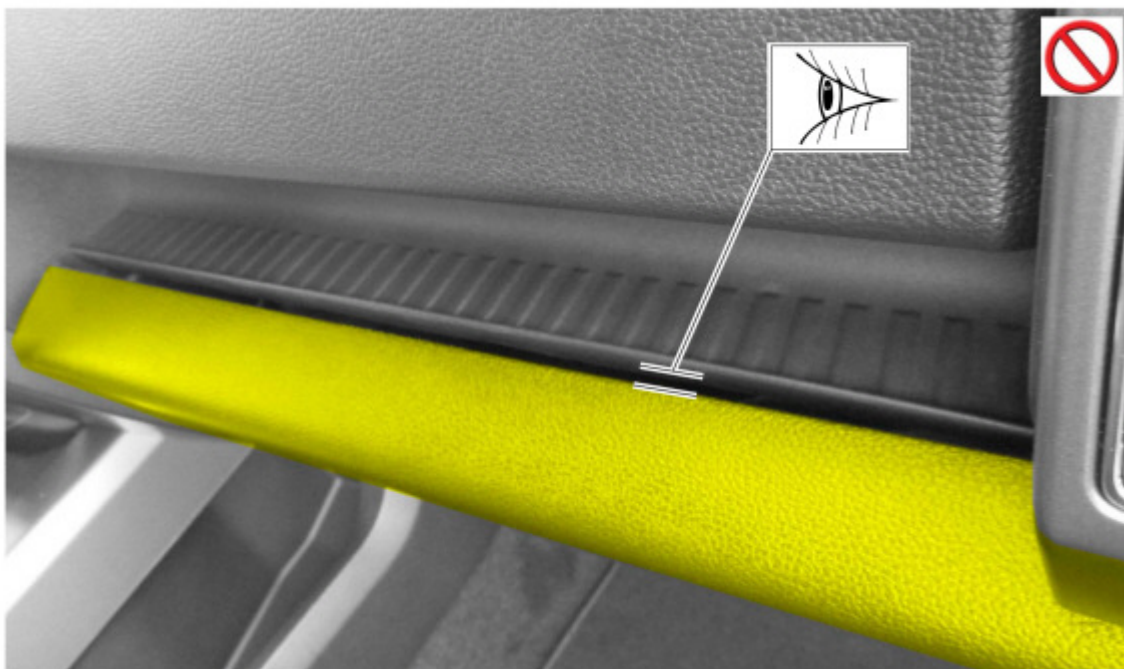
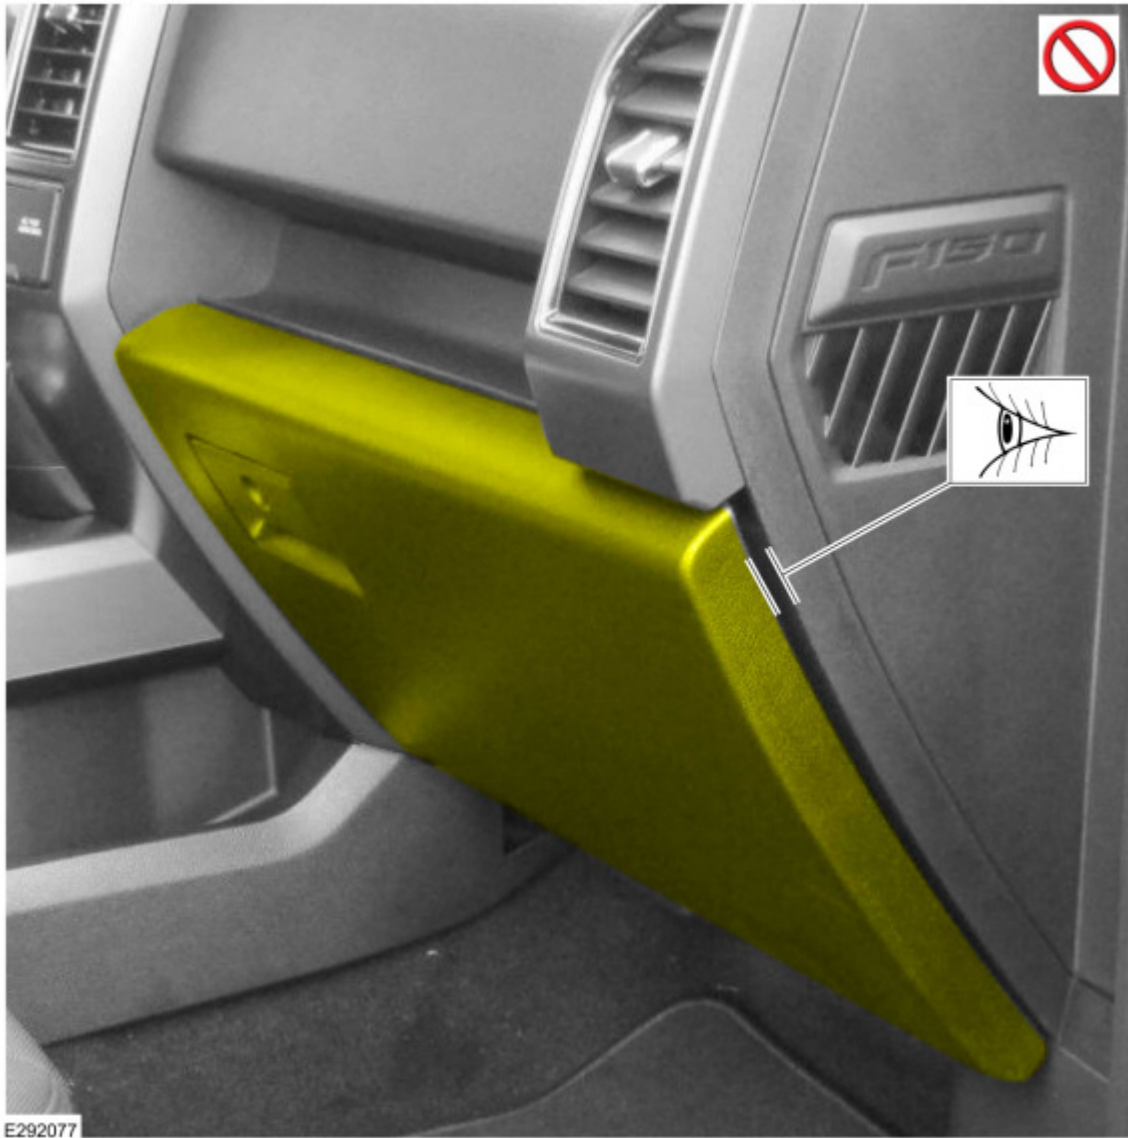
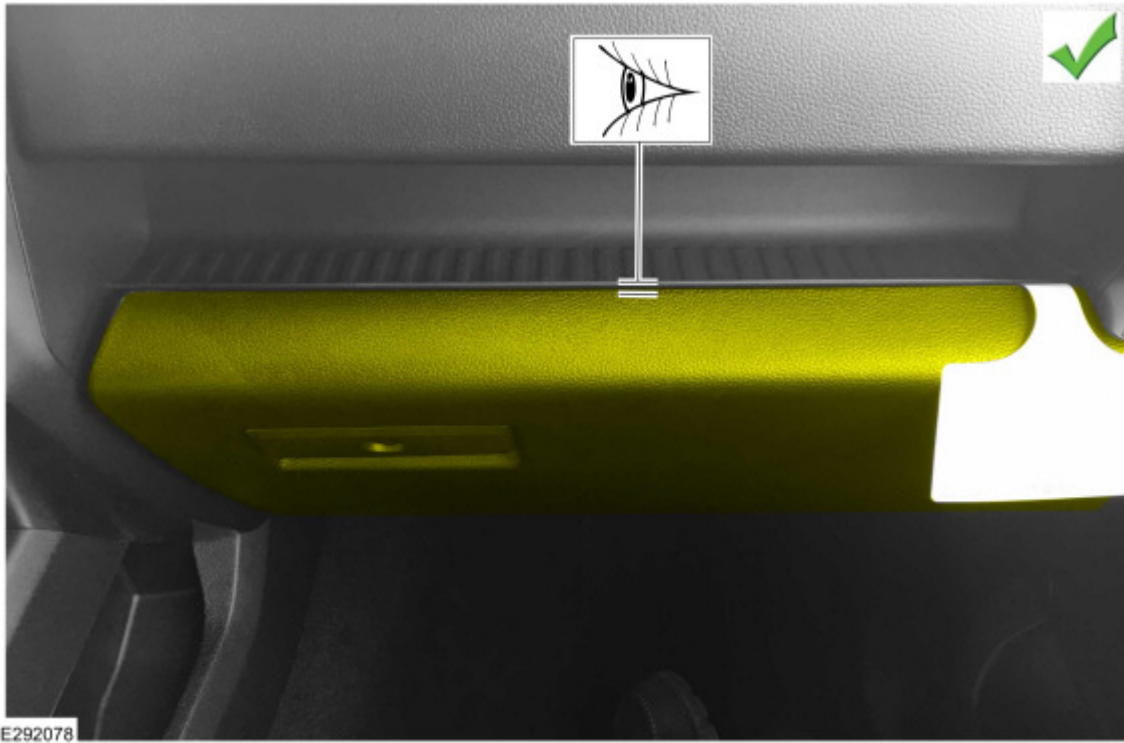
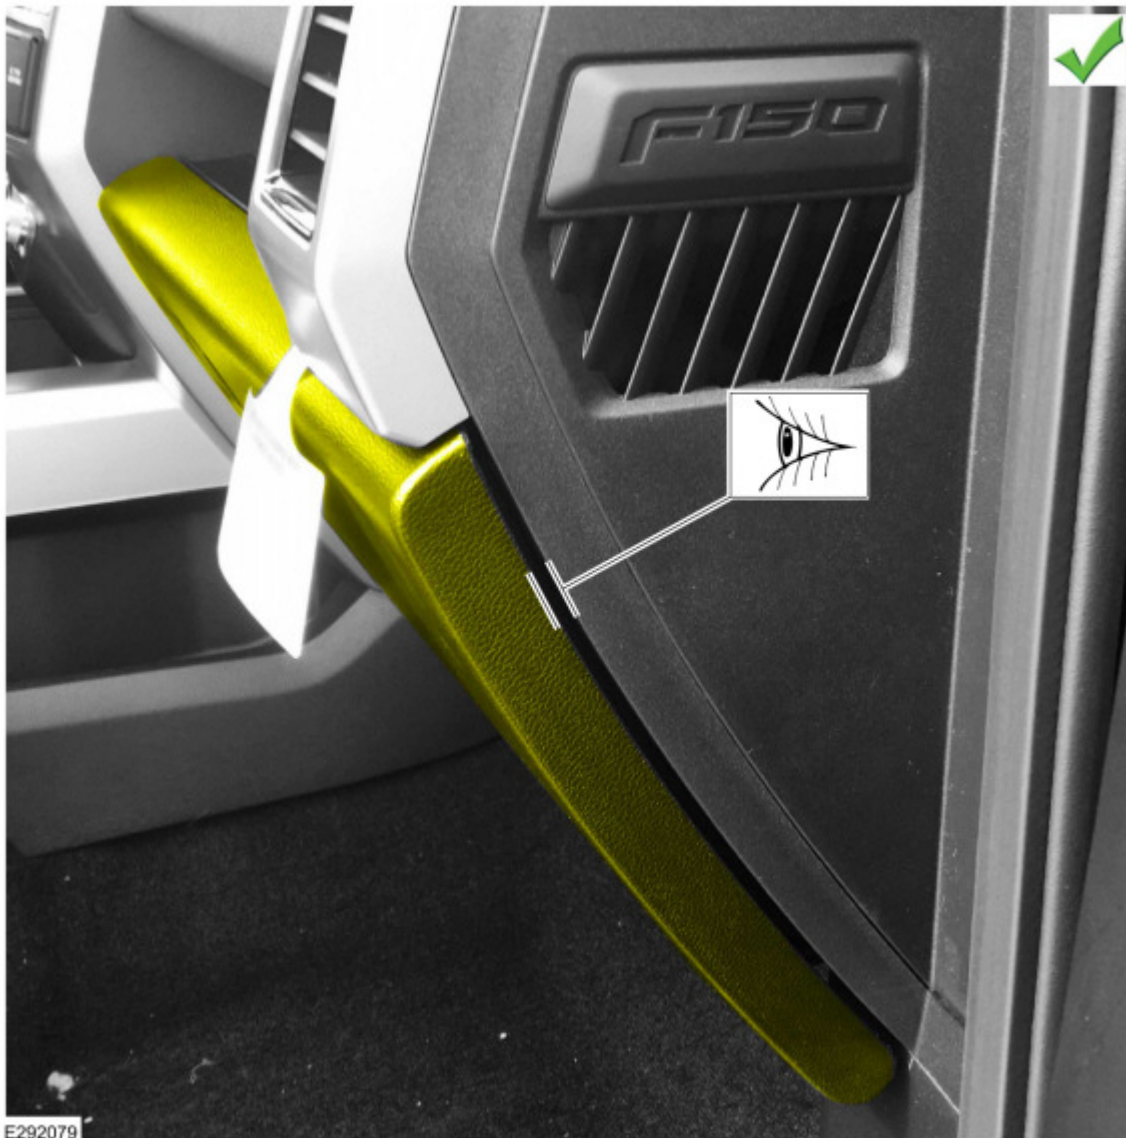
1. Inspect the glove box door in the closed position. Does the glove box exhibit a misalignment at the storage tray and/or right side instrument panel with no other visible defect? (Figures 1-4)

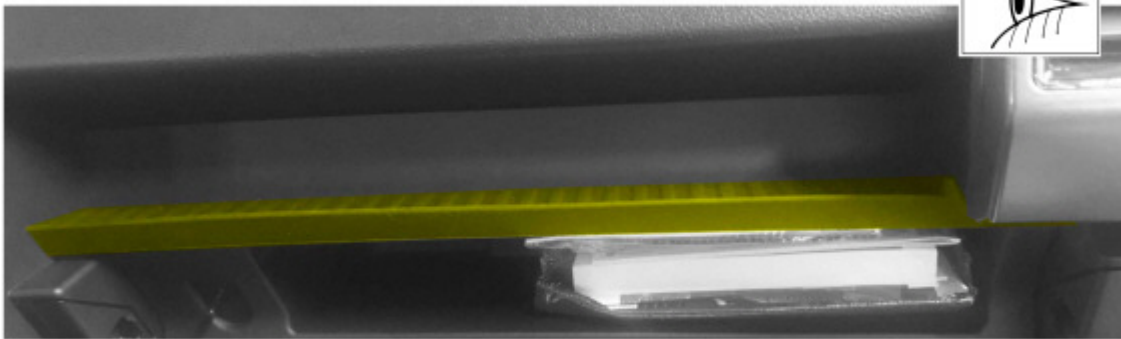
Figure 6

2. Inspect the glove box storage tray rubber mat. Is the mat properly seated and flush on both end of the instrument panel? (Figures 5-6)

3. Remove the rubber mat and close the glove box door. Refer to WSM, Section 501-12. Does the glove box door close properly?
 - (1). Yes - The rubber mat was installed incorrectly. Install the rubber mat making sure the right hand side is properly tucked and seated to the instrument panel. Refer to WSM, Section 501-12. Proceed to Step 4.
 - (2). No - install the rubber mat and proceed to Step 4. Refer to WSM, Section 501-12.
4. Inspect the glove box door left and right hand strikers. Are the strikers fully seated? (Figures 7-9)
 - (1). Yes - proceed to Step 6.
 - (2). No - proceed to Step 5.

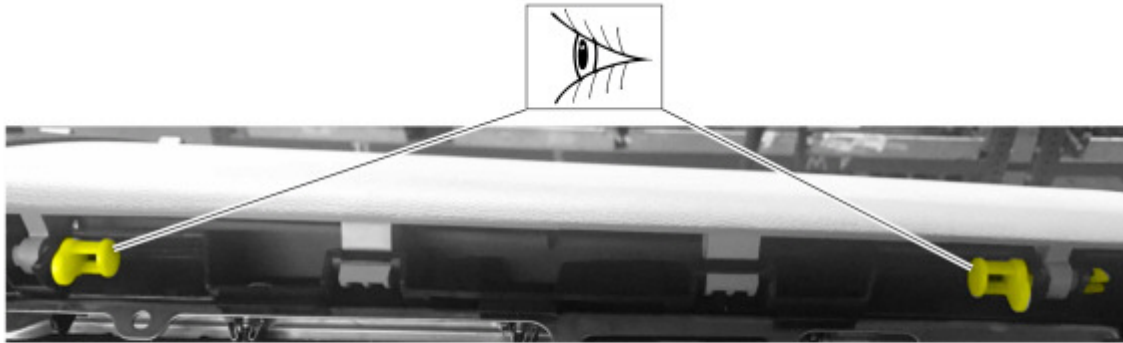
Figure 10

5. Remove the improperly installed striker using a non-marring pry tool and reinstall. Make sure the striker is fully seated.
6. Inspect the glove box door hinge pins. Are both pins fully seated? (Figure 10)
 - (1). Yes - proceed to Step 8.
 - (2). No - proceed to Step 7.

7. Remove and reseal the hinge pins.
8. Close the glove box door and inspect for proper alignment. Is the door properly aligned and latched on both sides?
 - (1). Yes - repair is complete.
 - (2). No - proceed to Step 9.
9. Remove the bumpers from the glove box door and close it. Does the glove box door latch properly? (Figure 11)
 - (1). Yes - If the glove box door closes properly with the bumpers removed, the bumpers have taken a set in the door open position which will increase closing force and inhibit proper latching. Install the bumpers and close the glove box door fully. Make sure both sides are latched. Increased closing force may be required to properly latch the glove box door. Allow the glove box door to remain in the closed position for 2 hours to allow the bumpers to take a set in this position. Repair is complete.
 - (2). No - proceed to Step 10.
