TECHNICAL SERVICE BULLETIN

Intermittent Power Mirror And/Or Power Window Operation From Master Switch - Built On 23-Jul-2018 And Through 07-Nov-2018

19-209222 March
2019

| Lincoln 2019 MKC |

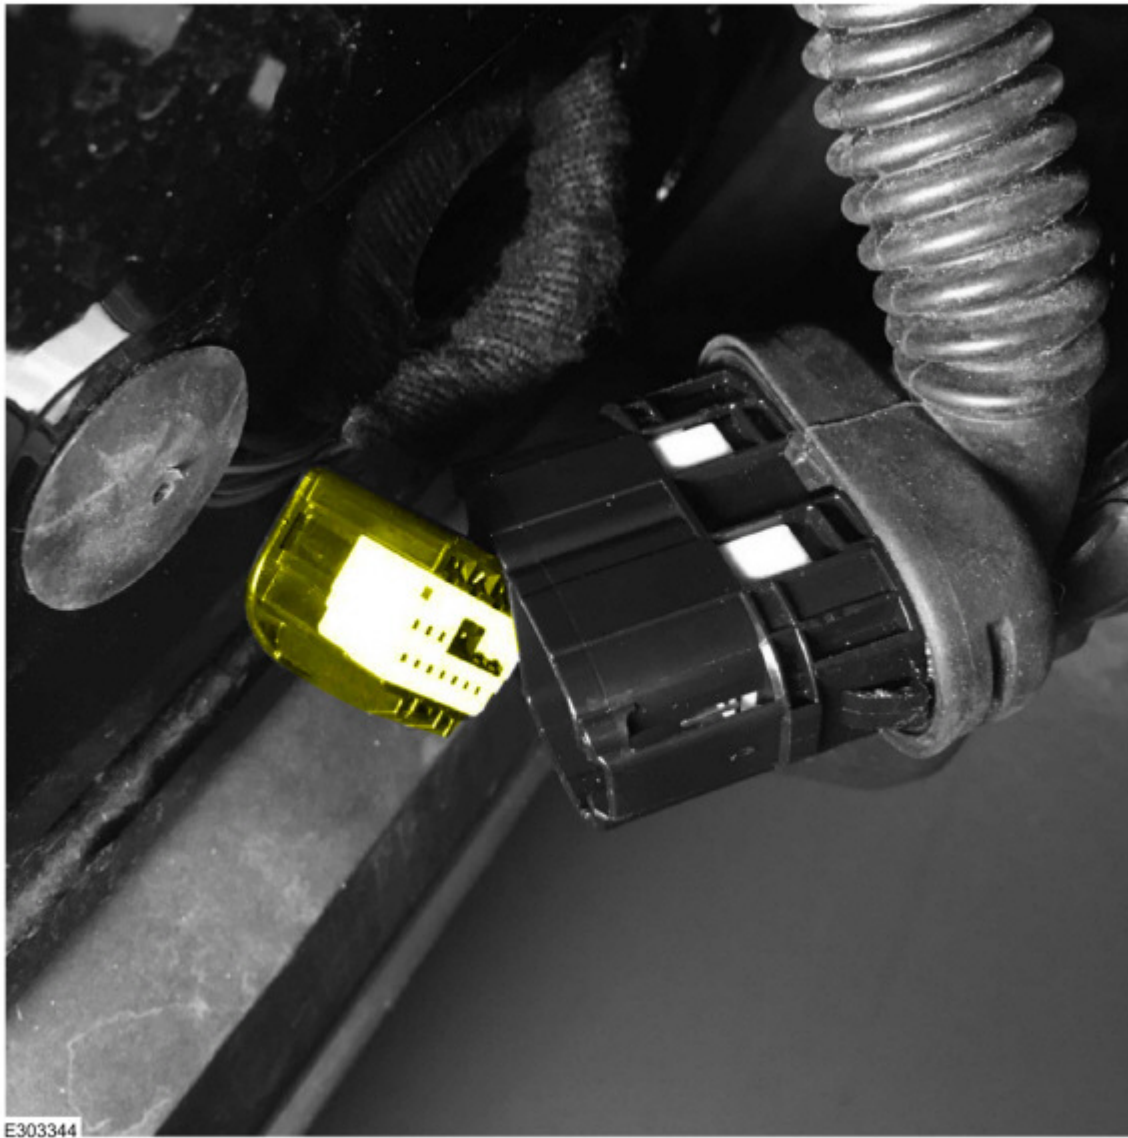
Figure 5

Issue: Some 2019 MKC vehicles built on 23-Jul-2018 and through 07-Nov-2018 may exhibit intermittent function of the power mirrors and/or power windows from the master switch. These symptoms may also be present with or without diagnostic trouble codes (DTCs) B1087 and/or B1088 stored in the driver door module (DDM) and/or passenger door module (PDM). This may be the result of a small impression in the left B-pillar sheet metal which has allowed water to overcome the sealing capability of the electrical harness grommet and enter connector C315. To resolve this concern, remove all moisture from the connector, apply electrical grease and seal the B-pillar wiring harness grommet to the left B-pillar sheet metal.

5. Disconnect connector C315 and inspect for water intrusion. (Figure 5)
