TECHNICAL SERVICE BULLETIN

5.0L - Rattling Sound From The Transmission Bellhousing Area - Built On Before 12-Feb-2019

19-2093
25 March 2019

Ford 2018-2019 F-150

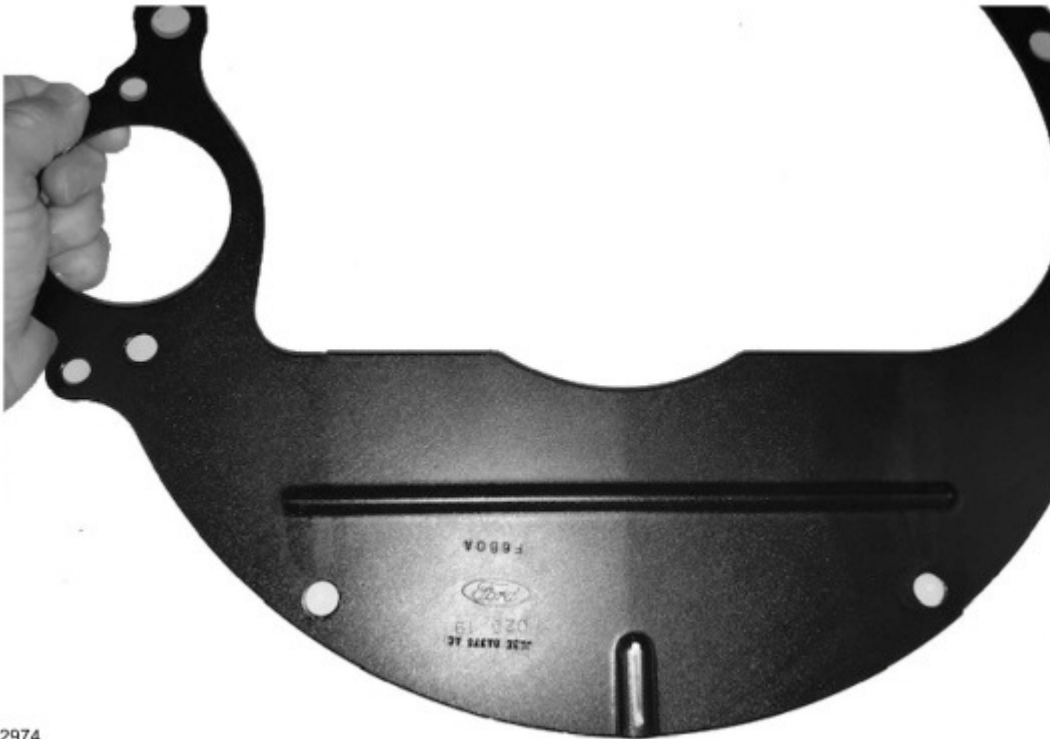
Figure 1

Issue: Some 2018-2019 F-150 vehicles equipped with a 5.0L engine and built on or before 12-Feb-2019 may exhibit a rattling sound coming from the transmission bellhousing area. This may be due to the torque converter studs contacting the engine to transmission spacer plate. To resolve this concern, replace the engine to transmission spacer plate with a new engine to transmission spacer plate that includes a bend for additional clearance.

1. Remove the flexplate. Refer to Workshop Manual (WSM), Section 303-01D.
2. Replace the engine to transmission spacer plate. (Figure 1)

3. To install, reverse the removal procedure.

- (1). Reuse the transmission fluid cooler tube bracket bolt. Clean the threads and install a small patch of Motorcraft® Threadlock and Sealer or equivalent.
