## Preliminary Information

### PIP5527B Drivability Concerns Caused By Intake Rocker Arm Oil Control Valve - Chuggle Surge Misfire P0101 P0106 P0171 P0300 P219A

Brand:	Model:	Model Years:	VIN:		Engine:	Transmissions:
			from	to		
Chevrolet	Impala (VIN 1)	2014 - 2015	All	All	2.5 LKW	All
Chevrolet	Malibu	2014 - 2015	All	All	2.5 LKW	All

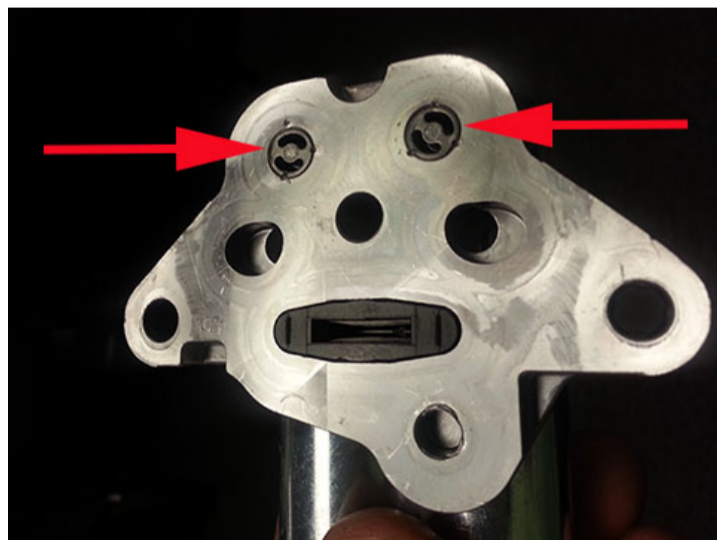
This is a good valve with components still in place.

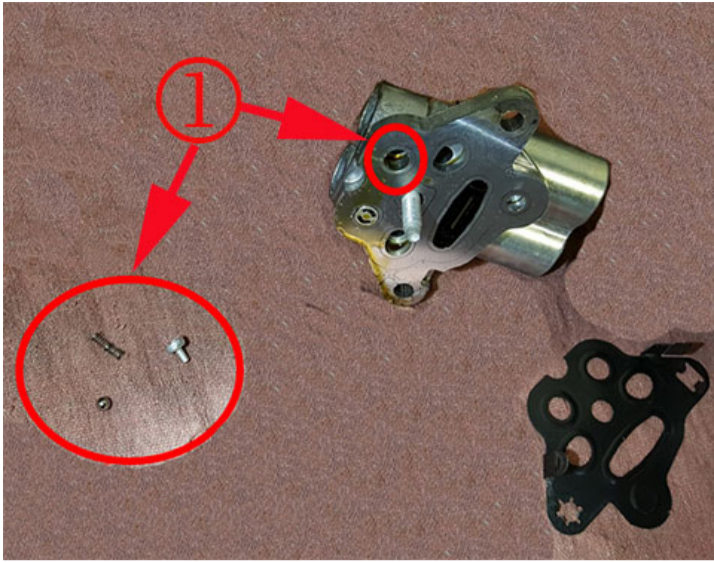
See illustrations below for items #1 being missing.

The camshaft cover must be replaced because the components become lodged in the camshaft cover oil passages and can not be removed.

This is a bad valve with components missing.

If any of the components are missing, replace the intake rocker arm oil control valve and camshaft cover.
