# Preliminary Information

## PIT5648C Trailer Disconnected Check Connection Message on DIC Without a Trailer Connected (Reprogram the Trailer Lighting Control Module K68)

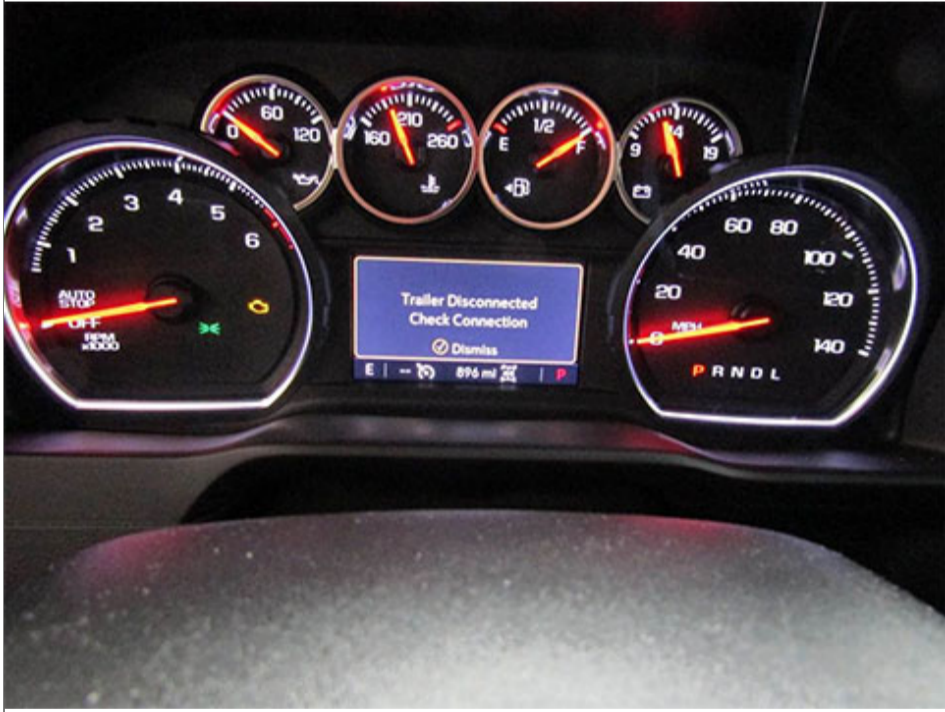
| Condition | <p>Some customers may comment on a "Trailer Disconnected Check Connection" message being displayed on the DIC without a trailer connected, message shown below. In addition to this message, there may also be the following messages depending on the vehicle content:</p> <ul style="list-style-type: none"> <li>- Rear Park Assist Off</li> <li>- Lane Change Alert System Off</li> <li>- Rear Cross Traffic Alert Off</li> </ul> <p>This condition is more likely to occur with colder ambient temperatures.</p> |
| Cause | This concern could be caused by the Trailer Lighting Control Module software. |

To correct this concern, reprogram the Trailer Lighting Control Module (K68) with the latest software available in Tis2Web, per Service Update

[N192213550](#) – Trailer Integration Module Software Error.
