Bulletin No.: PIT5666

PIT5666 Squeak/Creak/Squawk/Itch Type Noise Heard From The I/P or Center Console Area

Brand:	Model:	Model Years:	VIN:		Engine:	Transmissions:
			from	to		
Chevrolet	Silverado 1500 (New Model)	2019	All	All	All	All
GMC	Sierra 1500 (New Model)	2019	All	All	All	All

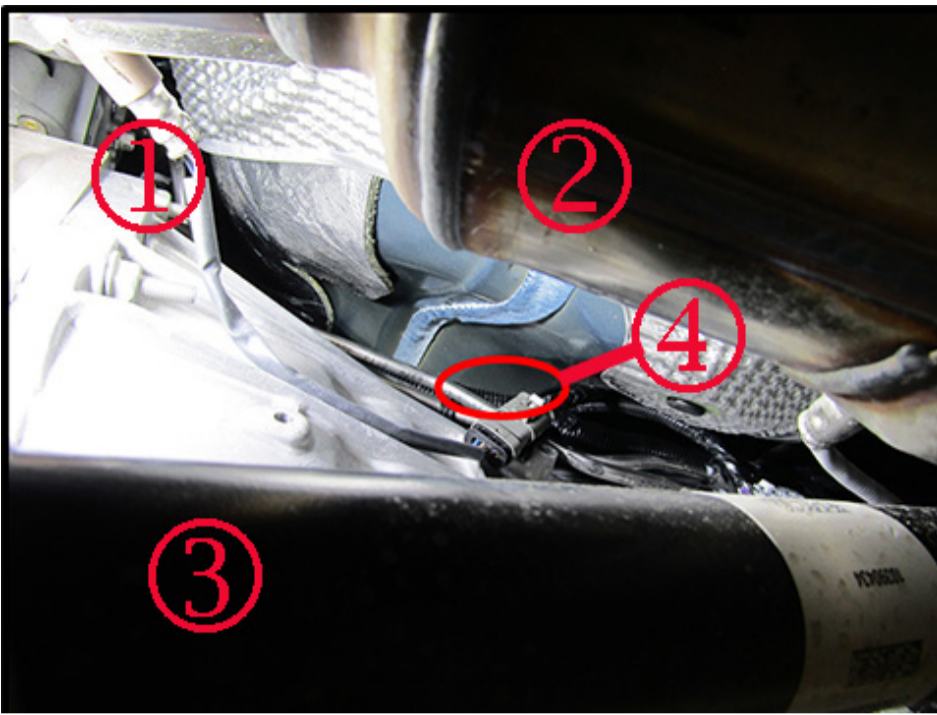
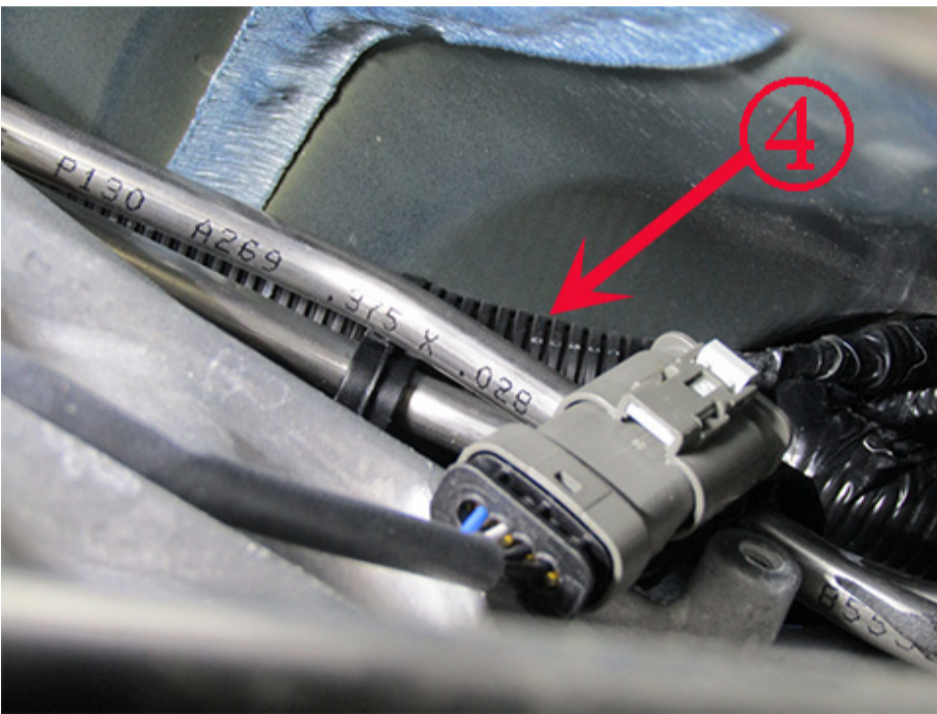
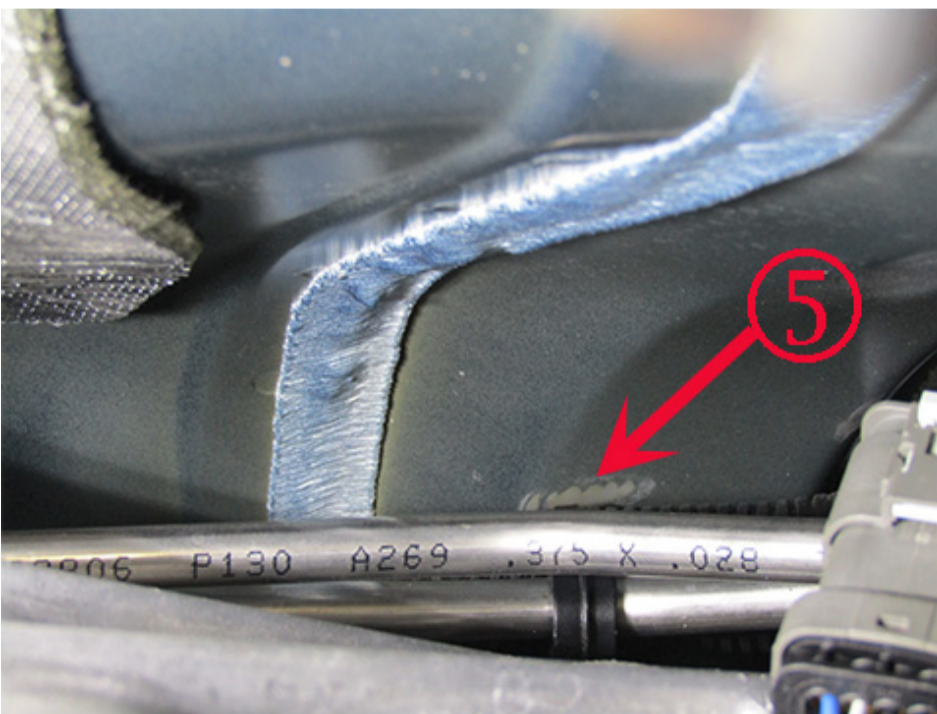
Involved Region or Country	North America
Condition	<p>Some customers may comment of a squeak, creak, itch, or rubber type noise heard from the IP dash or center console area. The noise may be duplicated by the following:</p> <ul style="list-style-type: none"> - Driving over bumps (noise may go away if coasting or if transmission is shifted into "N") - During acceleration - Brake torqueing in drive (noise may not occur when brake torqueing in reverse)
Cause	<p>This noise could be caused by the engine harness rubbing on the floor pan above the transmission (item numbers 4 and 5), as shown below. The photos below were taken from under the vehicle looking up along the driver's side of the transmission bell housing.</p> <p>Callout 1 - Bank 1 Sensor 1 O2 sensor Callout 2 - Bank 1 Catalytic Converter Callout 3 - Front Driveshaft (on 4WD vehicles) Callout 4 - Engine Harness rubbing on floor pan Callout 5 - Engine Harness pushed aside to show the contact on the floor pan</p>
