# Service Bulletin

Bulletin No.: 18-NA-246

**Subject:** Malfunction Indicator Lamp (MIL) Illuminated - DTC P0172 Set

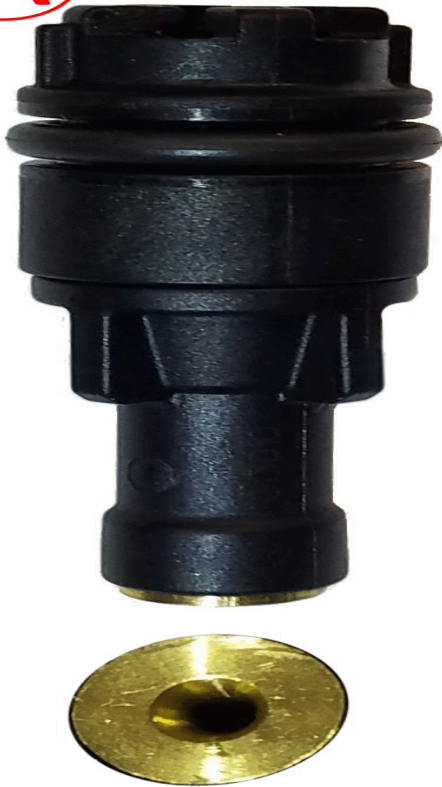
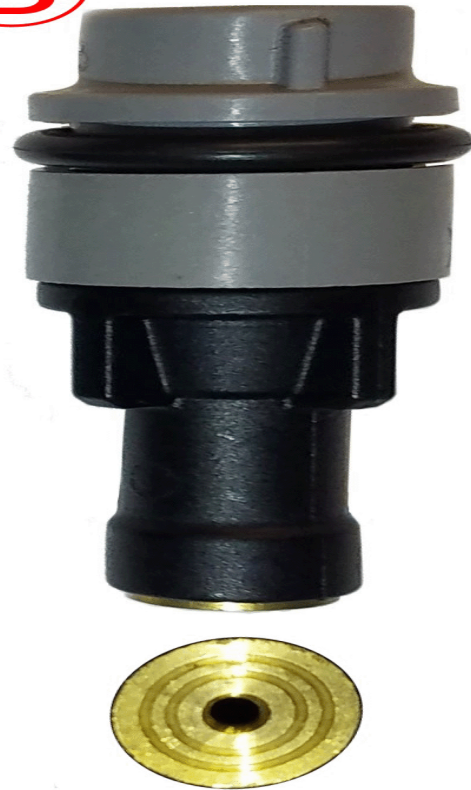
**Note:** The graphic above compares the old style primary PCV valve (A) to the revised PCV valve (B).
