# Service Bulletin

Bulletin No.: 18-NA-383

**Subject: Water Found in Rear Interior of Cab, Water Leak at Rear Sliding Window**

Brand:	Model:	Model Year:		VIN:		Engine:	Transmission:
		from	to	from	to		
Chevrolet	Silverado 1500 (New Model)	2019	2019	SOP	Prior to October 1, 2018	All	All
GMC	Sierra 1500 (New Model)

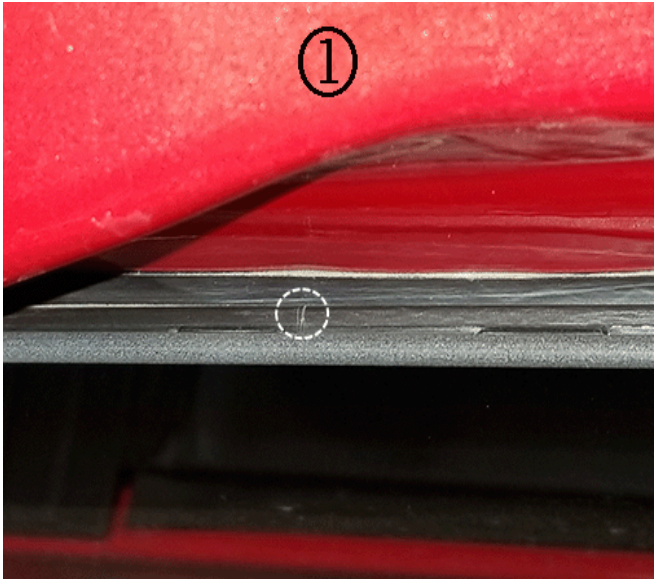
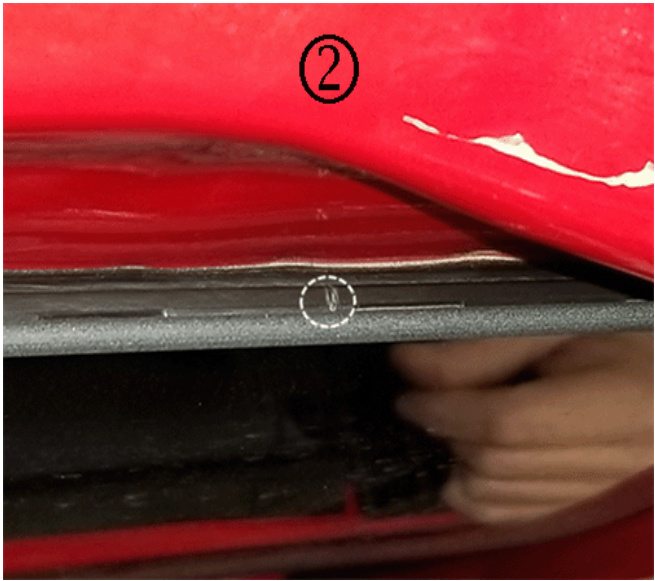
<p style="text-align: right; margin-right: 20px;">5201855</p> <p><b>Note:</b> The cracks can be in the left and/or right side of the rear sliding window plastic upper rail glass guide which is covered by the roof rear spoiler. Examples of a left (1), then right side (2) visual crack (with the spoiler removed) are shown in the graphics above.</p> <p>The cause of the condition may be cracking in the rear sliding window plastic upper rail glass guide. The plastic upper rail glass guide may develop small fractures/cracking which allows water to pass through on the glass side of the urethane that attaches to the vehicle body.</p> </div>
<p><b>Correction</b></p>	<p><b>Important:</b> When verifying this condition, ensure that the water leak path is due to cracks in the rear sliding window plastic upper rail glass guide, and NOT a leak in the primary urethane seal, between the window and the body; or from the spoiler attachments to the truck cab which are in the same area. Please indicate power sliding rear window crack in warranty claim verbiage.</p> <p><b>A leak in the primary urethane seal should be addressed by removing and resealing the window, using the standard service procedure from SI.</b></p> <p>R &amp; R the roof rear spoiler and apply seam sealer to the rear sliding window top encapsulate, following the steps in the Service Procedure below.</p>
