TECHNICAL SERVICE BULLETIN

Fender Mounted Auxiliary Marker Lamps Not Blinking With Turn Signal - Built On 03-Jan-2019 And Through 14-Feb-2019

19-2101
10 April 2019

Ford 2019 F-650/750

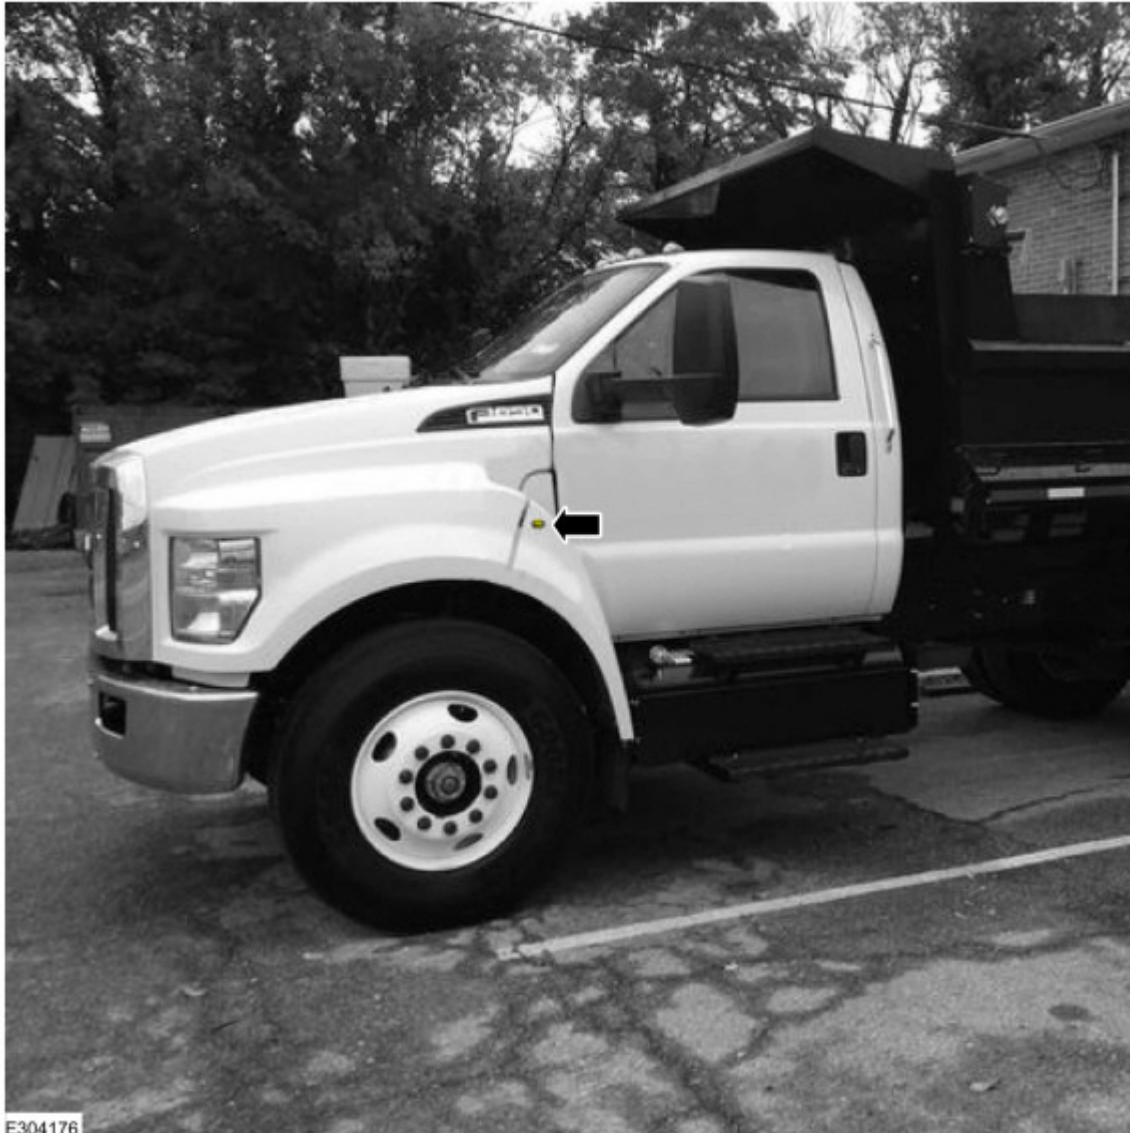
Figure 1

1. Are the front fender auxiliary marker lamp(s) blinking with the turn signal? (Figure 1)
 - (1). Yes - this article does not apply. Refer to Workshop Manual (WSM), Section 417-01 for normal diagnostics.
 - (2). No - proceed to Step 2.

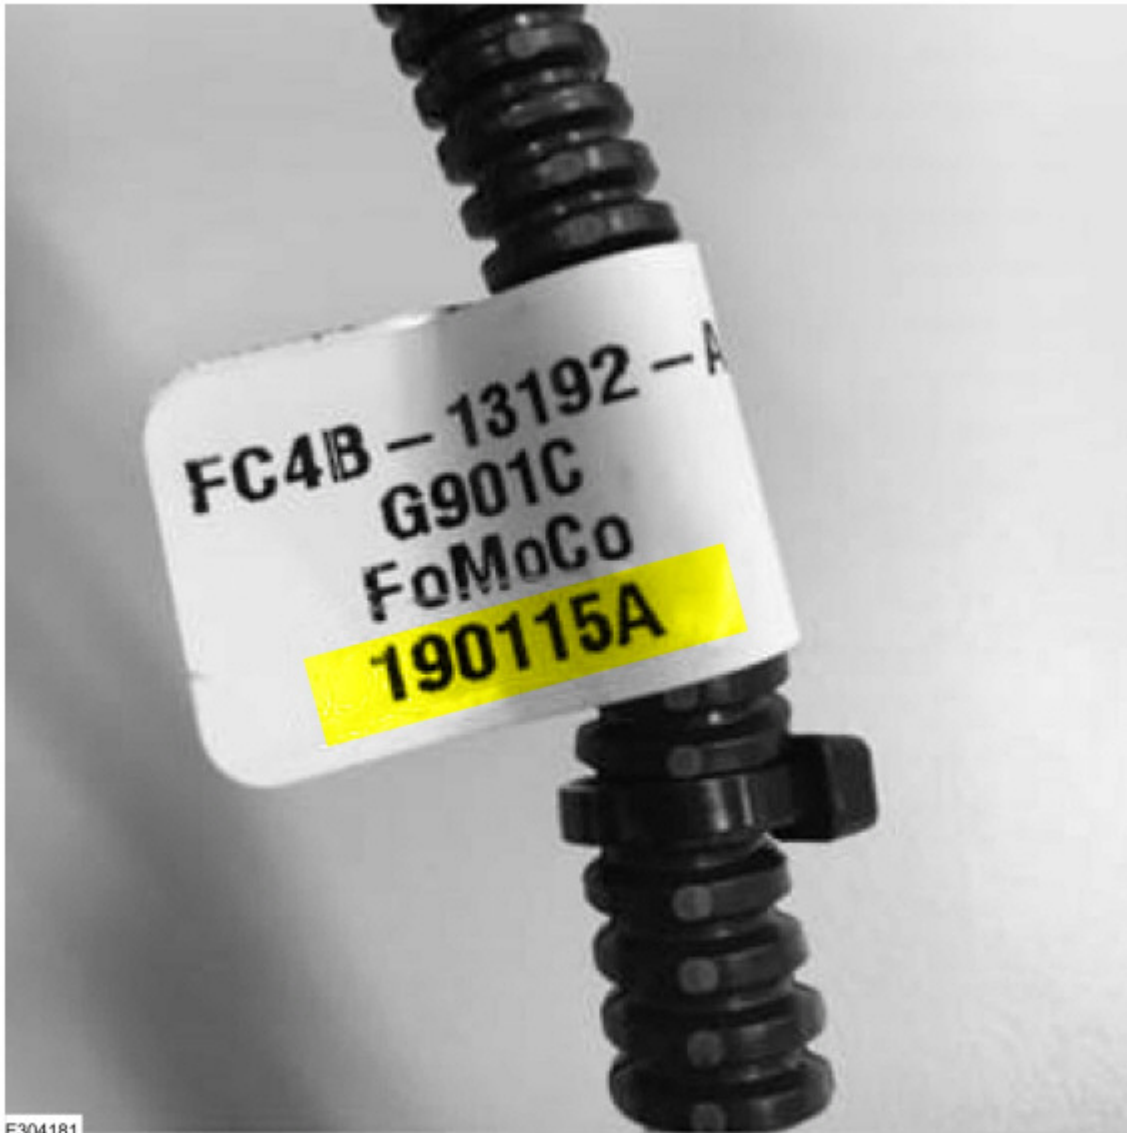
Figure 6 - example of before the Julian date code

NOTE: The new lamp should have a Julian date code (YYMMDD) 190215 or later. (Figure 6)
