Service Bulletin

Bulletin No.: 00-06-01-012H

Date: September, 2017

Subject: Use of "Surface Conditioning Disks" When Cleaning Gasket Sealing Surfaces and/or Reused Parts

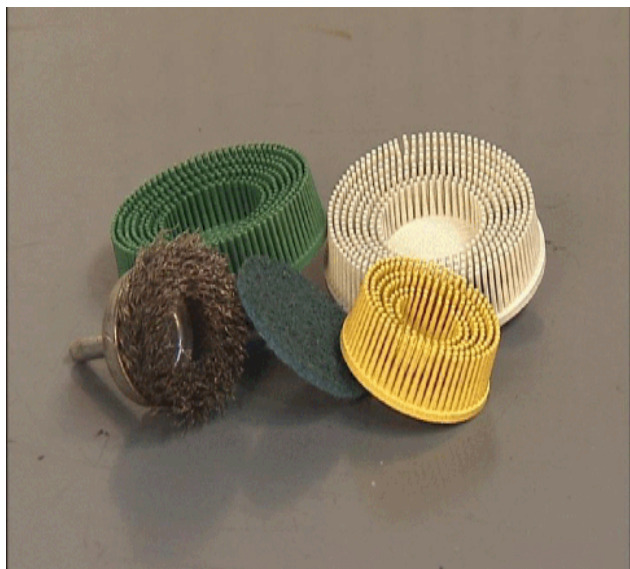
2726943

Notice: Do not use abrasive pad/bristle devices to clean the gasket surfaces of any engine, transmission, transfer case and axles as well as any other component that contains lubricant. Abrasive pads should not be used for some of the following reasons:

- Abrasive pads will produce fine grit that the oil filter will not be able to remove from the oil. THIS GRIT IS ABRASIVE AND HAS BEEN KNOWN TO CAUSE INTERNAL ENGINE DAMAGE. Abrasive pads can easily remove enough material to round cylinder head surfaces. This has been known to affect the gasket's ability to seal, especially in the narrow seal areas between the combustion chambers and coolant jackets.

- Abrasive pads, wire and abrasive rubber finger wheels can also remove enough metal to affect cylinder head, block, oil pan rail, and intake manifold runner flatness, which can cause coolant and oil leaks and air leaks. It takes about 15 seconds to remove 0.203mm (0.008in) of metal with an abrasive pad.

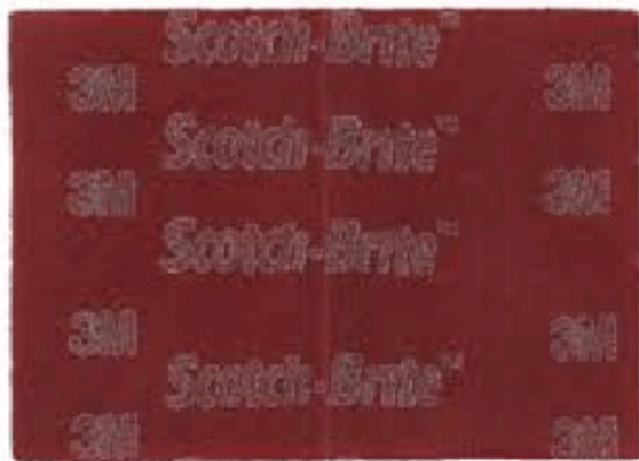
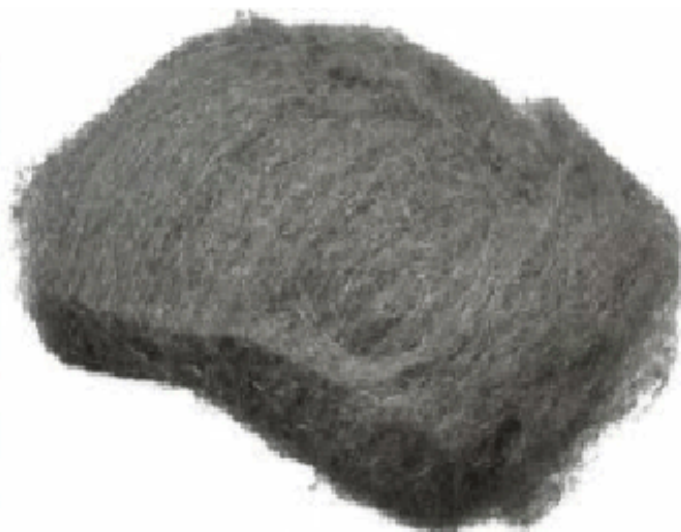
4809214

The use of an abrasive hand pads and/or steel wool can also create imperfections in the metal and therefore are not recommended for use when cleaning surfaces.

When cleaning gasket sealing surfaces and/or cleaning parts that are to be reused, surface conditioning disks, hand pads, or steel wool (typically constructed of woven fiber, steel or molded bristles) that contain abrasives, such as a high amount of Aluminum Oxide, should NOT be used.

The use of such surface conditioning items dislodges Aluminum Oxide (from the disk) and metal particles (from steel wool), which can lead to premature engine bearing failure.

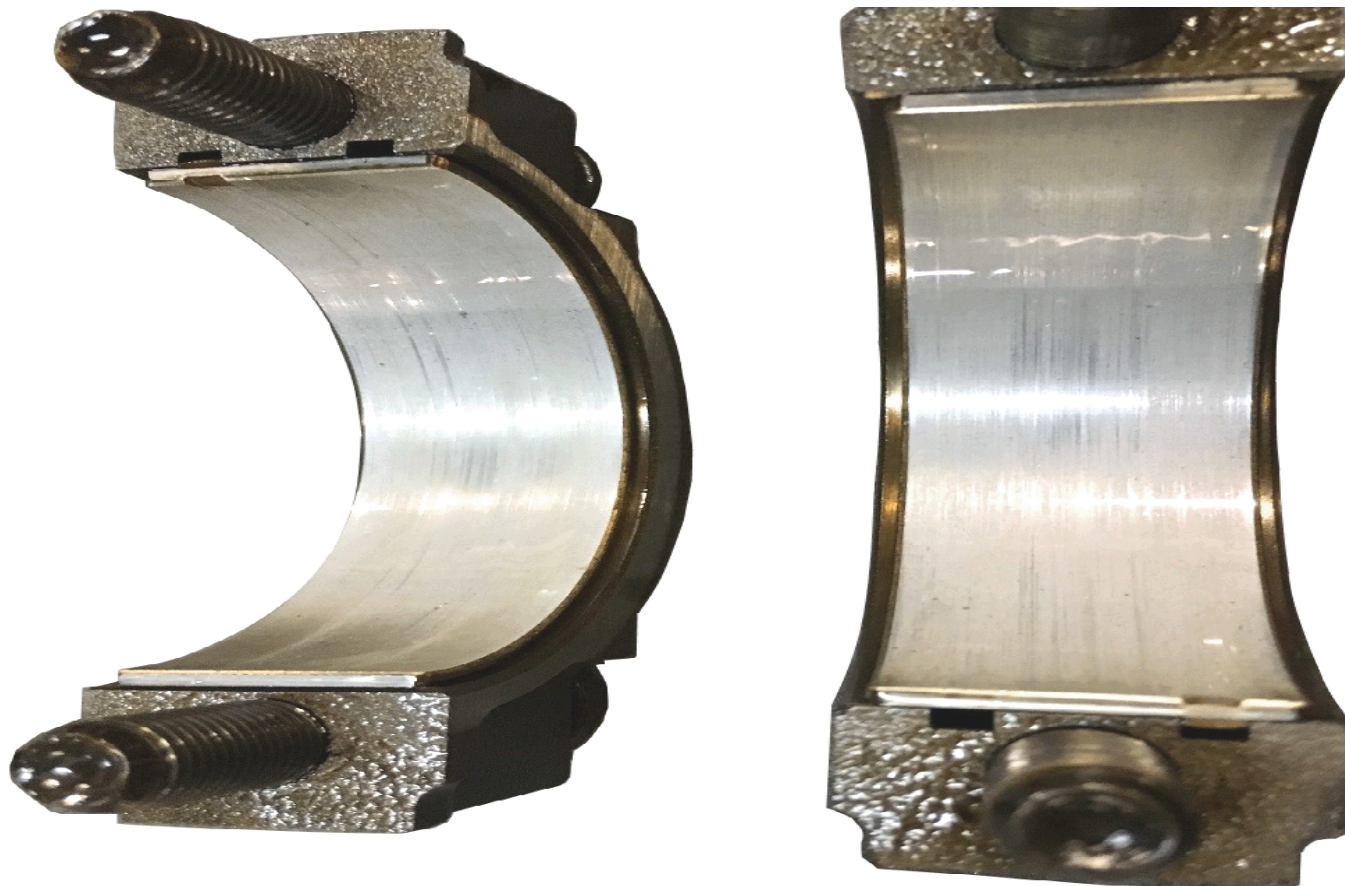
4788796

The presence of Aluminum Oxide in engine oil has been shown to cause premature engine bearing failure. In some cases, this failure occurs in as little as 2,200♦km (1,367♦mi) or less after the repair has been made.

The scratches on the bearings in the above picture were created when debris from an abrasive pad made its way into the bearing. This debris is a combination of the metal and particles from the abrasive pad that were removed when the engine was cleaned.

General Motors recommends the use of a razor blade or plastic gasket scraper to clean the gasket surface on components that are to be reused. When cleaning gasket surfaces, please note the following:

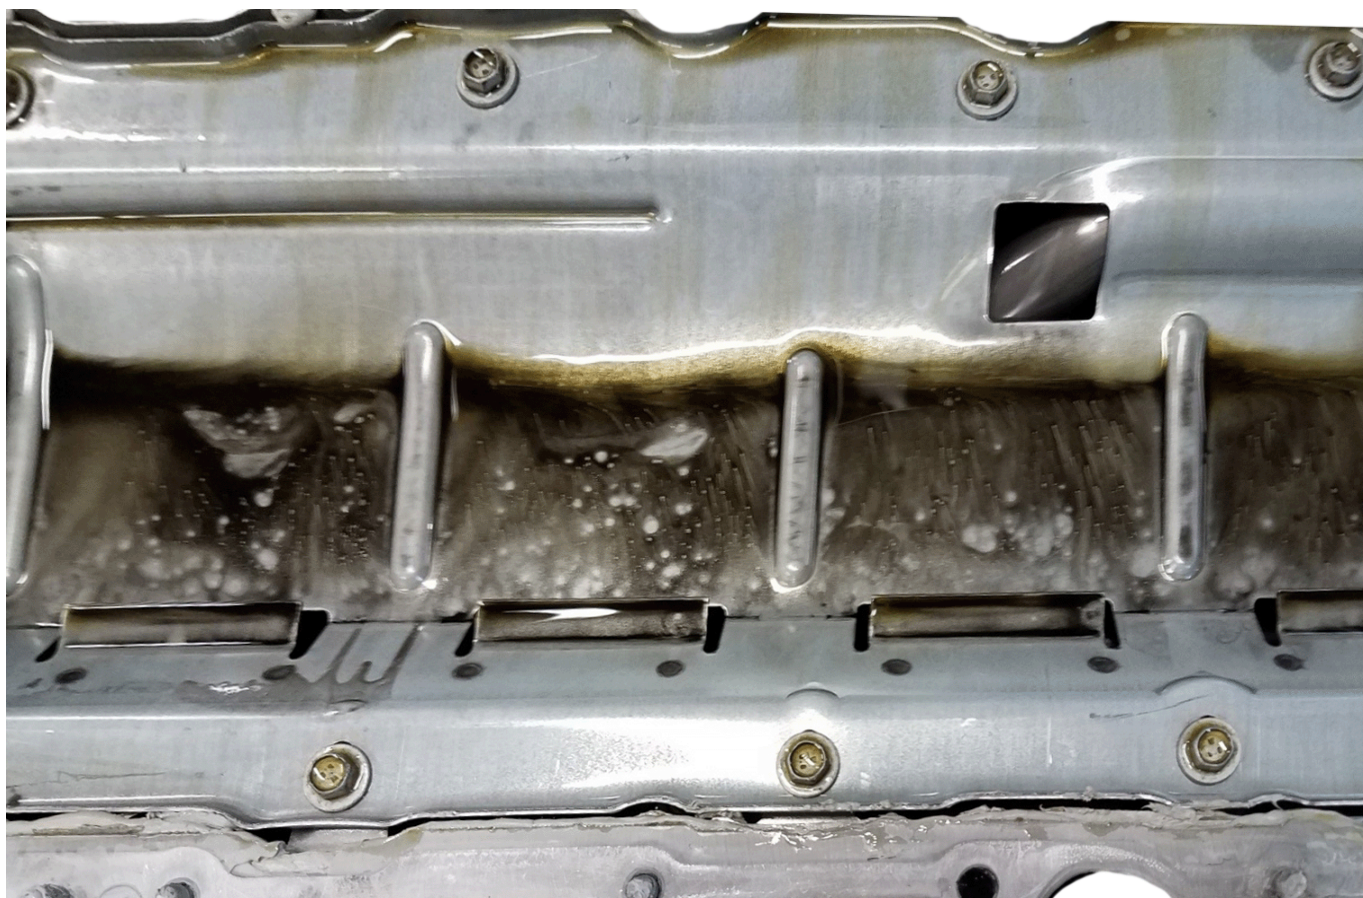
4789486

The crankshaft deflector in the picture above has debris that was left behind from the abrasive cleaning methods. Once the debris has gotten here, it can be distributed to any surface in the engine.

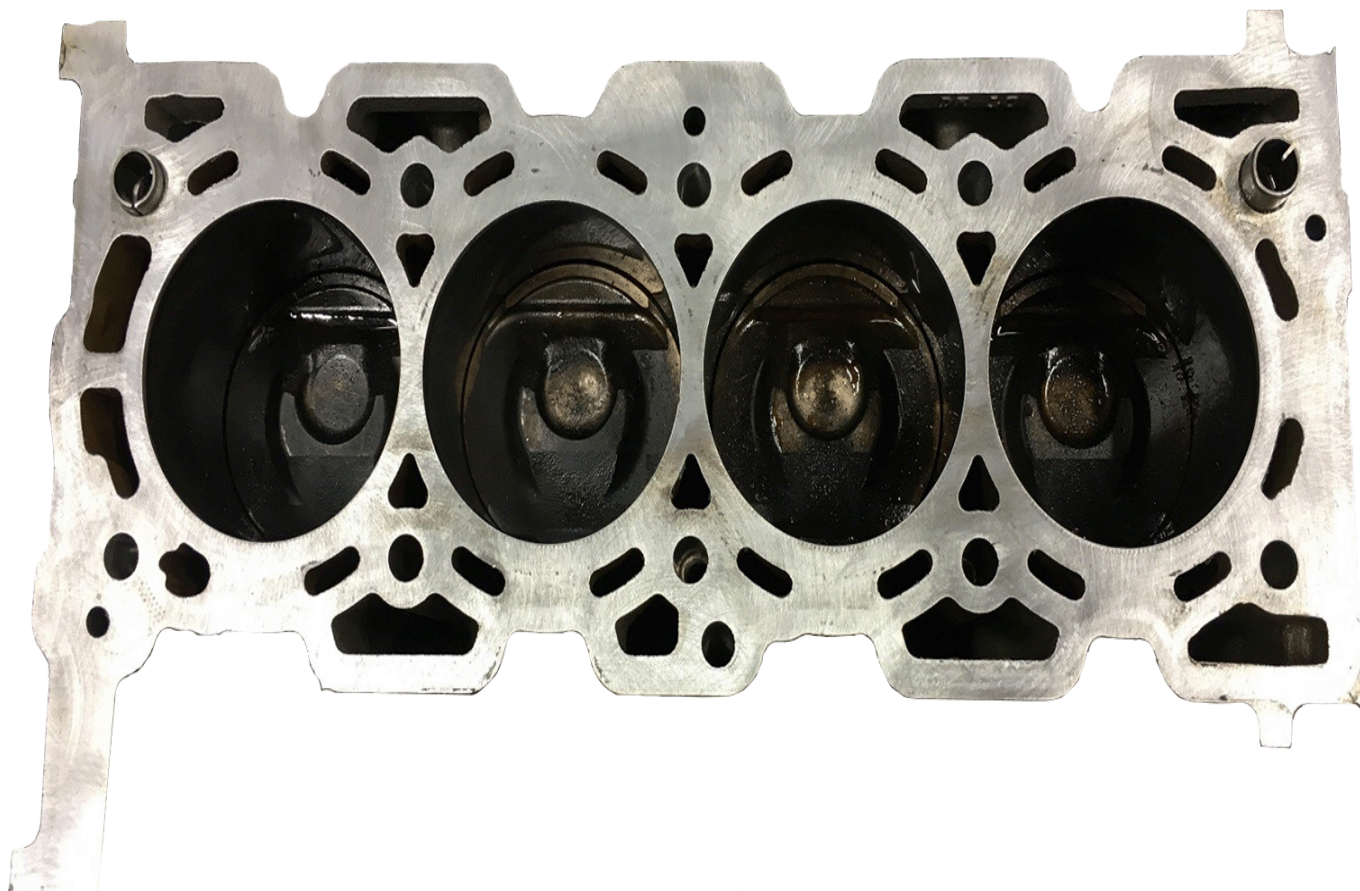
4788615

An overview of the deck face when it has been cleaned with an abrasive pad, left swirls on the surface and do not go in the same direction which caused changes the surface dimensions (flatness) of the block leaving it un-usable.

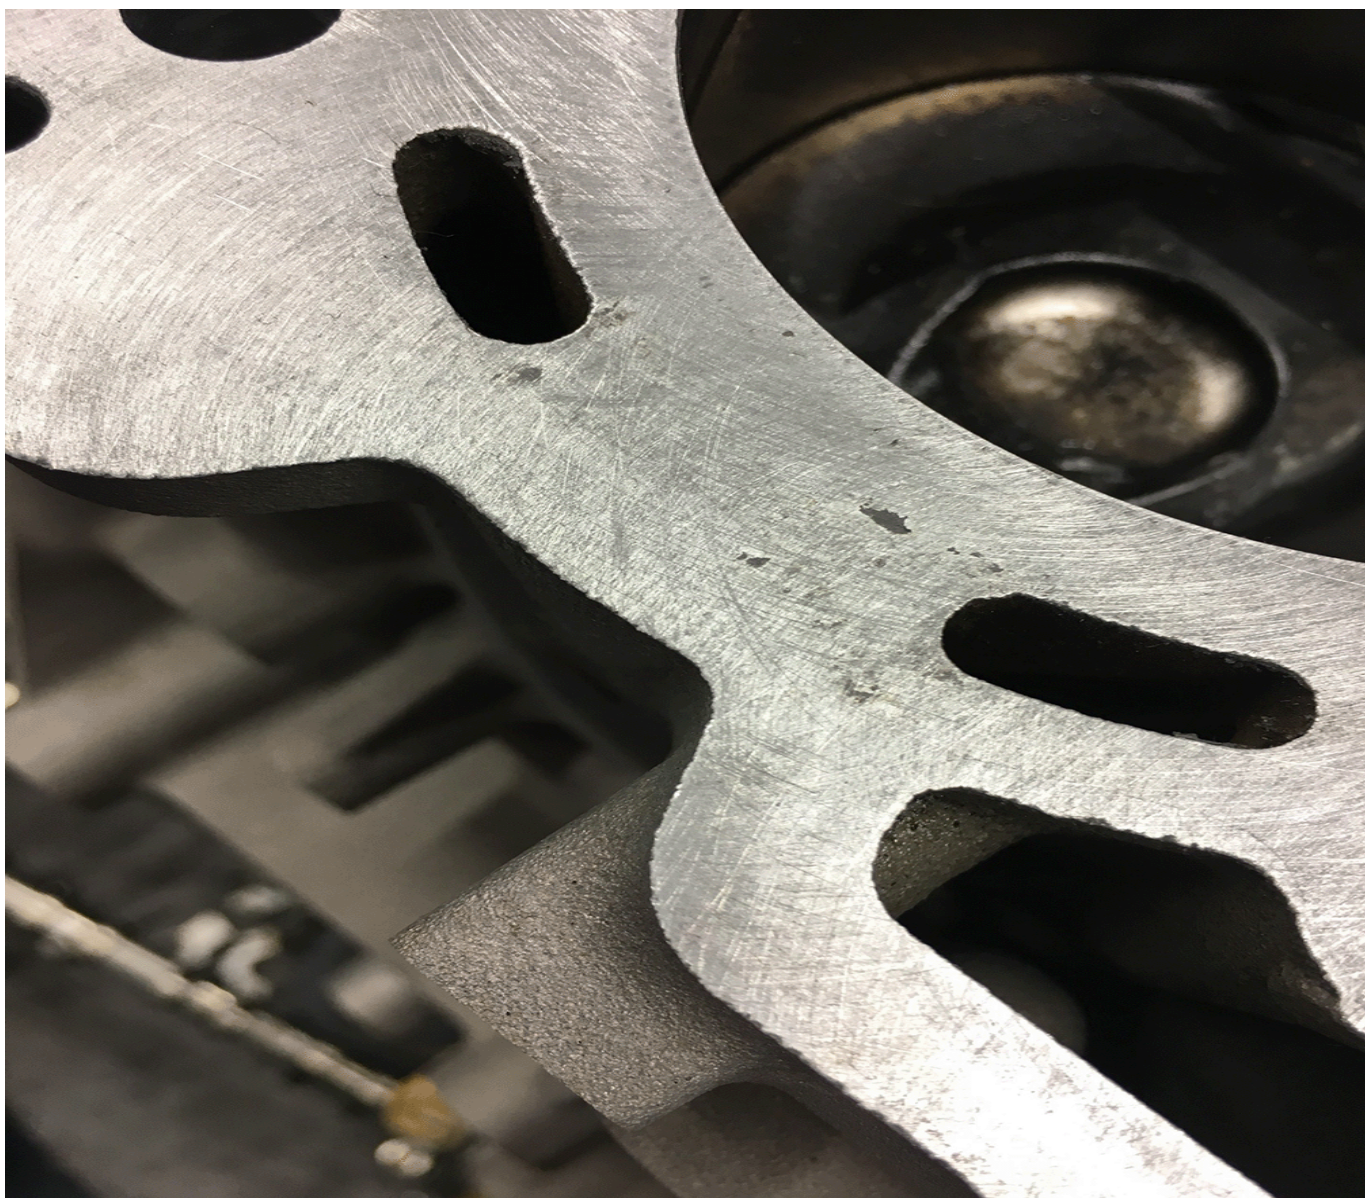
4789846

Scratches from the pad are deeper in some areas than others causing the gasket/seals not to properly seal against an uneven surface.

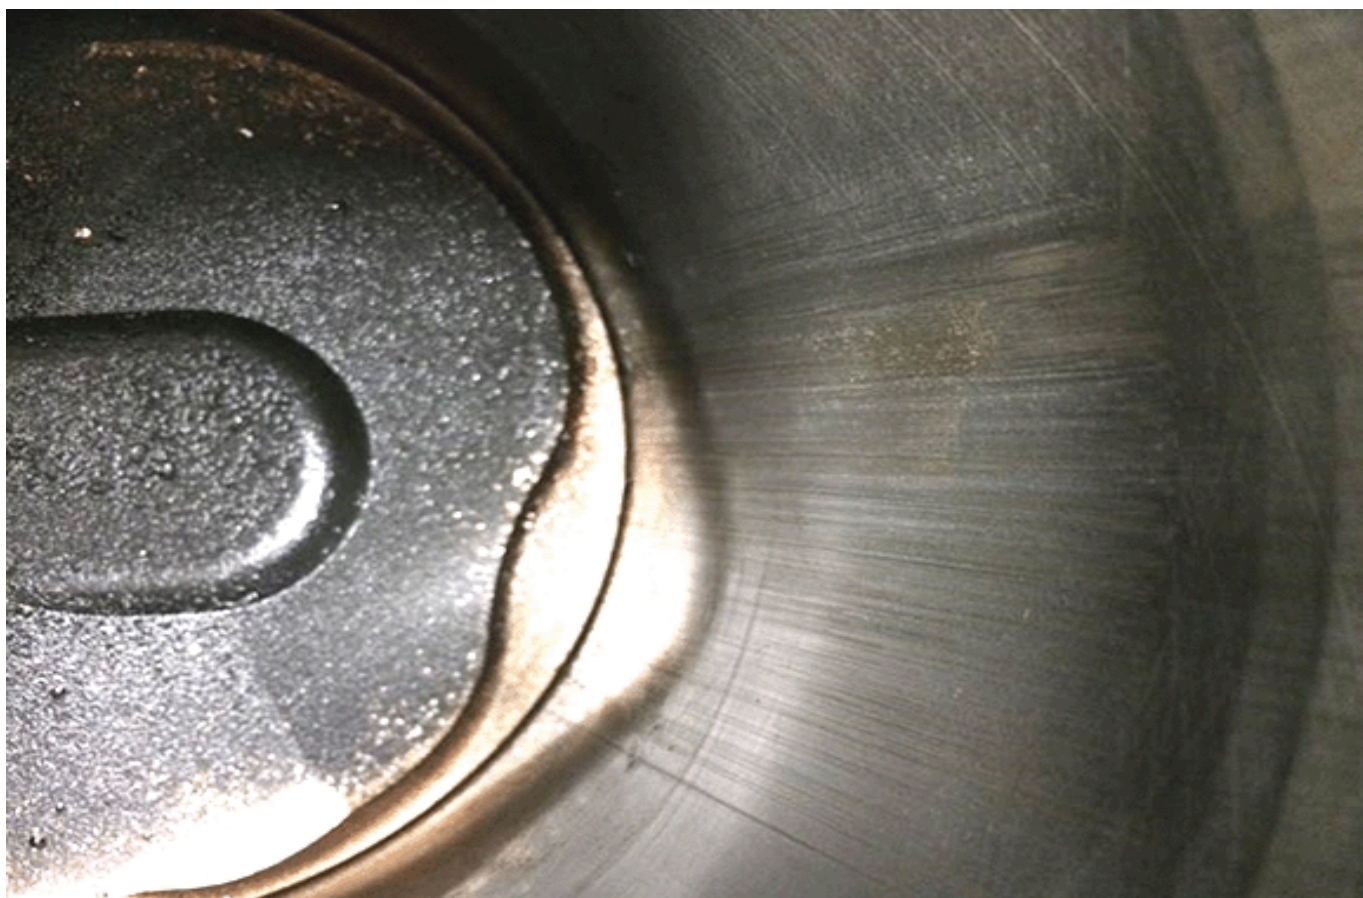
4788657

Note: Damage to the pistons and/or cylinder walls, may result in an engine knocking, tapping and/or possible low compression.

The sides of this cylinder wall were scarred with scratches as a result of the debris created by the abrasive cleaning pads. This debris gets trapped between the piston head and the cylinder wall causing damage the cylinder bore as the piston moves up and down.

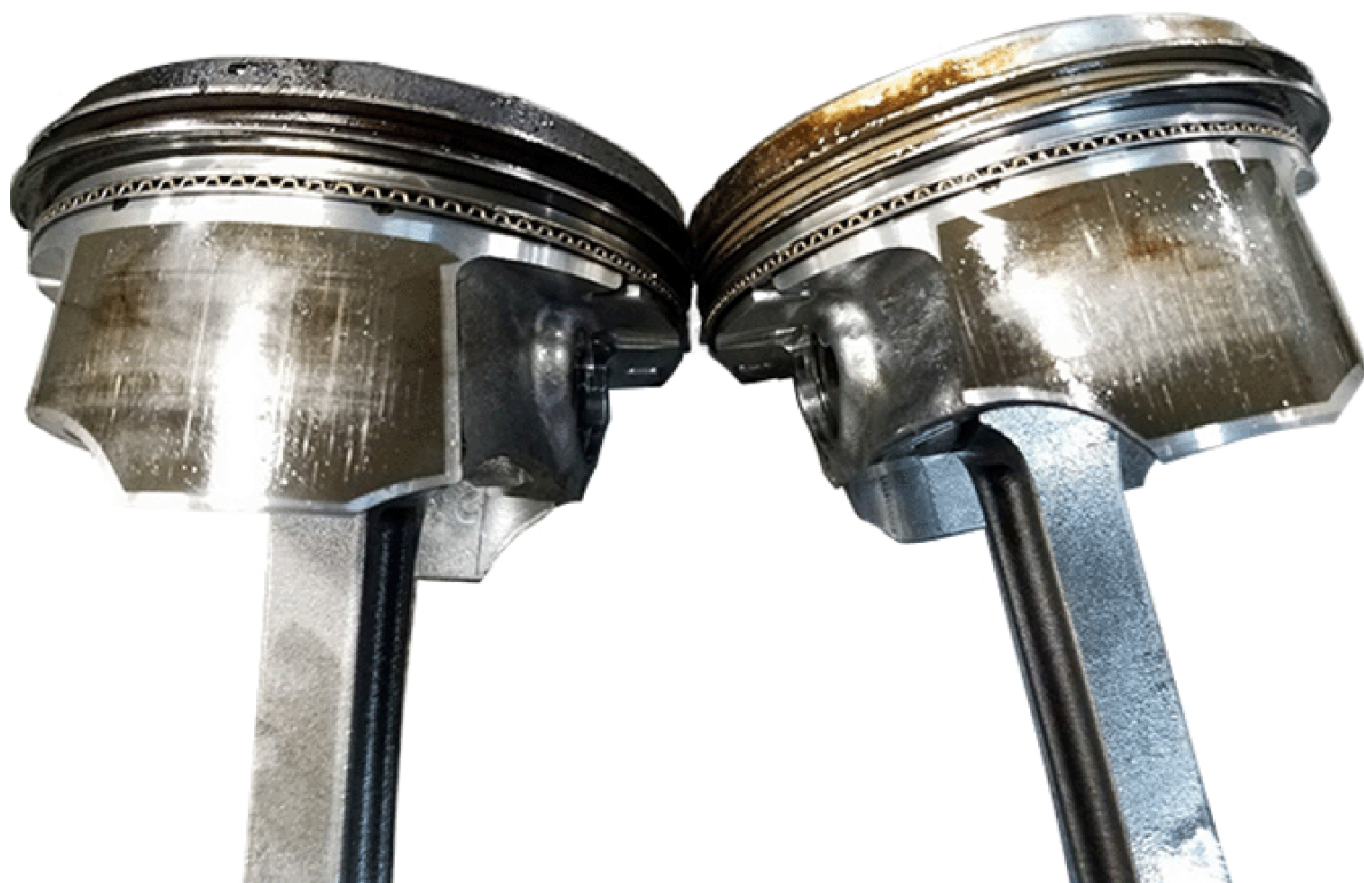
4800927

The piston skirt and piston ring damage caused by abrasive cleaning pads.

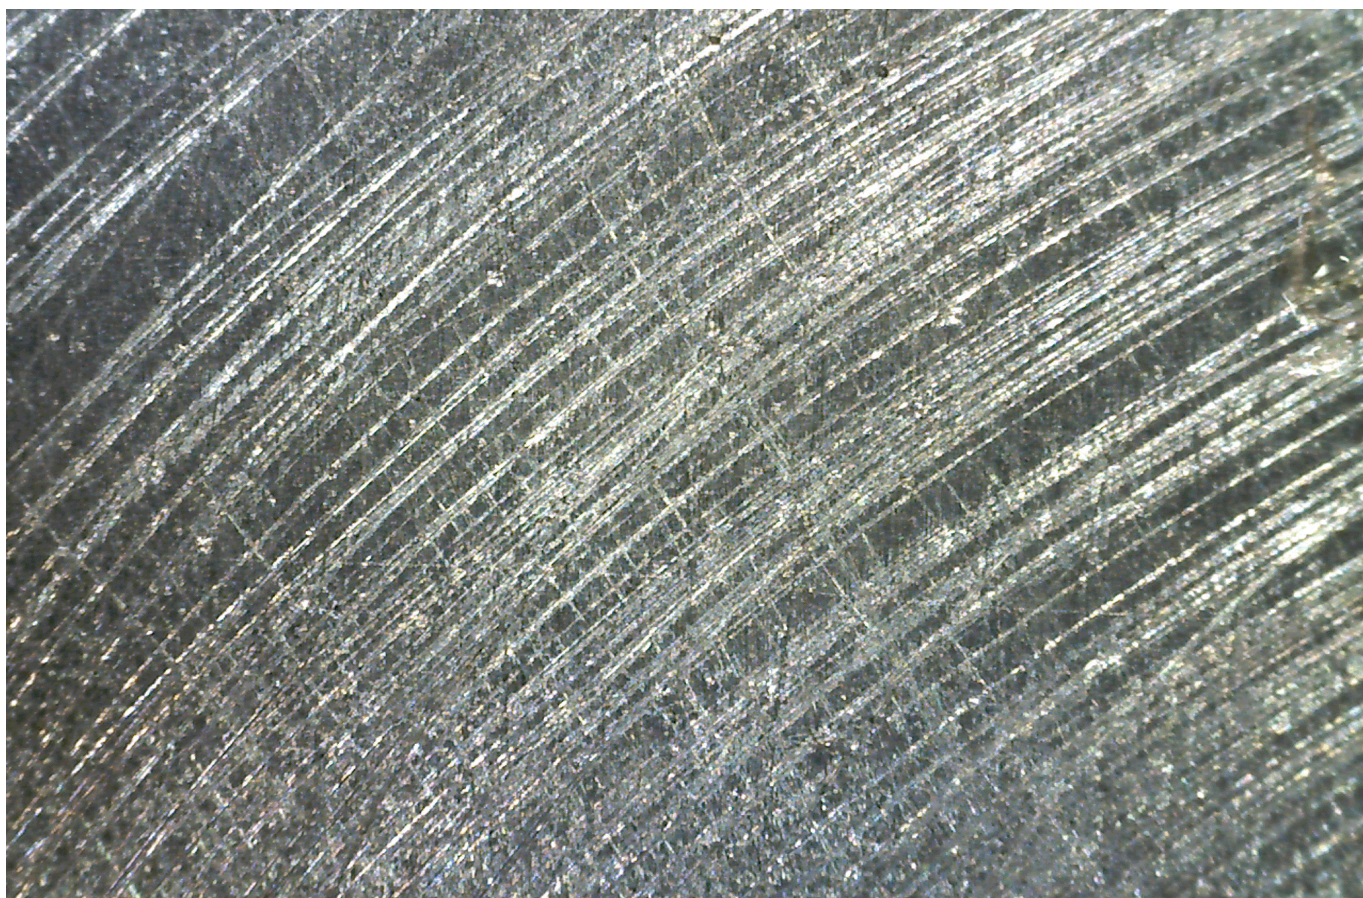
4791149

A close-up of the surface shows deep grooves caused by using an abrasive cleaning disc.

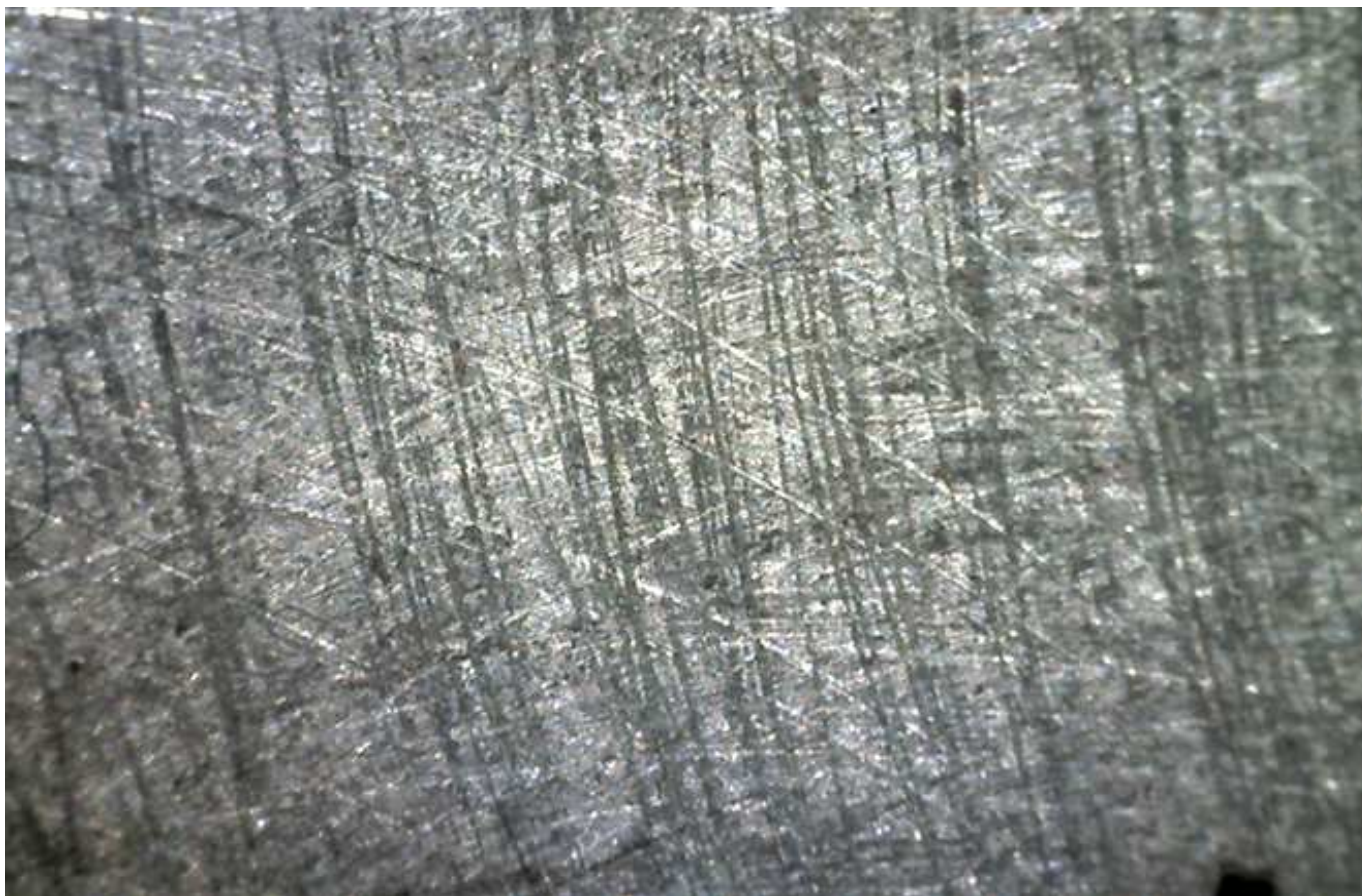
4791276

A close-up of the surface shows deep grooves caused by use of a wire wheel.
