Service Bulletin

Bulletin No.: 12-08-51-002G

Subject: Spray-in Bed Liner General Information and Repair Procedures

Models: 2013-2014 Chevrolet Silverado HD 2500/3500 Series

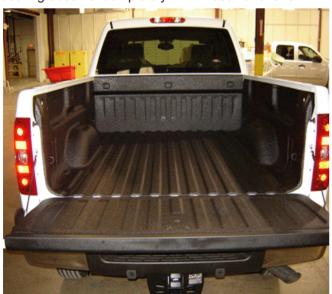
2968662

Because the bed liner material is sprayed on evenly, any variation in the bed such as seam sealer or spot welds in the sheet metal will show underneath the spray on coating. This is an expected condition. The coating does not completely fill in these variations.
