**PRODUCT CAMPAIGN BULLETIN**

**APPLICABILITY:** 2013-2017 Crosstrek  
 2014-2016 Forester  
 2008-2016 Impreza 4-door  
 2012-2016 Impreza 5-door  
 2008-2014 WRX 4-door

**NUMBER:** WUE-90R  
**NHTSA ID:** 19V-149  
**DATE:** 04/09/19  
**REVISED:** 04/24/19

**SUBJECT:** Brake Lamp Switch Replacement

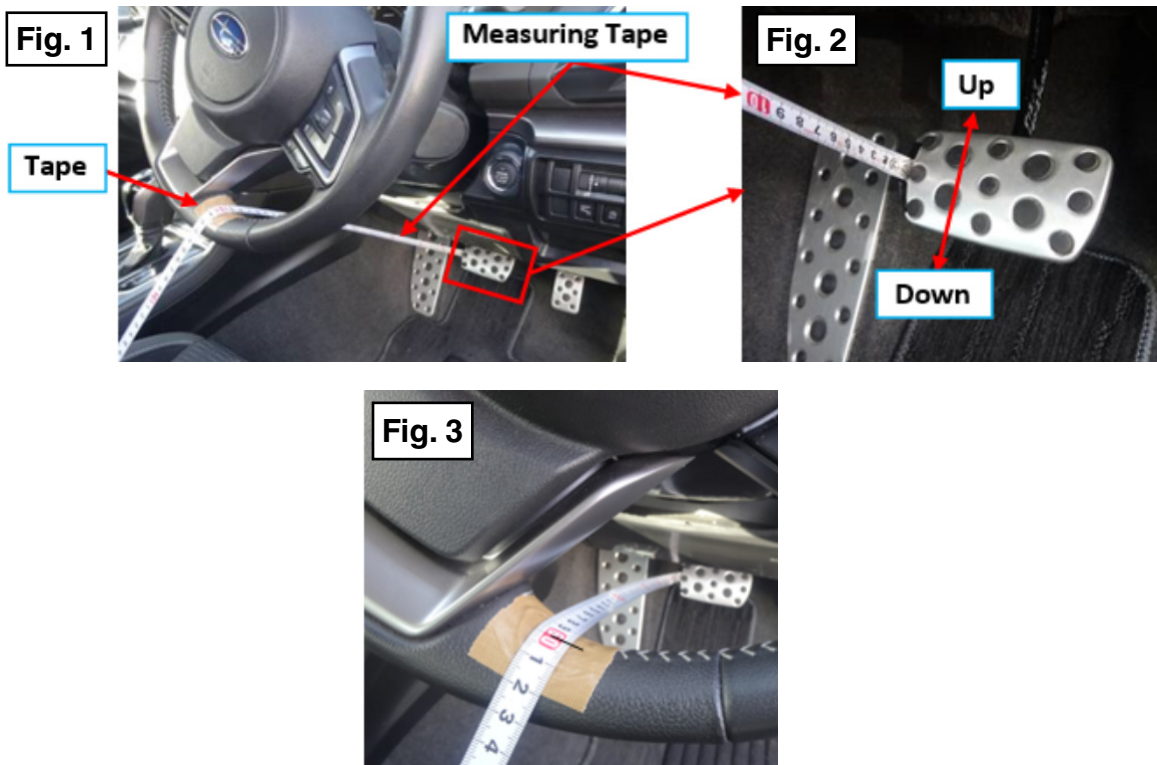
**The pedal stroke specification for these models is 4mm to 6mm.**

- › Telescopic position: **All the way IN.**
- Apply a small piece of tape to the steering wheel at the 6:00 position (**Fig. 1**). Use a fine-point pen or sharp pencil to make a thin line (**Fig. 3**) below. **IMPORTANT:** To avoid possible damage to the steering wheel cover, use a tape with enough adhesive strength to keep it attached while measuring and remove it as soon as possible. Blue painter’s tape or other low adhesive, residue-free tape is recommended.

- “Hook” the end of a tape measure to the end of the brake pedal as shown below. **NOTE:** The up-down position (**Fig. 2**, blue line) of the tape measure on the brake pedal is critical for making consistent measurements.

- **SLOWLY** depress the brake pedal until the brake lights illuminate. Measure the brake pedal stroke (distance from “free” position to stop light ON position) following the reference pictures below.

- If the measurement is within the standard value (4 mm - 6 mm), proceed to **11**) below and secure the conversion harness as described in **12**) below.
- If the measurement is out of standard value (less than 4 mm or more than 6 mm), repeat this step and **CAREFULLY** re-adjust the brake lamp switch position as necessary to achieve the standard value.
