SERVICE BULLETIN

APPLICABILITY: 2015-18MY WRX

NUMBER: 07-150-19

SUBJECT: Rear Combination Lamp Harness Replacement Procedure

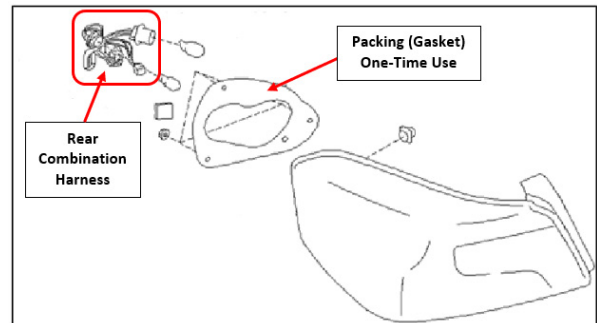
This bulletin provides a procedure for replacing the rear combination lamp wiring harness. The harness is now available as a service part separate from the lamp assembly.

The wiring harness part number is: **84981VA140**.
